CK-2055

LIUMCHEN 2.5km

2019 Inspection

| Crossing Name | Deer Creek | | |

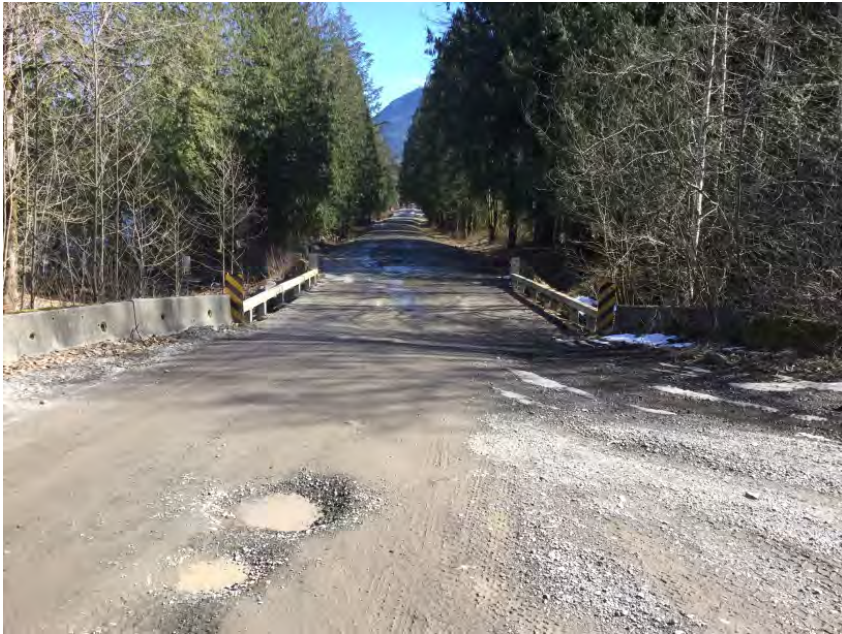
Approach from Left Bank when facing downstream

Road Surface Fair

Potholes at approaches

| Repair Item | Priority | Repair Description |
|---|---|---|
| 1 | Low | Grade approaches |

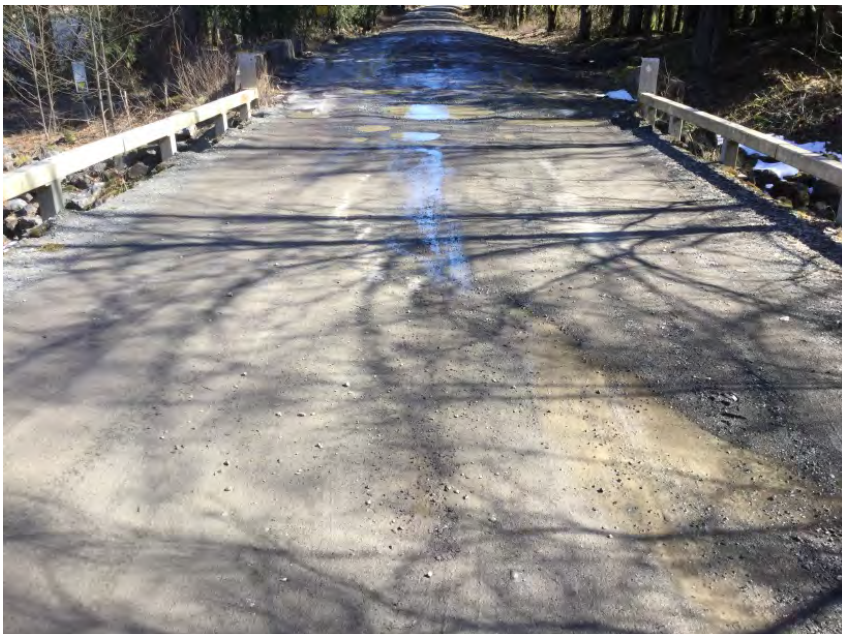
Overall Deck Condition      **Good**

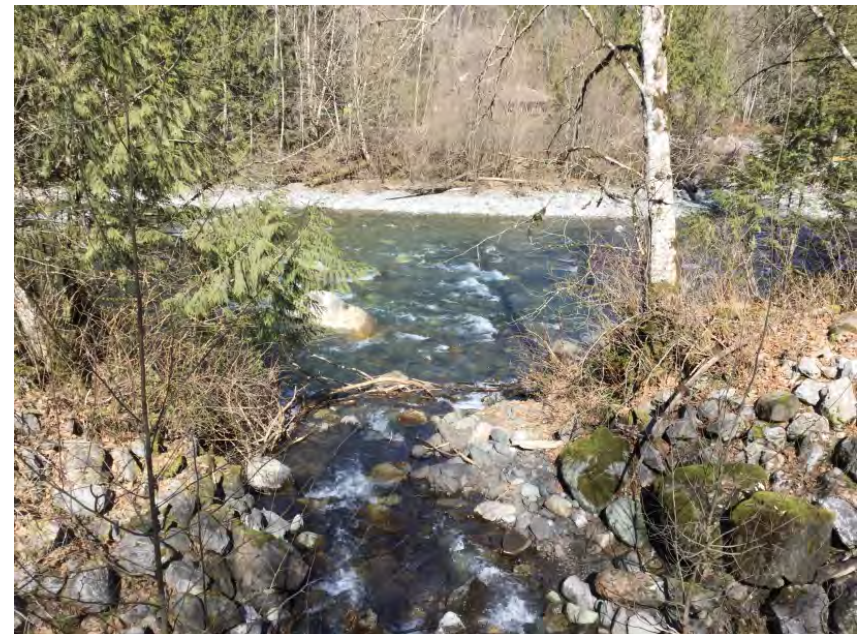
Downstream from Crossing

Comments    Downstream right bank riprap is scouring and requires monitoring

| Item | Monitor Description | Frequency |
|---|---|---|
| 1 | Riprap scour downstream | Routine Inspection |

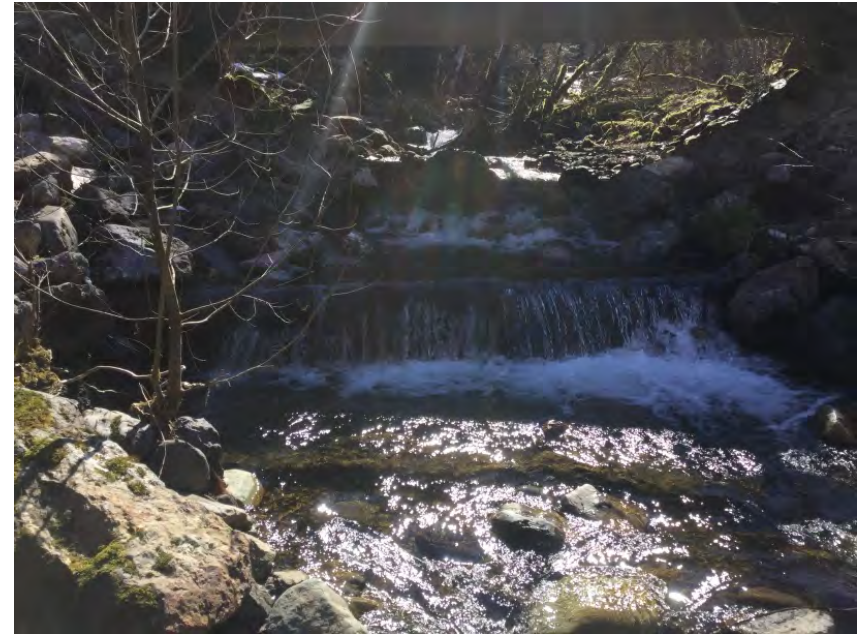
Riprap Fair Scour noted downstream

Log across stream is eroding and causing scour to riprap

Grade approaches and monitor the scour of the downstream riprap banks. The current load rating of BCL-625 or 63 tonnes to continue.

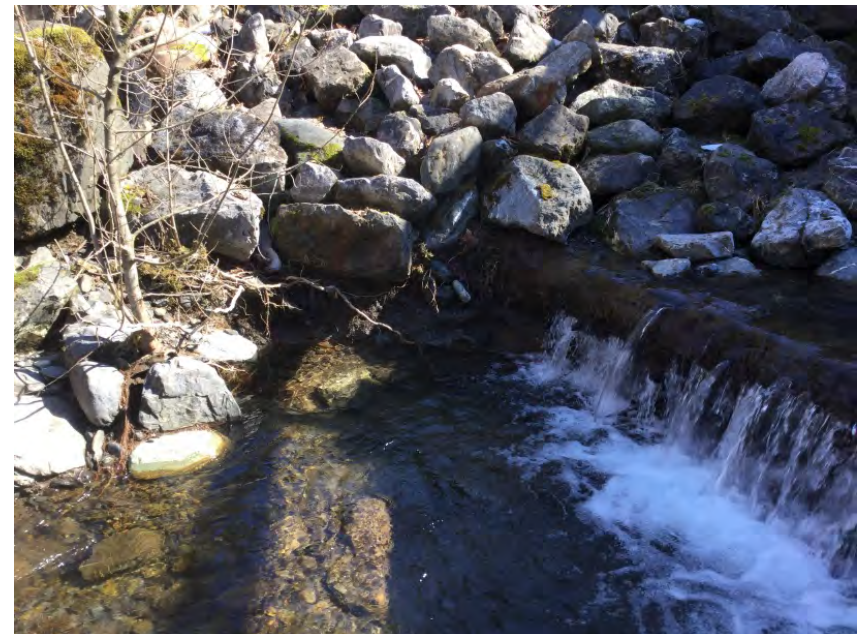
Log across stream is causing scour to riprap

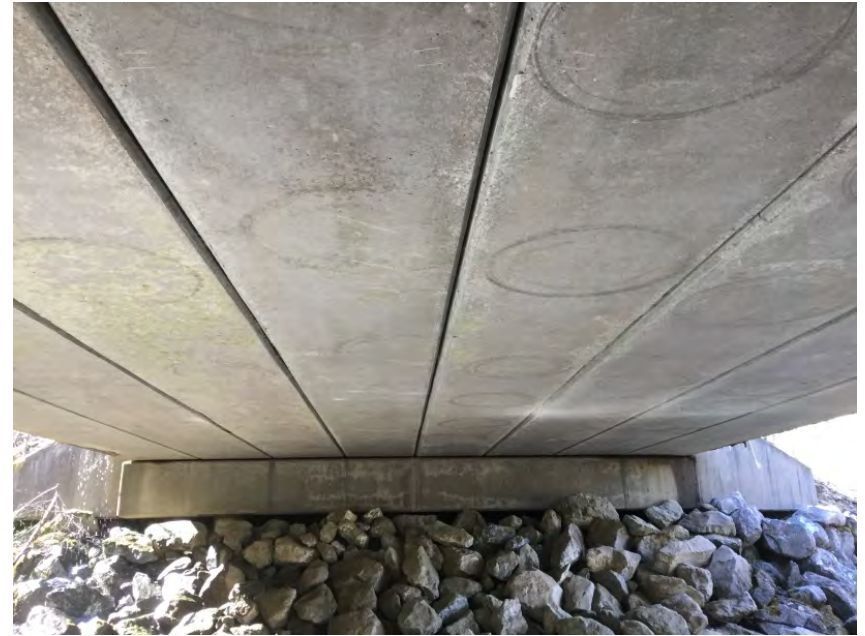
Superstructure

Girders Good 8 concrete slabs
