CK-2064

TAMIHI 6.3km

2019 Inspection

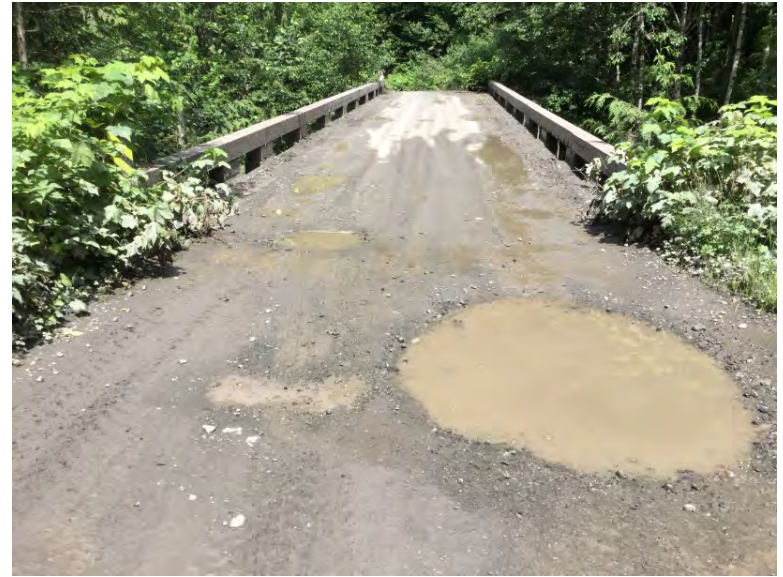
Road Surface Poor

Potholes at approaches

Add material and grade approaches

| 2 | Medium | Brush and grade approaches |

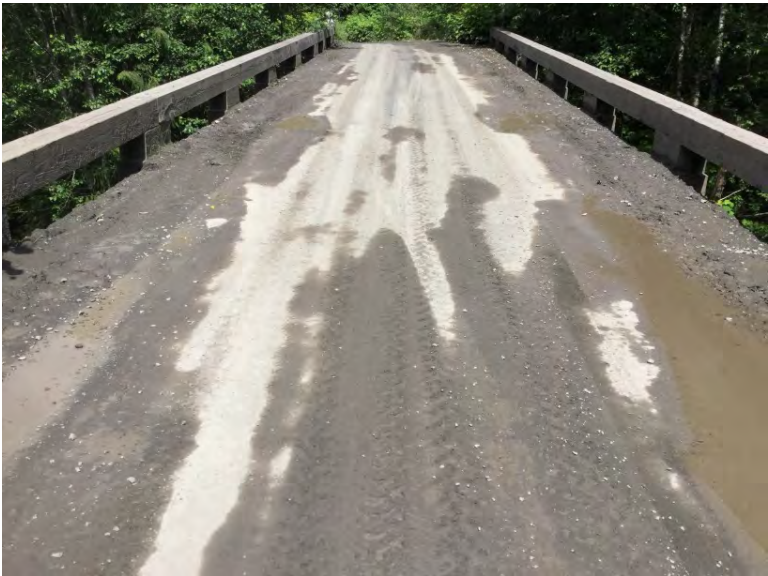
| Running Surface | Fair | Too much sediment from deck |

| Concrete Deck | Unrated | Too much sediment on deck to properly assess |

| 1 | Medium | Clean sediment off deck |

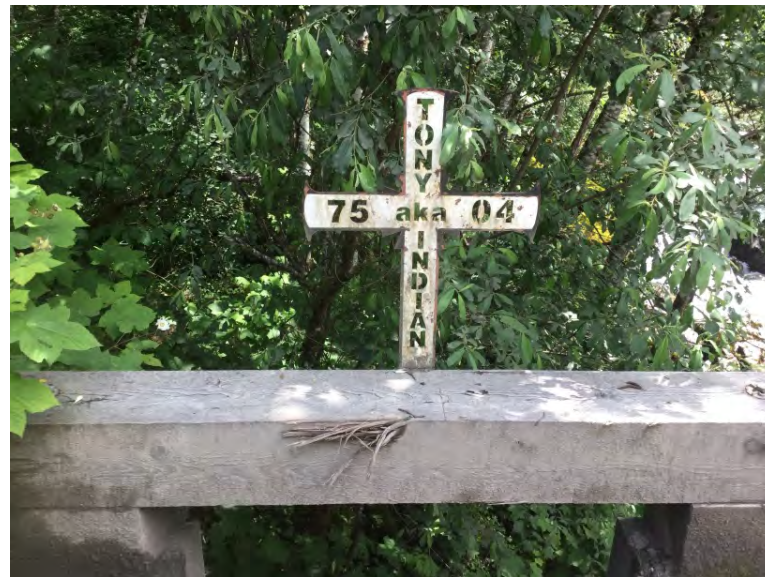
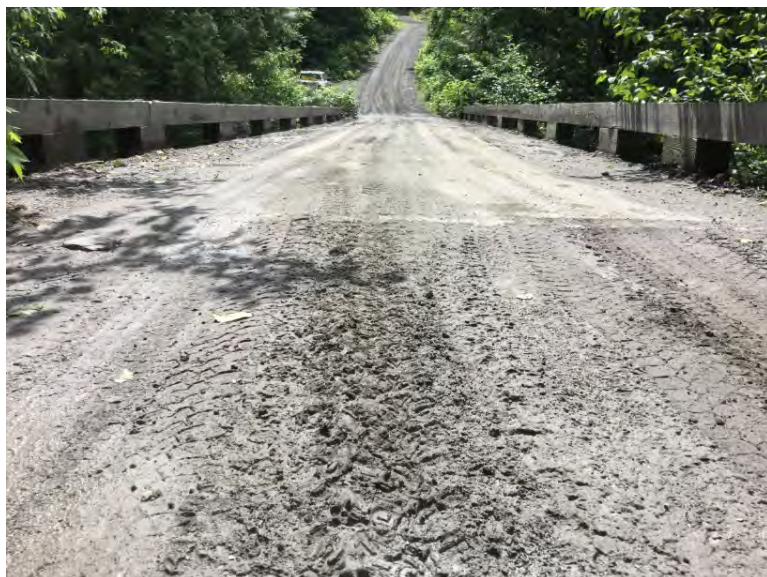
Could use additional fill at right approach

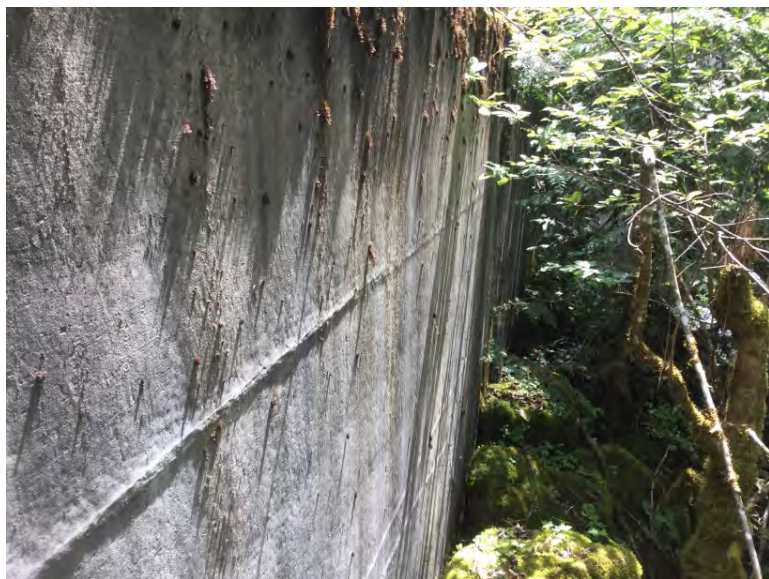
D/S right bank wingwall

Wing Wall Good

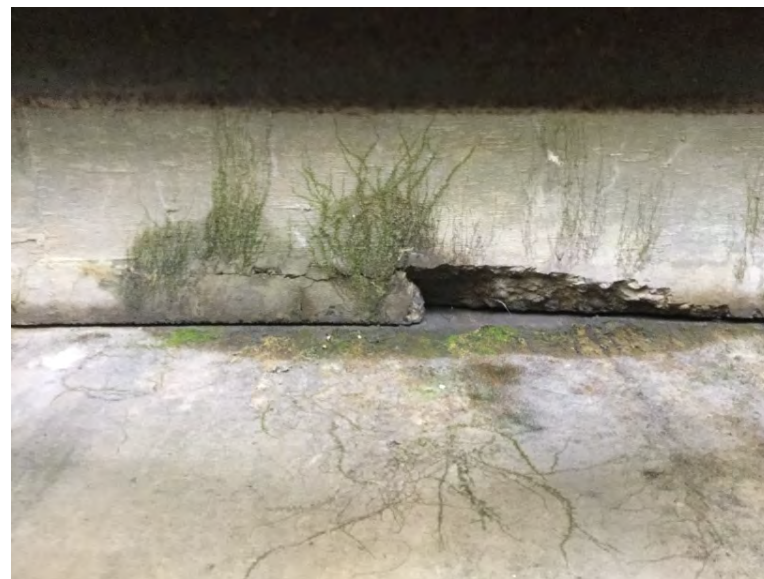
Panel damage at right bank

Repair the deck panel consistent with the Concrete Repair Guide for Concrete Bridge Components (MoFLNRO, 2017). Realign the left upstream fender log. Brush and grade approaches. Clean the sediment off the deck. The current load rating of L75 or 68 tonnes to continue.

| 4 | Medium | Repair the concrete deck panel |

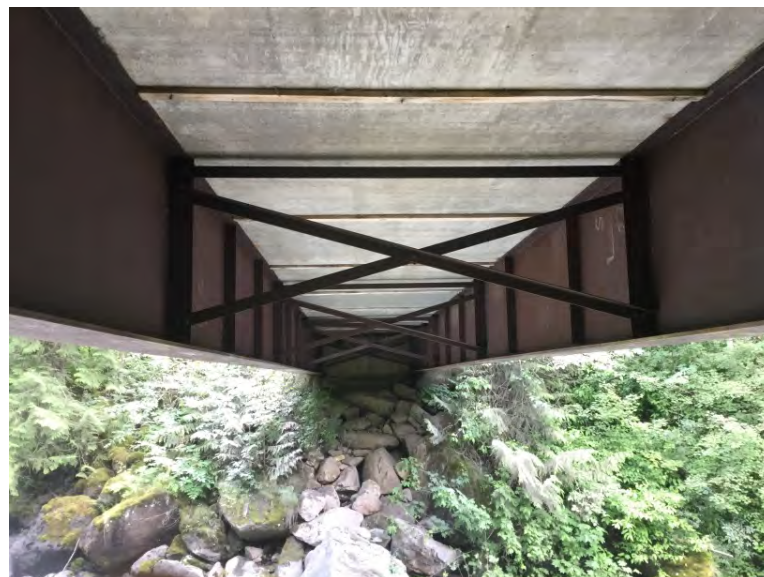
Superstructure

**Steel/Concrete**Girders **Good**Diaphragms **Good** 5 bolted bays

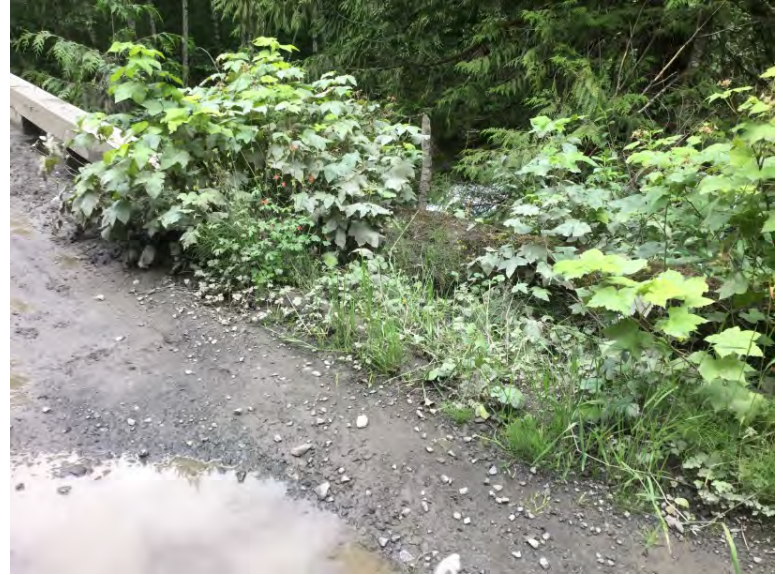
Upstream left bank fender log has fallen off road

| 3 | Medium | Realign upstream left bank fender log |
