CK-2065

TAMIHI 8.3km

2019 Inspection

| Crossing Name | Fumerol Creek |

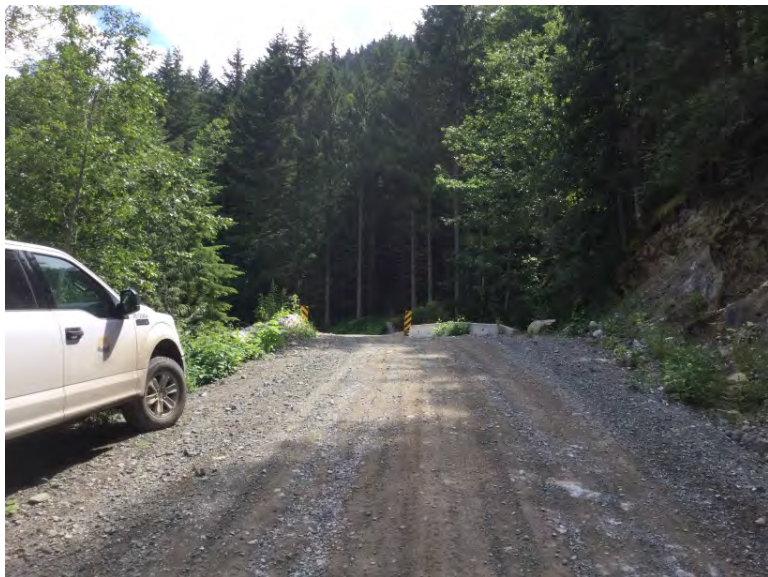
Approach from Left Bank when facing downstream

Steep VC left approach limits visibility

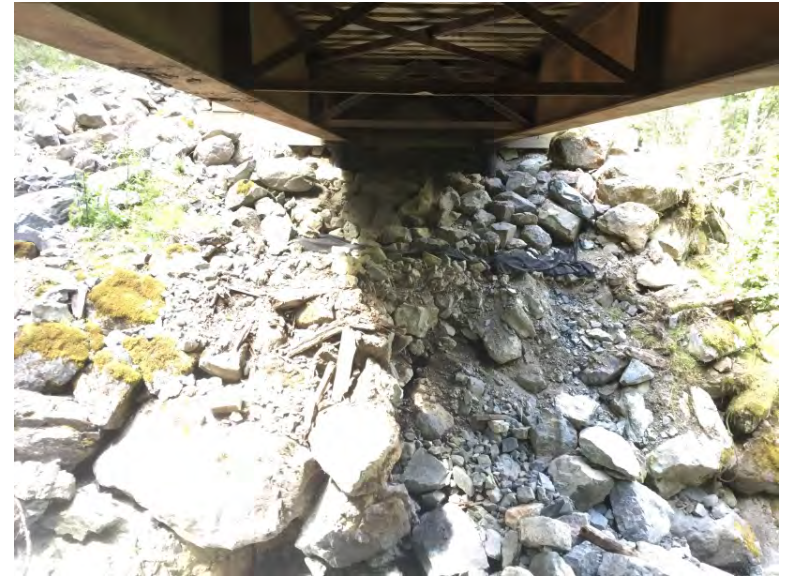
Left Bank Abutment when facing downstream

The downstream left bank abutment riprap is scoured and needs to be monitored, especially when in use and following high precipitation events. The current load rating of L100 or 91 tonnes to continue.

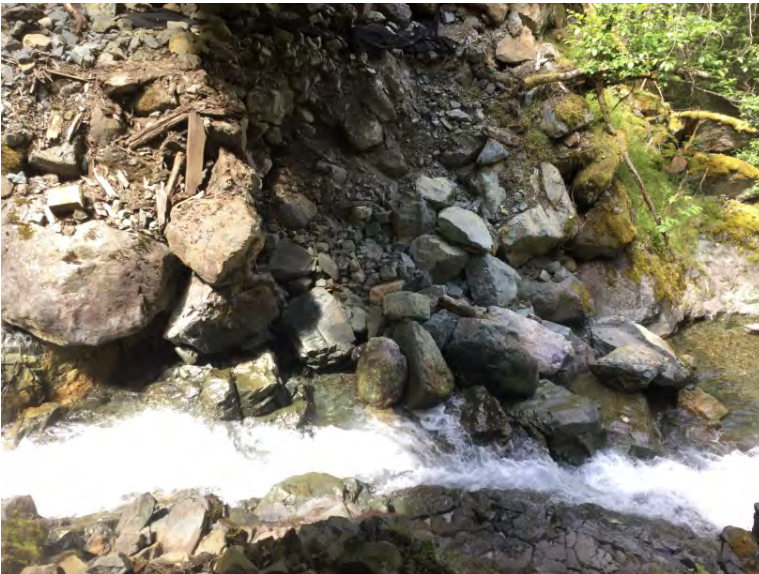
Riprap Poor Downstream left bank has failed

**Comments** Left bank riprap has scoured and remaining riprap above scour will continue to ravel until a stable angle is achieved. The upstream portion of the riprap on the left bank is still intact and provides for scour resistance at this point. This bank will need to be monitored.

Failed riprap at left bank

1 Riprap condition at left bank

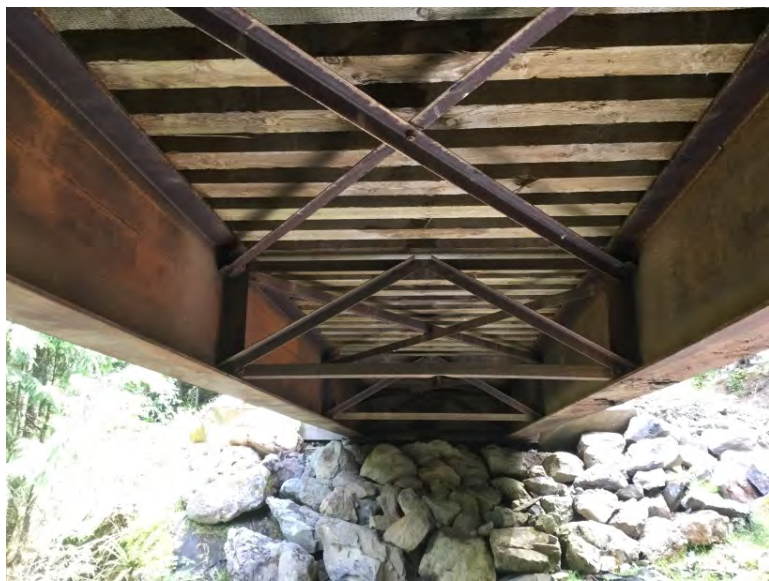
Superstructure

Girders Fair Light corrosion

Diaphragms Fair 5 bolted bays with light corrosion

Bracing Fair Light corrosion

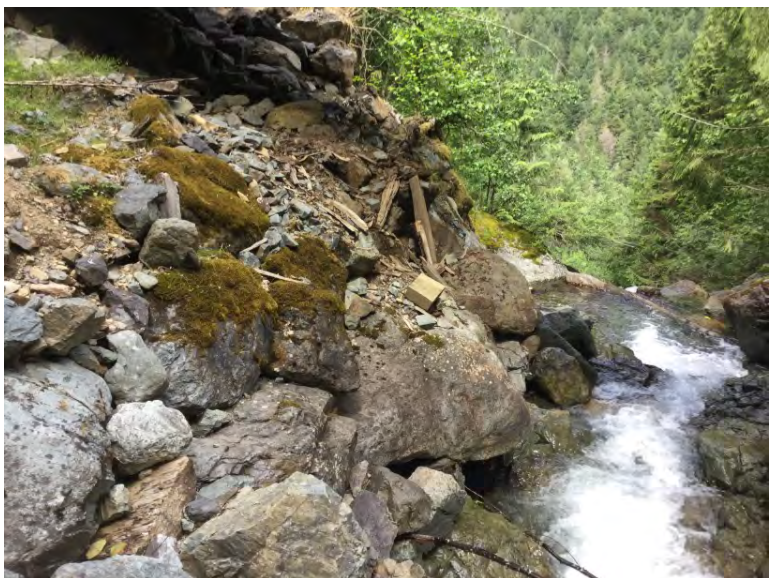
Upstream portion of left bank riprap
