CK-2066B

TAMIHI 10.3km

2019 Inspection

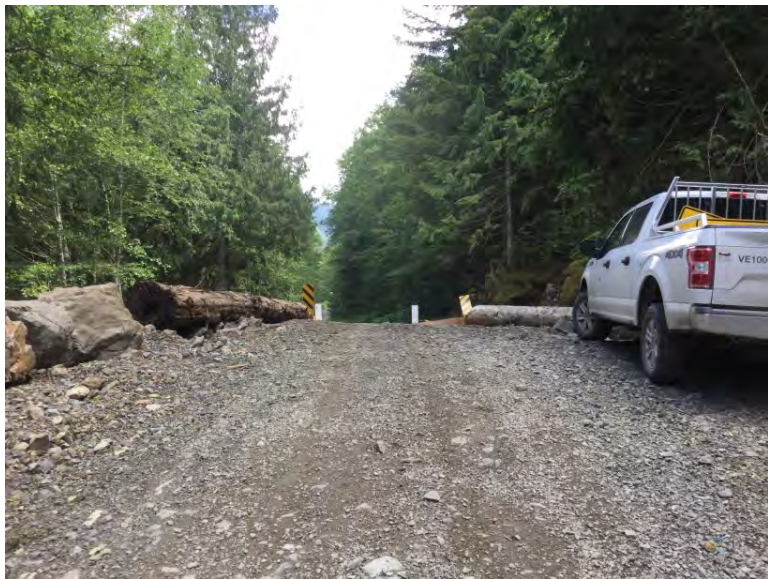
Approach from Left Bank when facing downstream

Steep VC left approach

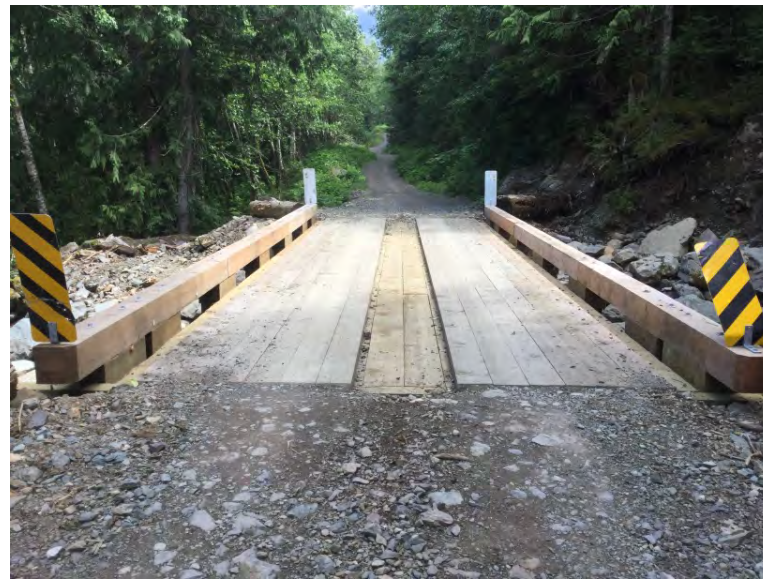
Overall Deck Condition

Good

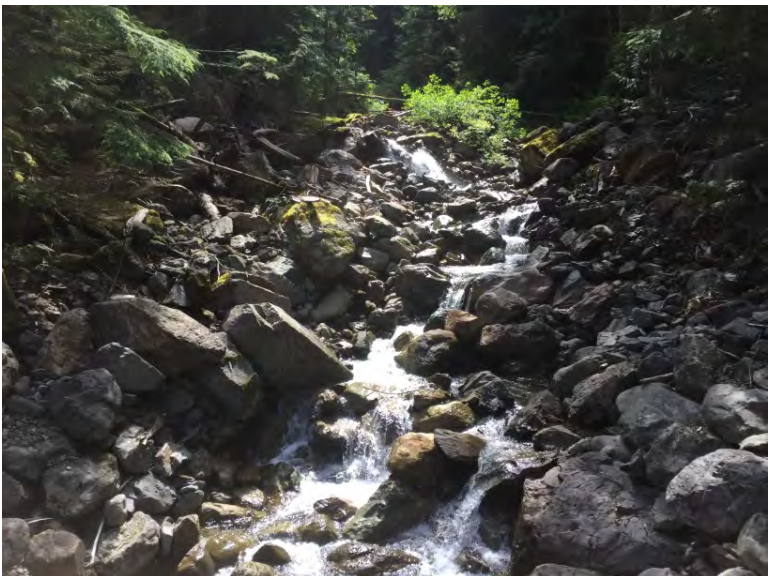
Upstream from Crossing

Some woody debris noted upstream of crossing

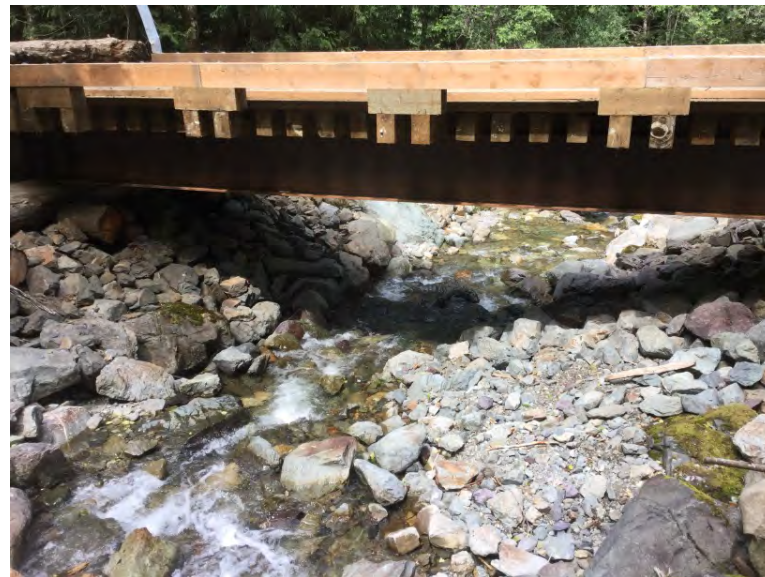
Upstream Profile

Stream channel consists of gravels, cobbles and boulders up to 1.5m in diameter, bigger than what's visible within the abutment scour protection

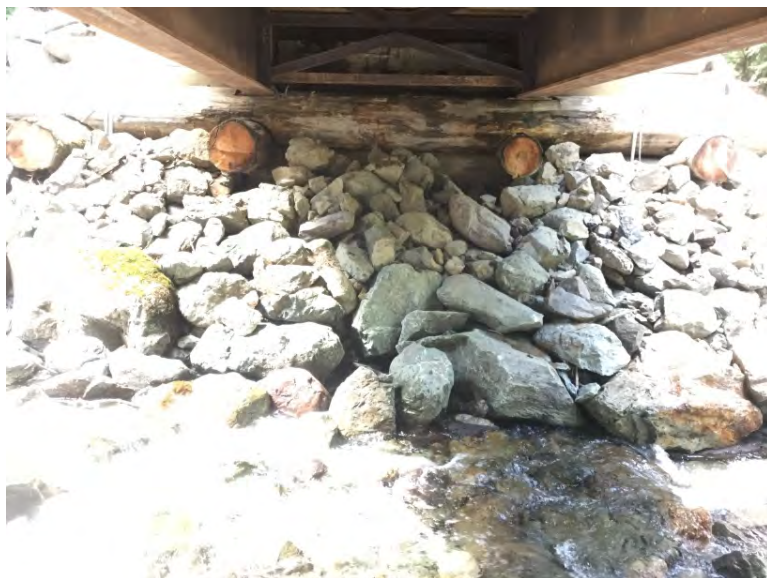
Left Bank Abutment when facing downstream

Log/Timber Cribbs Good Closed face

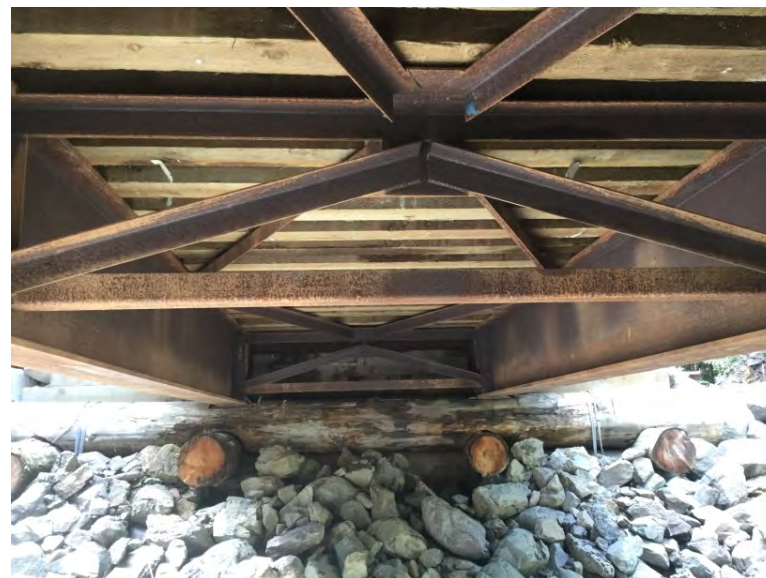
Superstructure

Girders Fair

Light corrosion - recycled girders that appear to have been shortened for this site

Diaphragms Fair

3 welded bays with light corrosion

Bracing Fair

Light corrosion
