CK-2067

TAMIHI 10.6km

2019 Inspection

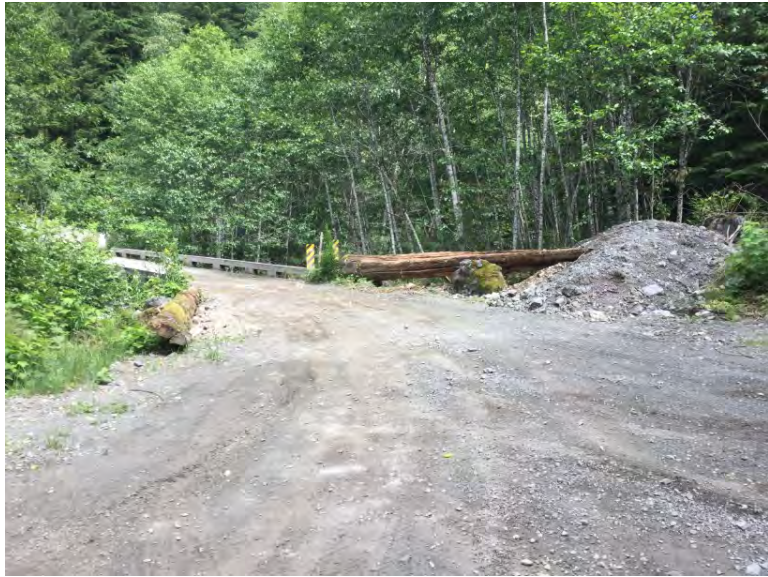
Approach from Left Bank when facing downstream

Large potholes at left approach

| 2 | Medium | Brush and grade approaches |

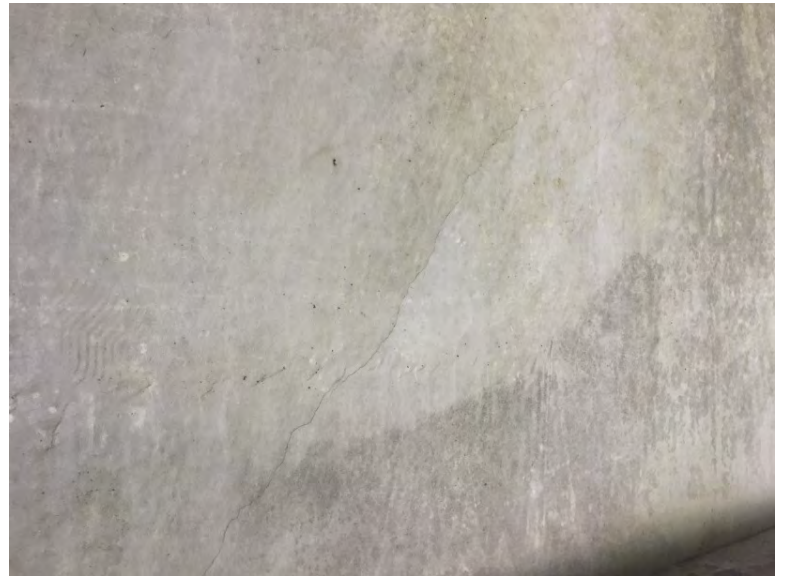
Girders    Good    Composite - hairline cracks noted

Hairline cracks noted on girders

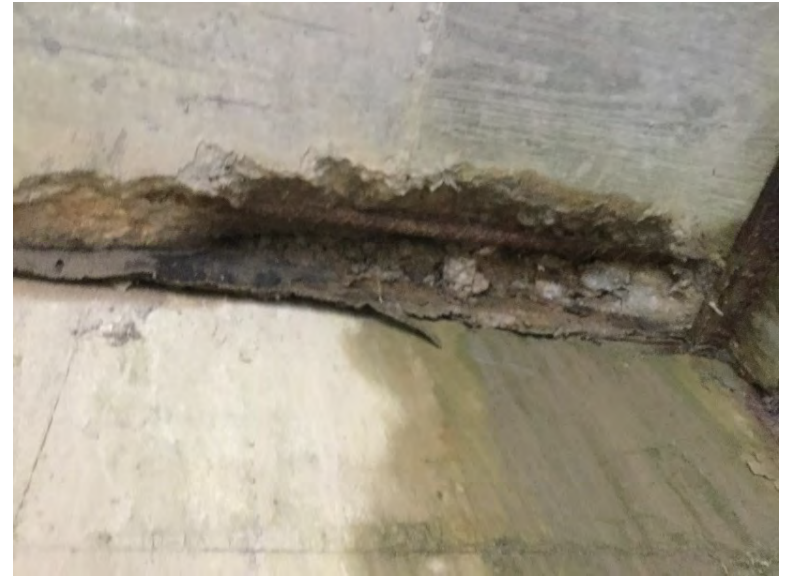
Concrete Deck Fair Damage noted to underside of panel 1 at left approach

Damage noted to left bank panel

Repair the damage to the deck panel at the left approach consistent with the Concrete Repair Guide for Concrete Bridge Components (MoFLNRO, 2017). Brush and grade approaches. The current load rating of L75 or 68 tonnes to continue.

| 1 | Medium | Repair damage noted to panel |
