CK-2073

CHIPMUNK 1.5km

2019 Inspection

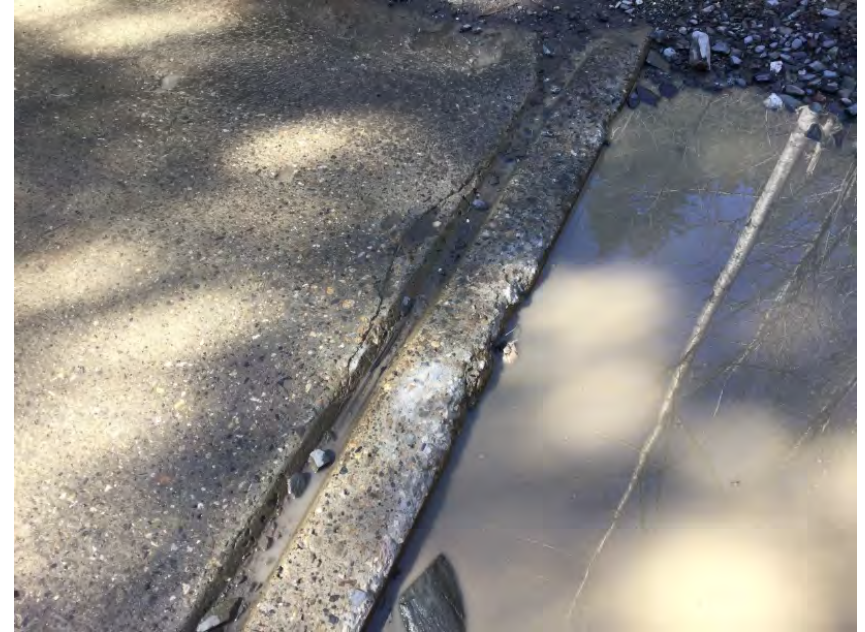
Ballast Wall Fair Minor damage noted at road surface

Damage to left approach panel and ballast wall

| Item | Monitor Description | Frequency |
|---|---|---|
| 1 | damage noted to concrete deck and top of ballast walls | Routine Inspection |

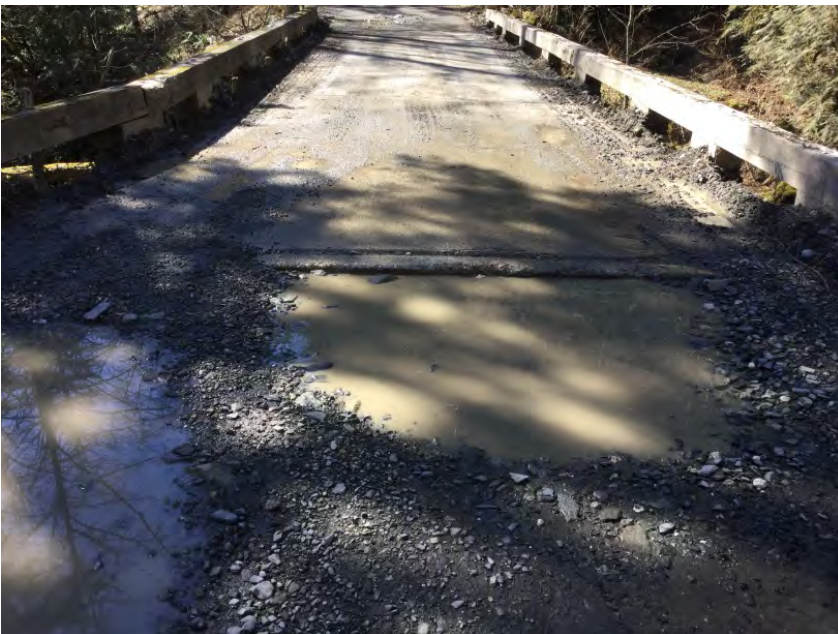
Road Surface Poor

Large potholes

Potholes left approach

| 2 | Medium | Grade approaches |

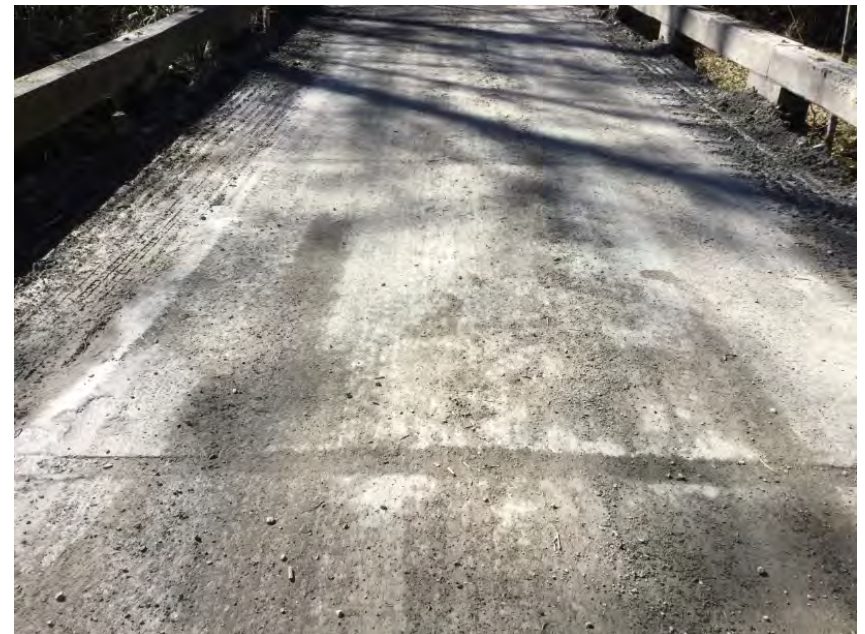
Deck

Sediment on deck

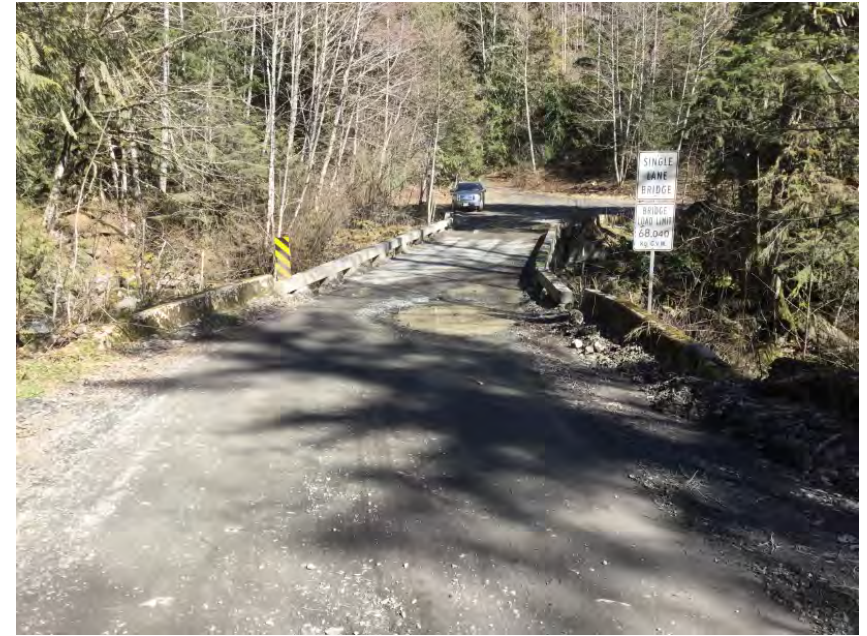
HC left approach, HC &amp; VC right approach

Approach from Right Bank when facing downstream

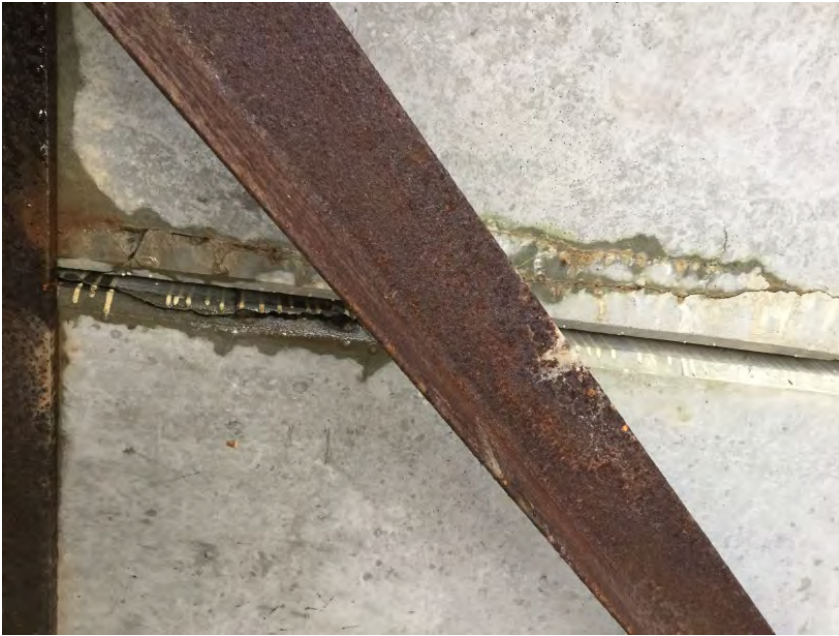
Minor damage noted, see pictures

Damage noted to underside of panels

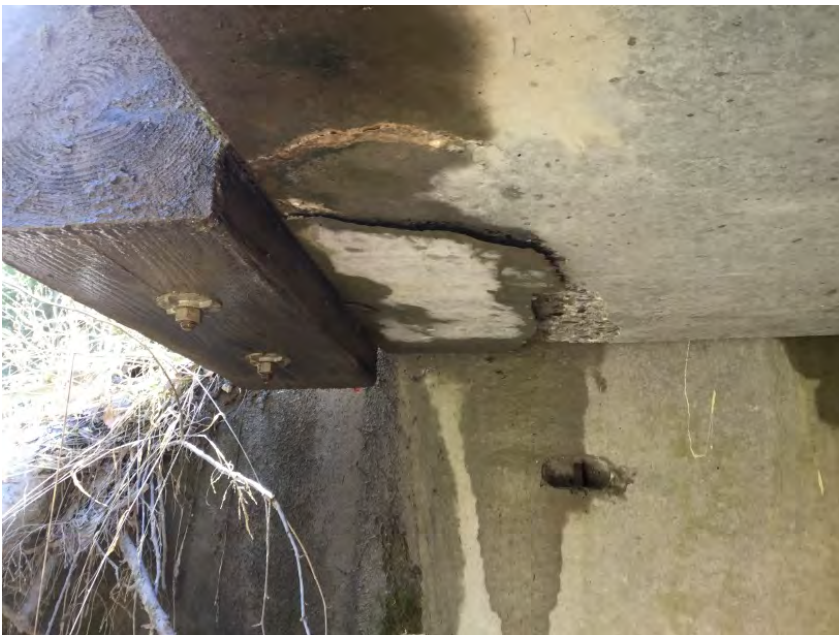
Damage noted to underside of panel 1 right approach

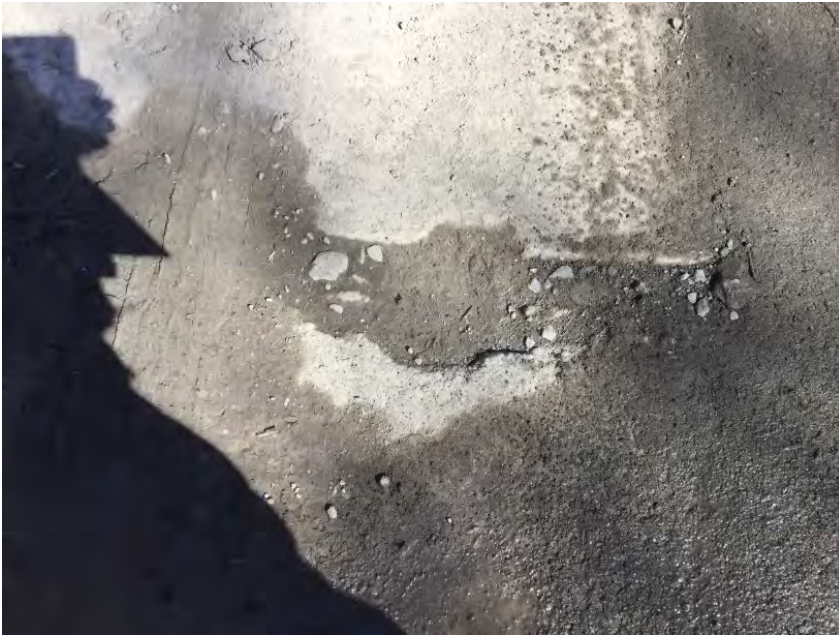
Damage noted to panel 1 and 2 at right approach
