CK-2075

FOLEY 2.1km

2019 Inspection

| Crossing Name | Foley Creek | | |

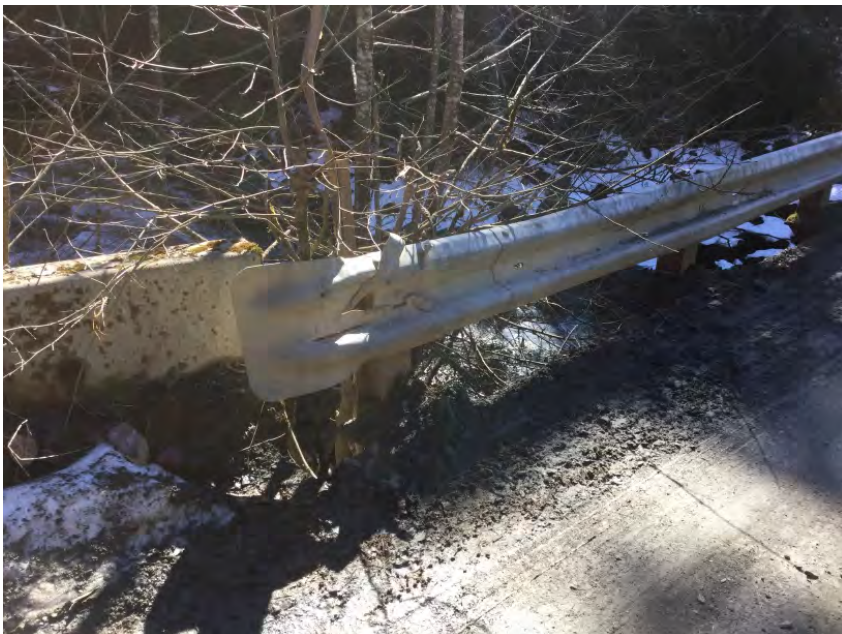
Curb Rail/Blocks/Posts Good Minor damage noted at right approach

Rail damage

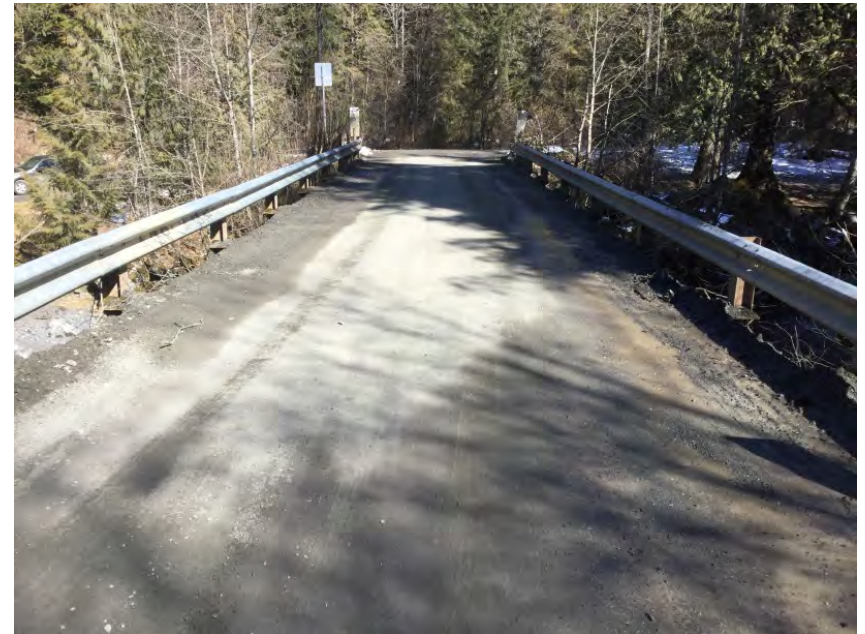
Overall Deck Condition Good
