CK-2086

CHILLIWACK SOUTH 4.4km

2019 Inspection

| Crossing Name | Center Creek |

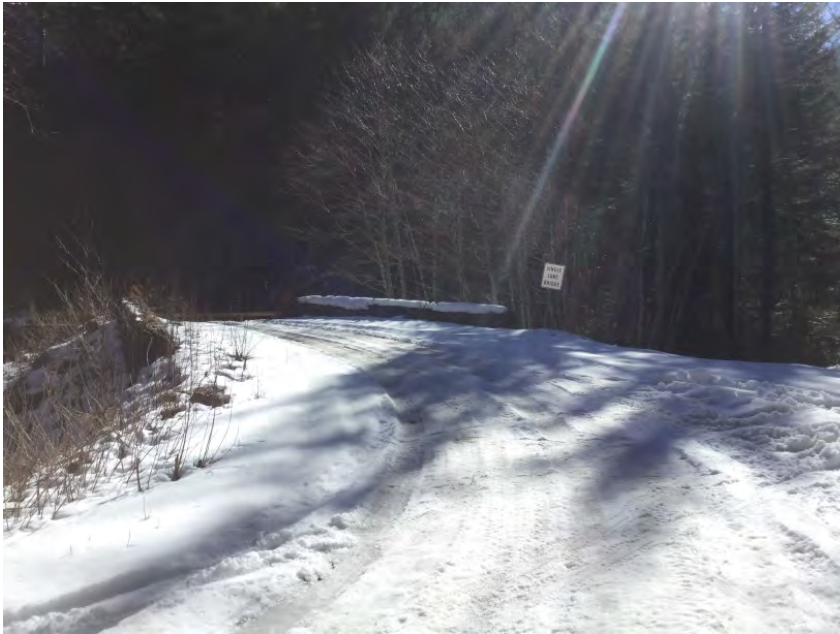
Approach from Left Bank when facing downstream

Brushing Required Y Minor

| 1 | Low | Brush approaches |

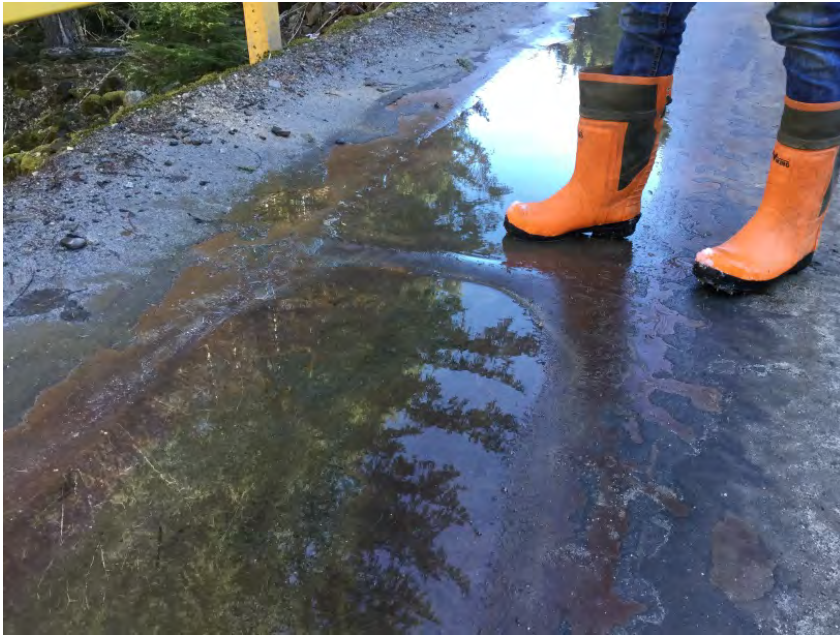
Steel Deck Plate      Fair      Minor deformation on wheel path

Deck plate deformation noted on wheel path

Brush approaches and monitor the steel deck plate deformation on the wheel path. The current load rating of L75 or 68 tonnes to continue.

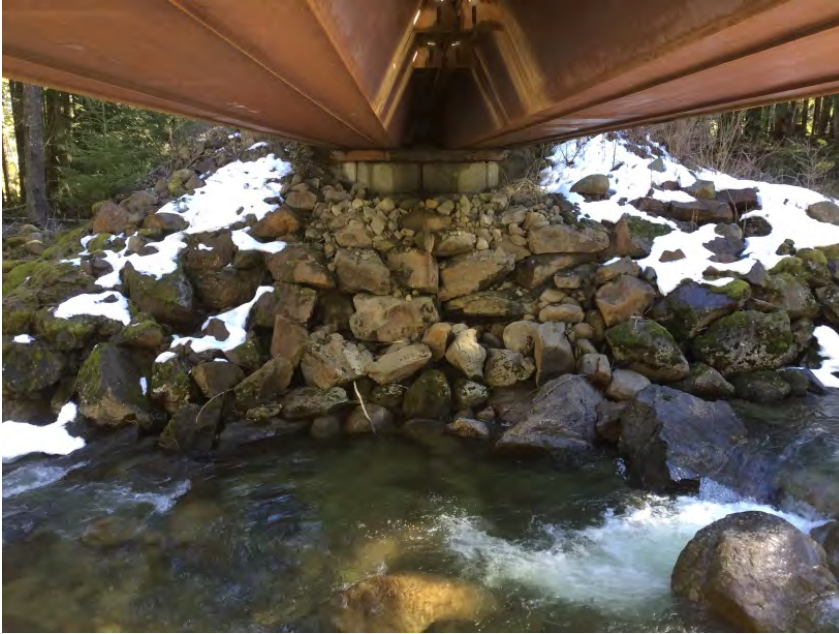
Right Bank Abutment when facing downstream

Concrete Good Lock blocks on right bank visible
