CK-2087

DEWDNEY 5.2km

2019 Inspection

| Crossing Name | Cedar Flat Creek |

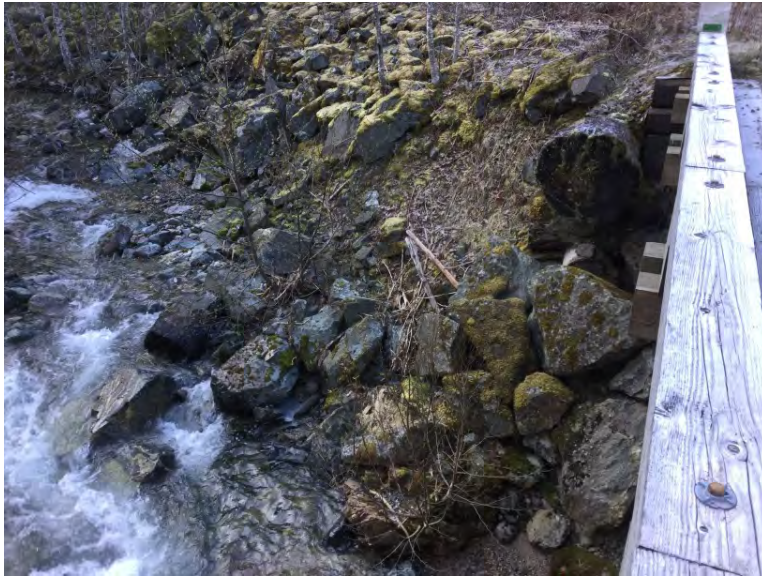
Scoured upstream left bank

Upstream left bank riprap scour

| Item | Monitor Description | Frequency |
|---|---|---|
| 1 | Riprap scour at left upstream abutment | Routine Inspection |

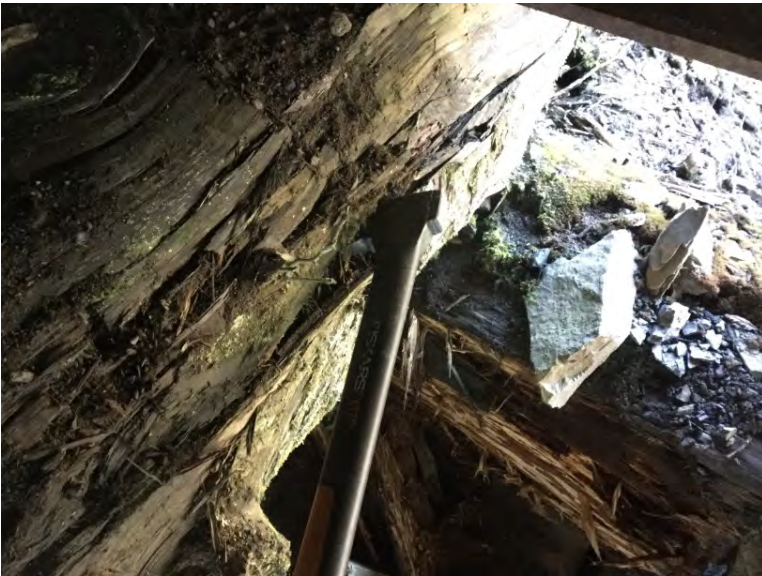
Up to 70mm sap rot on face logs, rotten face logs at ends

Up to 70mm sap rot in face logs and tiebacks

| Item | Monitor Description | Frequency |
|---|---|---|
| 3 | Crib condition | Routine Inspection |

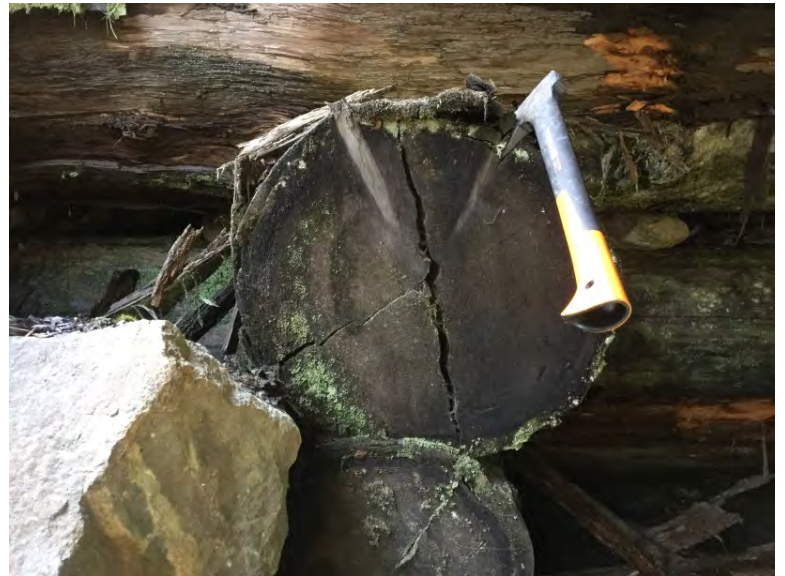
Some ends split and up 70mm sap rot

Tieback ends spilt and up to 70mm sap rot

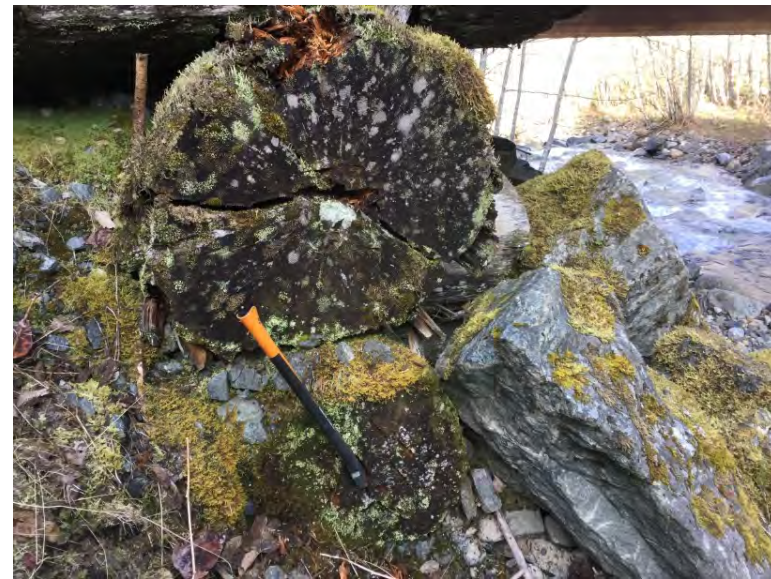
Upstream face log ends are rotten

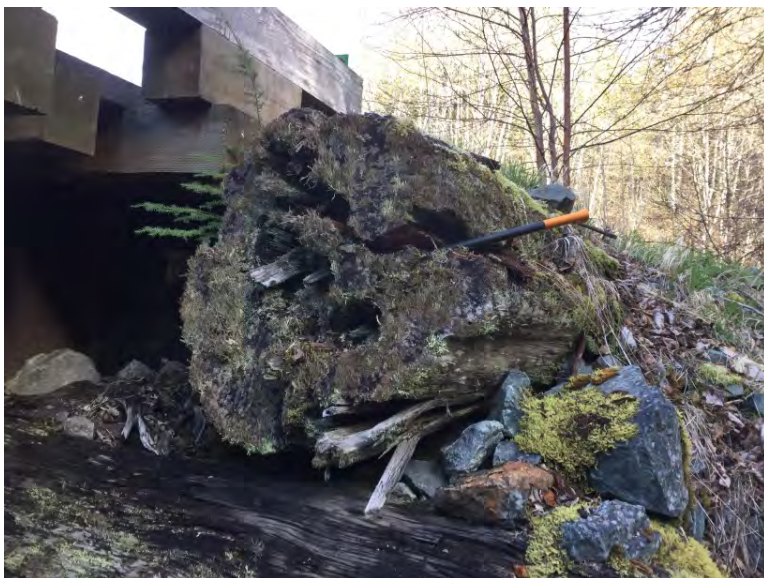
Fill retaining logs rotten at their ends

Fill retention logs rotten

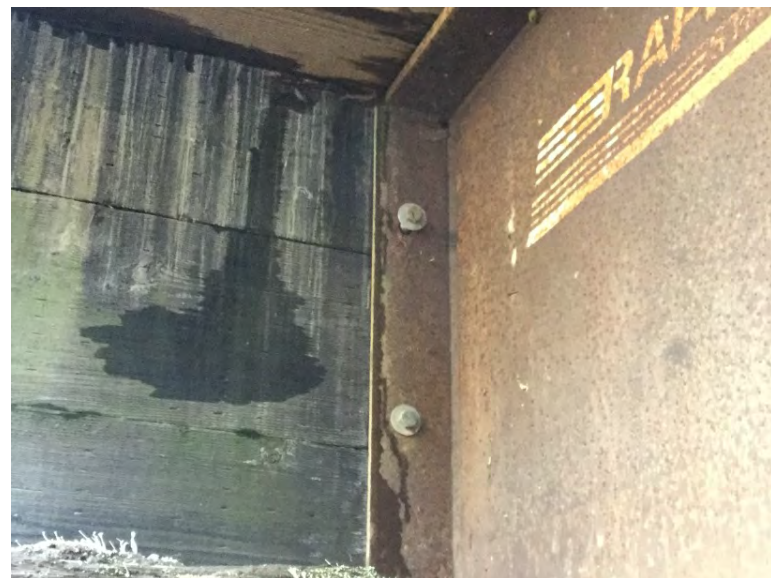
1 loose ballast wall bolt

Ballast wall to girder connection loose

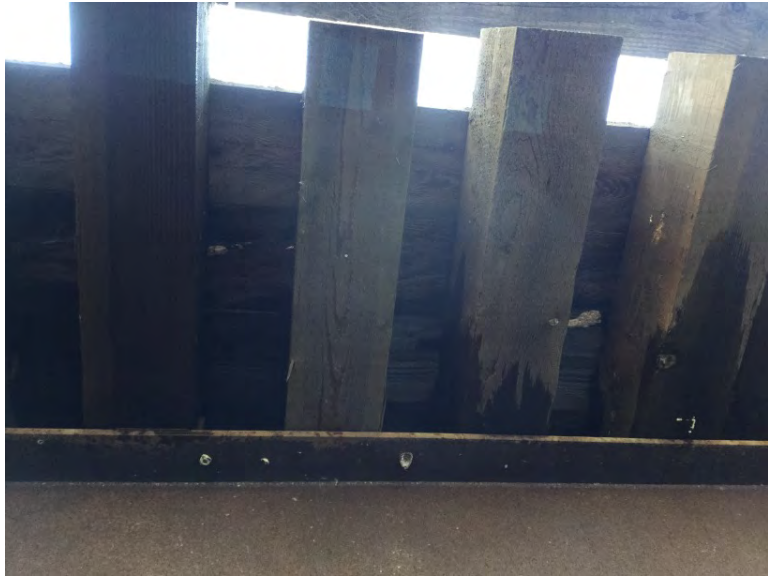
Indications of surface rot

Indications of rot in subdeck, surface rot only

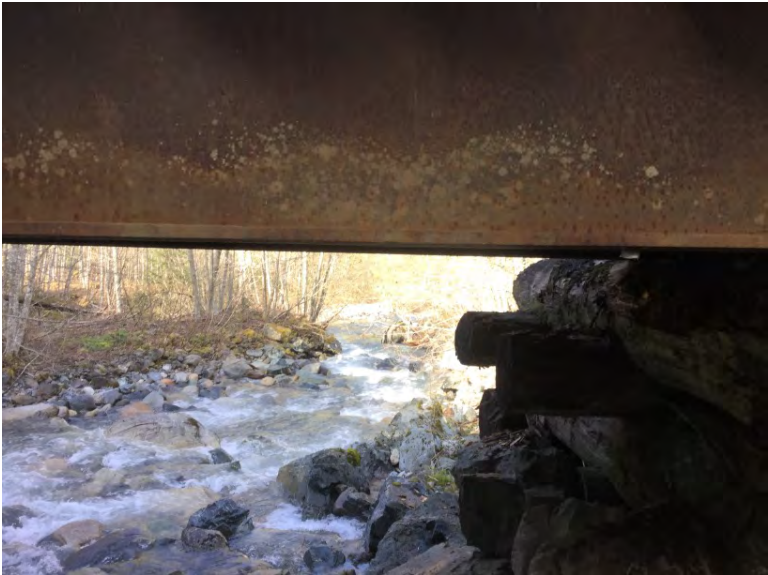
The girders at right bank appear to be settling, most likely due to the deteriorating crib condition. Monitor.

Downstream right bearing location slightly lower then upstream

Approx 10mm settlement of downstream girder at right bank

| Item | Monitor Description | Frequency |
|---|---|---|
| 2 | Girder settlement at right abutment | Routine Inspection |
