CK-2100

FLORENCE LAKE 14km

2019 Inspection

| Crossing Name | Clem's Creek |

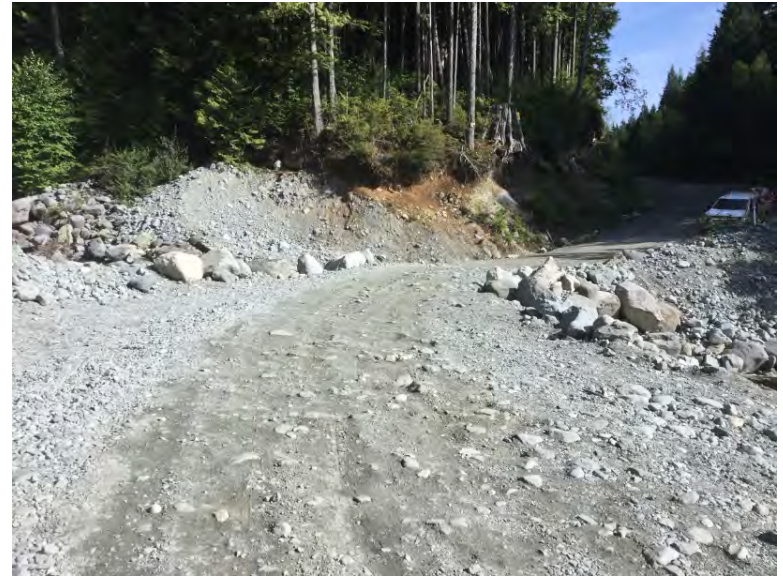
Road narrows substantially at culvert crossing  
Recommend placing fenders or large rocks to delineate road edge  
If existing structure washes out consider replacing with a properly designed ford if appropriate with road use.

Road narrows substantially over culverts

| Item | Priority | Repair Description |
|---|---|---|
| 1 | High | Place proper fenders or large rocks to delineate the road edge through crossing location |

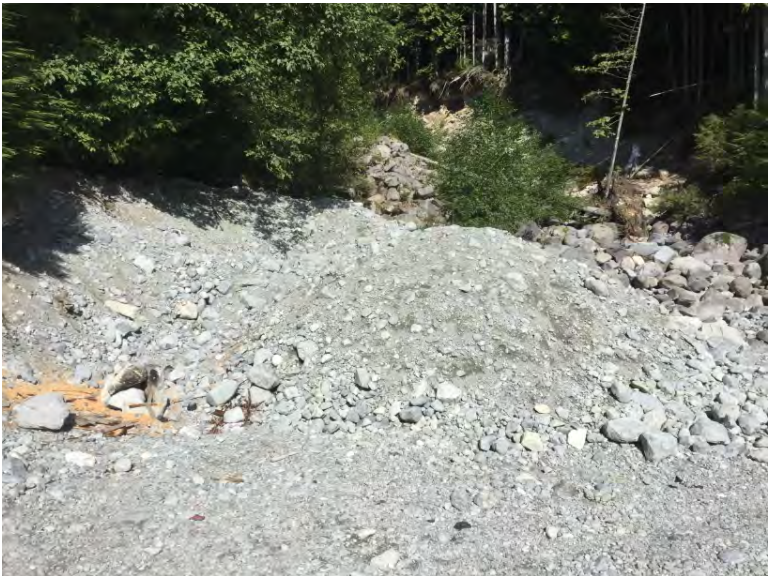
Comments 5 - 75mm thick smooth wall rubber culverts  
Stream appears to aggrade often, most likely following heavy precipitation events

Material excavated from stream channel

| Item | Monitor Description | Frequency |
|---|---|---|
| 1 | For aggradation and/or scour | Anually |
