CK-2102

ROCKY POINT 0.2km

2019 Inspection

| Crossing Name | Sayers Creek | | |

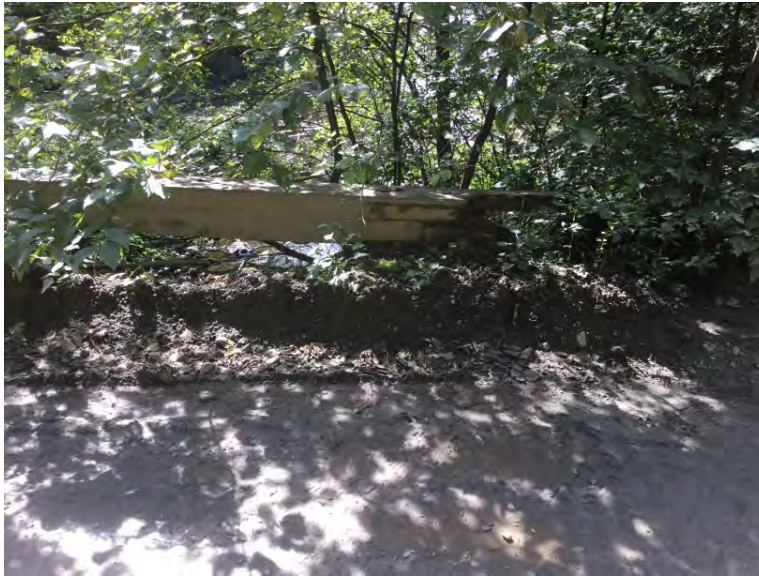
Sediment on deck

Rotten risers and blocks

Sediment on deck and damaged guardrail

| Item | Priority | Repair Description |
|---|---|---|
| 1 | High | Replace guardrail, risers and blocks; and replace delineators |
| 2 | Medium | Clean sediment from deck and brush approaches |

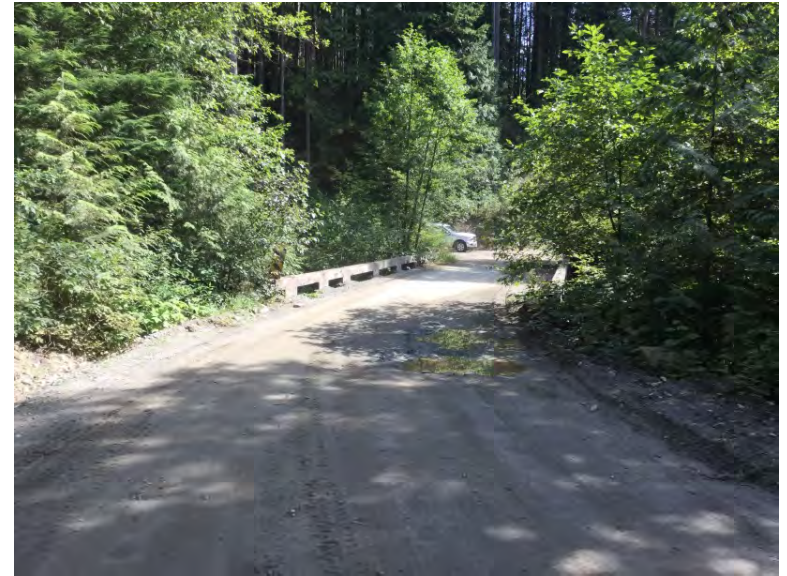
Approach from Right Bank when facing downstream

No post barriers pushed off road at right approach

| Item | Priority | Repair Description |
|---|---|---|
| 3 | High | Reset no post barriers |

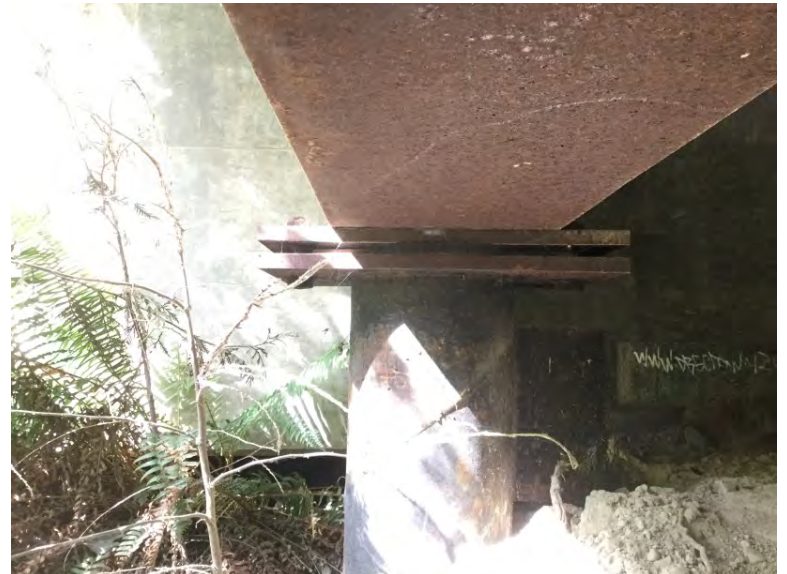
Slight bulging of bearing pads

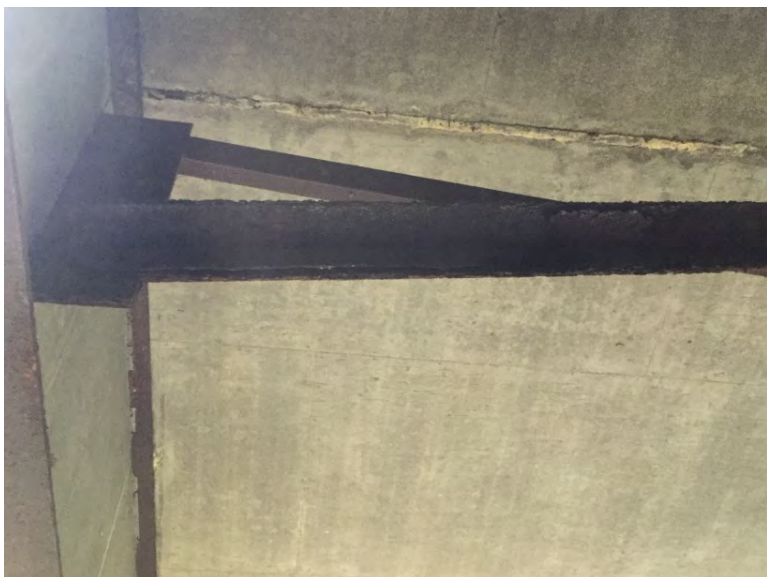
Corrosion noted

Corrosion noted on center diaphragm

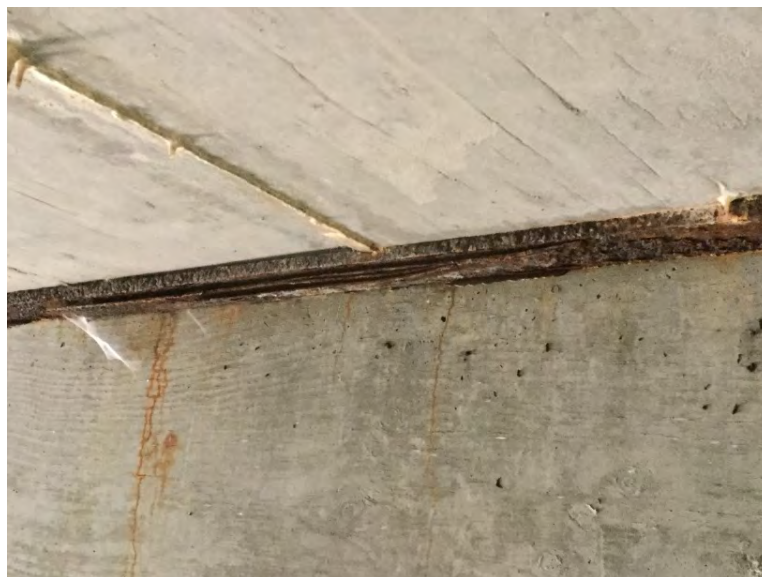
Section loss not anticipated based on limited extent of corrosion on girders

Composite girders with sections of corrosion at deck joint and grout pocket locations

Corrosion of girders noted at deck panel joints

| Item | Monitor Description | Frequency |
|---|---|---|
| 1 | Deck joint and grout pocket condition and the steel girder corrosion in these locations | Routine Inspection |

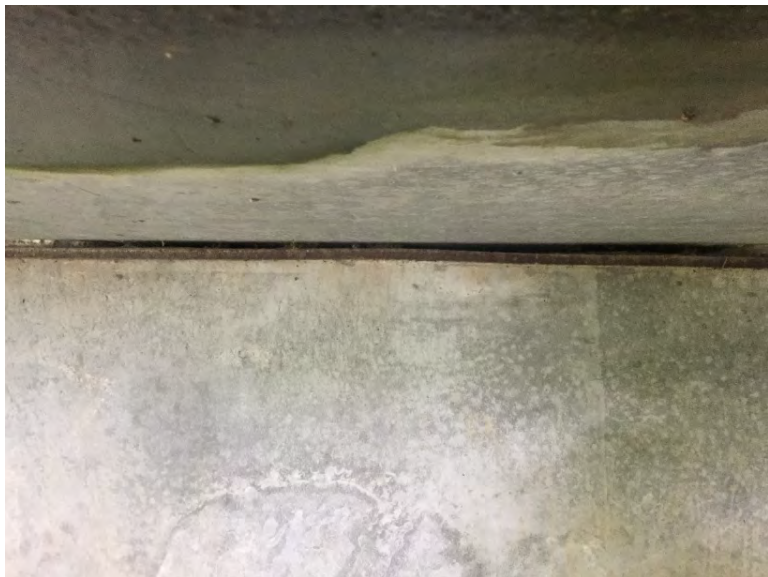
Slight top flange deformation noted downstream left bank
