CK-2103

GARNET 8.8km

2019 Inspection

| Crossing Name | East Fork Garnet Creek |

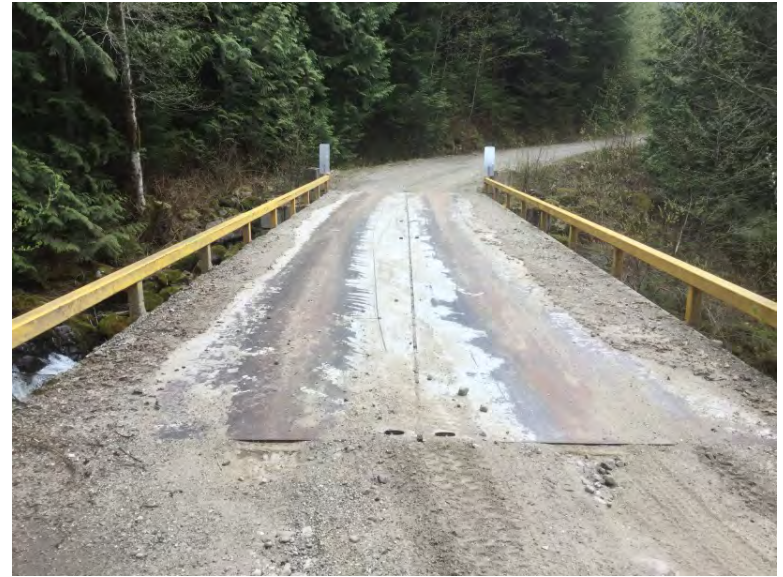
Steel Deck Plate      **Good**      Anti skid all worn off

| Item | Priority | Repair Description |
|---|---|---|
| 2 | Low | Consider replacing anti skid surfacing to deck plate |

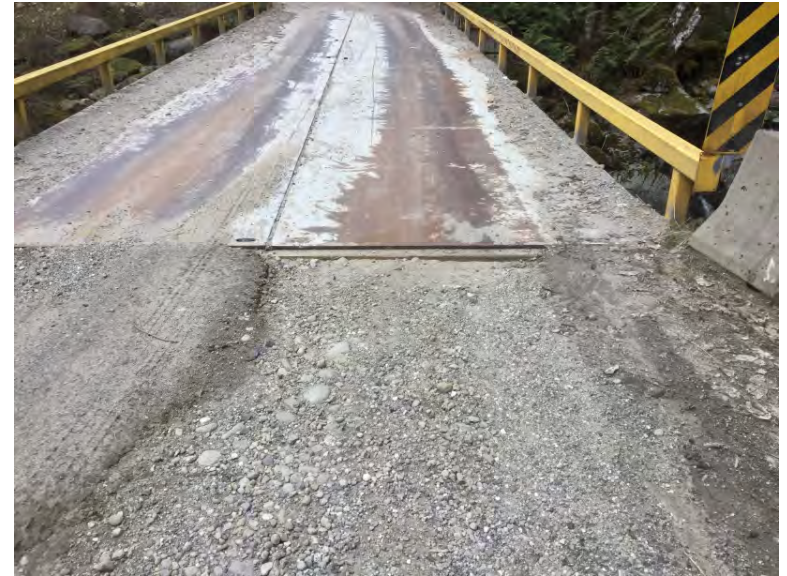
Requires surfacing at both approaches

| Item | Priority | Repair Description |
|---|---|---|
| 3 | Medium | Add surfacing to approaches prior to industrial activity |
