CK-2108

HARRISON EAST 30.7km

2019 Inspection

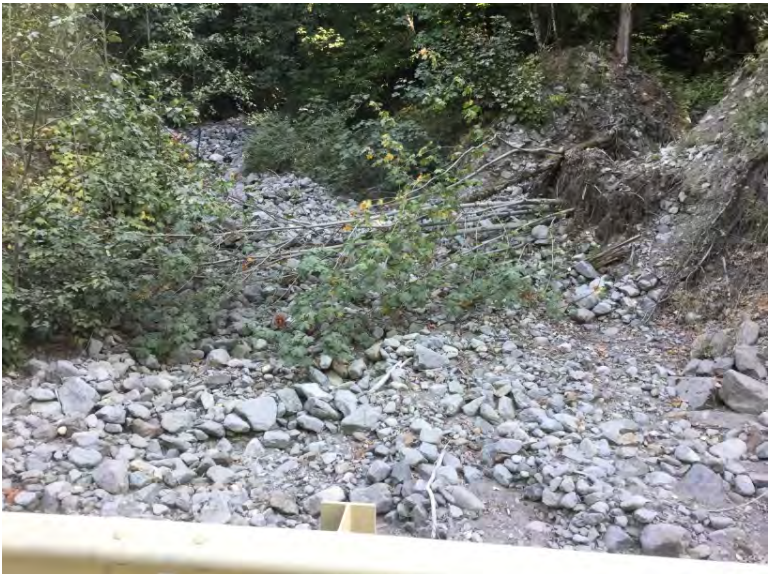
Upstream from Crossing

Comments Stream banks are highly erodible upstream

| Item | Monitor Description | Frequency |
|---|---|---|
| 1 | Aggradation and abutment erosion from periodic high flows | Anually |

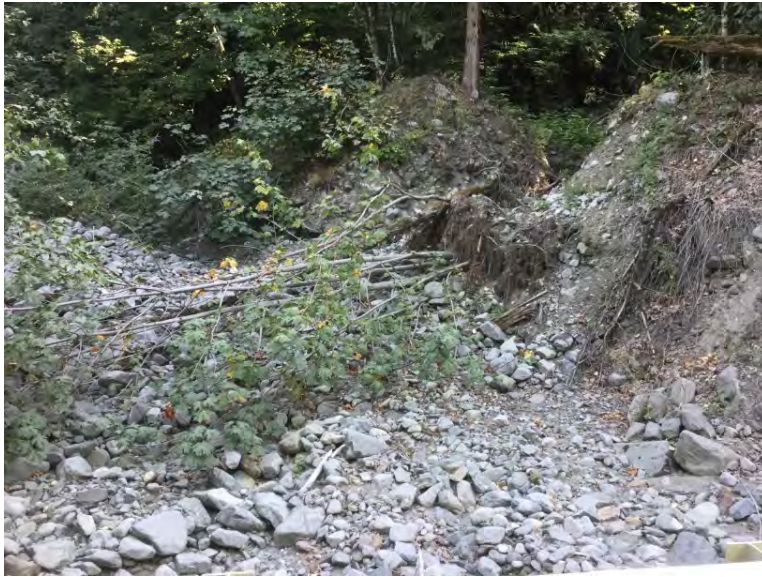
Debris in channel upstream

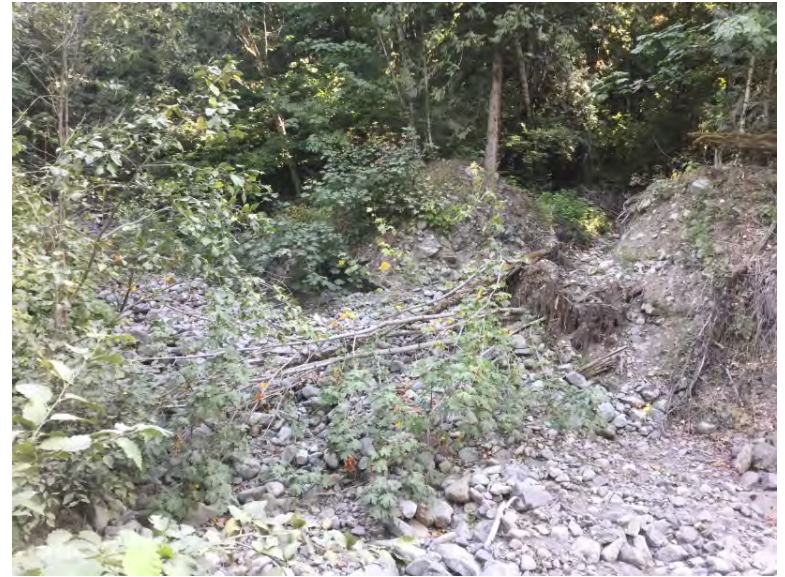
The stream banks appear highly erodible and the riprap appears undersized for the expected flows. The stream appears to have "jumped" its banks upstream recently causing bank erosion - stream is on an active flood plain. Monitor the stream bank condition and inlet aggradation, especially following heavy precipitation events. Replace all the paraseal joints and clean sediment from deck. Brush approaches. The current load rating of L150 or 136 tonnes to continue.

Multiple channels upstream of crossing

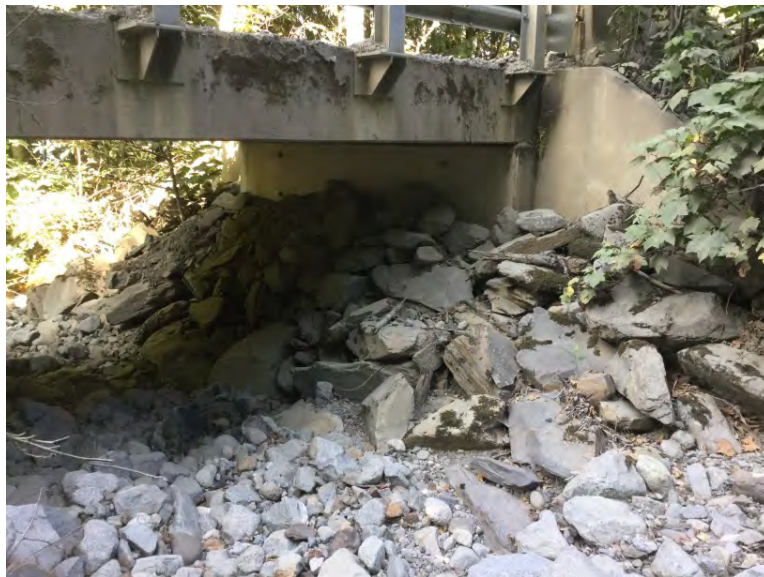
Right Bank Abutment when facing downstream

Riprap Fair

Appears undersized - monitor condition

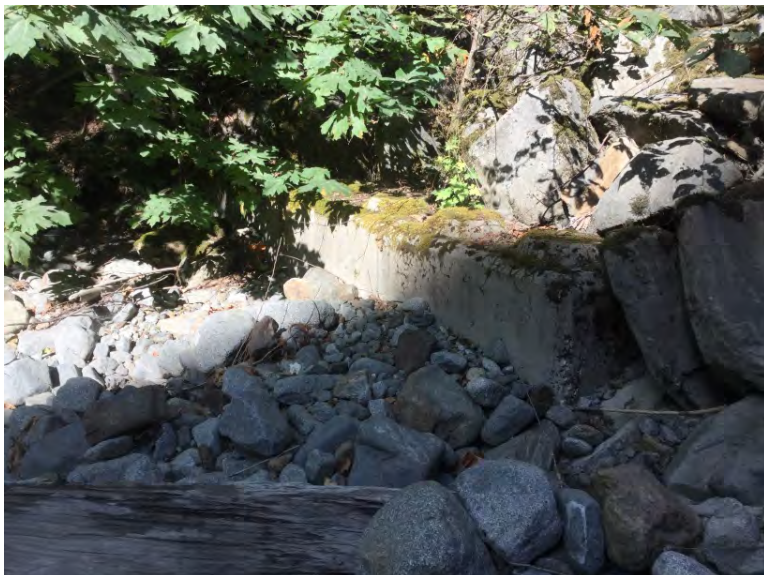
Lock blocks at downstream right bank

Lock blocks downstream right bank

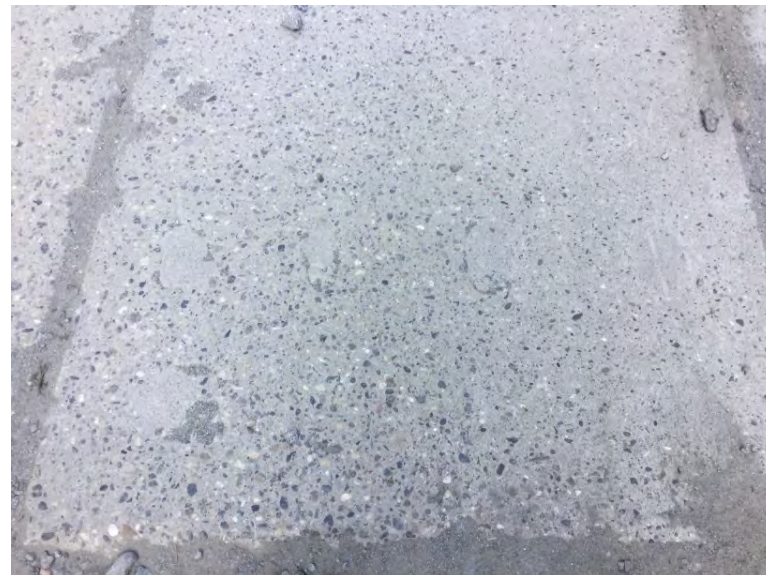
No shear connectors on concrete slabs

Each slab appears to have 4 connections at abutment

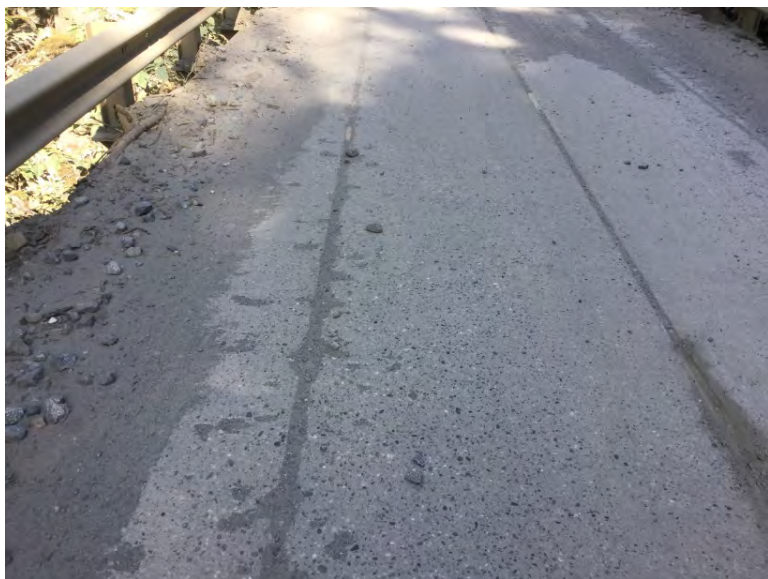
Paraseal is in poor condition

| Repair | | Repair Description |
|---|---|---|
| 2 | Medium | Replace all paraseal joints |
