CK-2109

HARRISON EAST 35.3km

2019 Inspection

| Crossing Name | Hornet Creek |

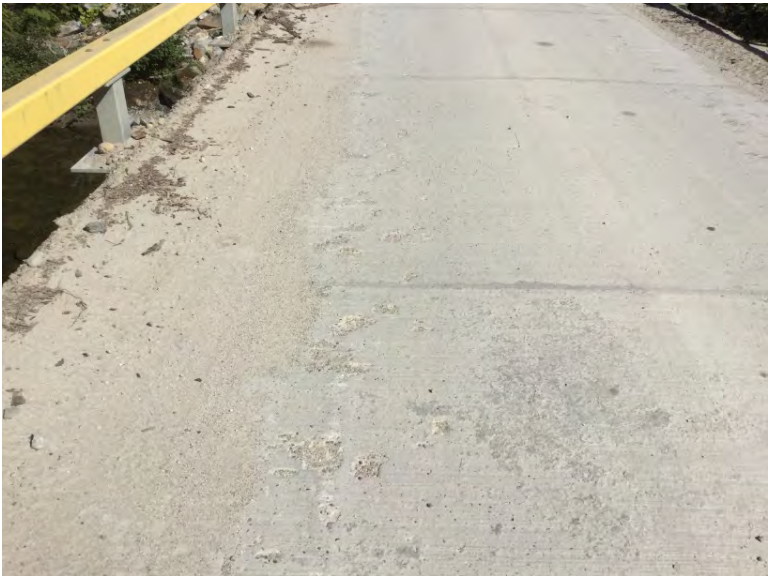
Concrete Deck      **Fair**      Some damage from walking tracked equipment overGrout Pockets      **Good**Deck Joints      **Good**

Track wear on wheel path

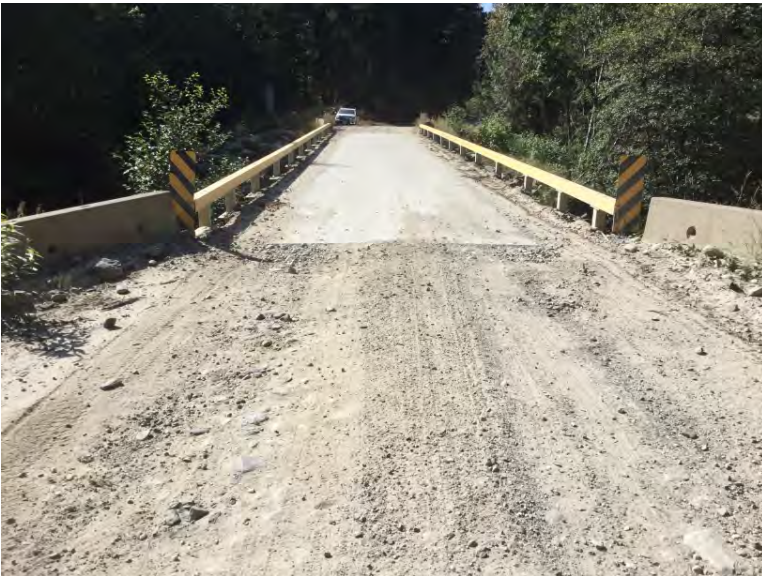
Potholes at approaches

Grade approaches. The current load rating of L150 or 136 tonnes to continue.

| Repair Item | Priority | Repair Description |
|---|---|---|
| 1 | Low | Grade approaches |

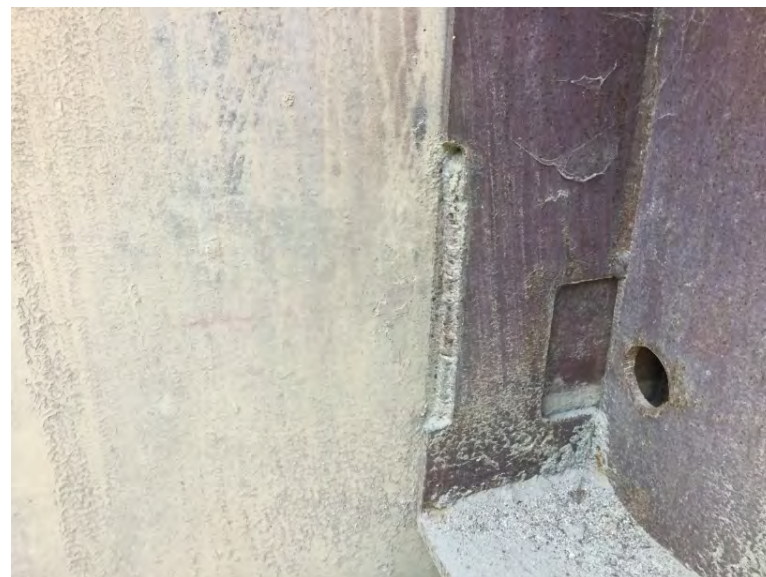
Section of end plate cut out for connection to ballast wall
