CK-2110

HARRISON EAST 38.5km

2019 Inspection

| Crossing Name | Clear Creek (structure # 29) |

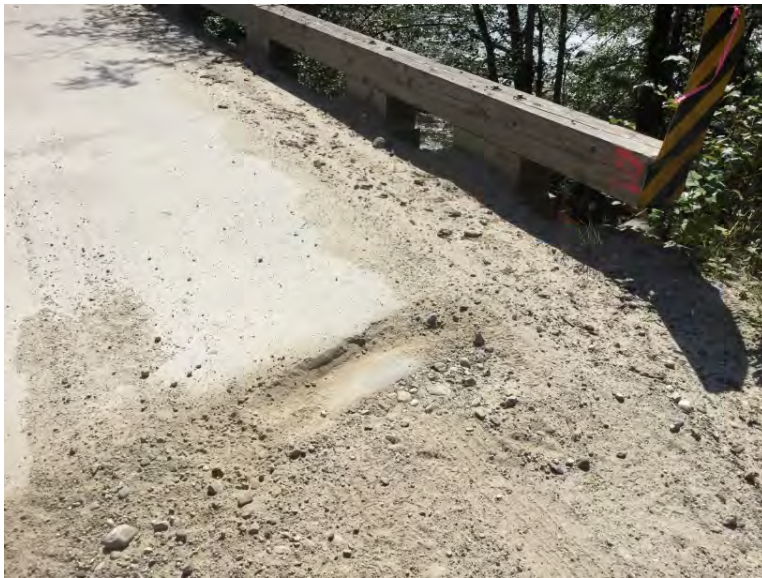
Ballast Wall Fair Right bank 50 mm lower than deck

Deck elevation 2 inches higher than ballast walls

| Item | Monitor Description | Frequency |
|---|---|---|
| 2 | Deck panel condition at the right bank | Routine Inspection |
