CK-2122

HARRISON EAST 57.6km

2019 Inspection

| Crossing Name | Big Silver Creek | | |

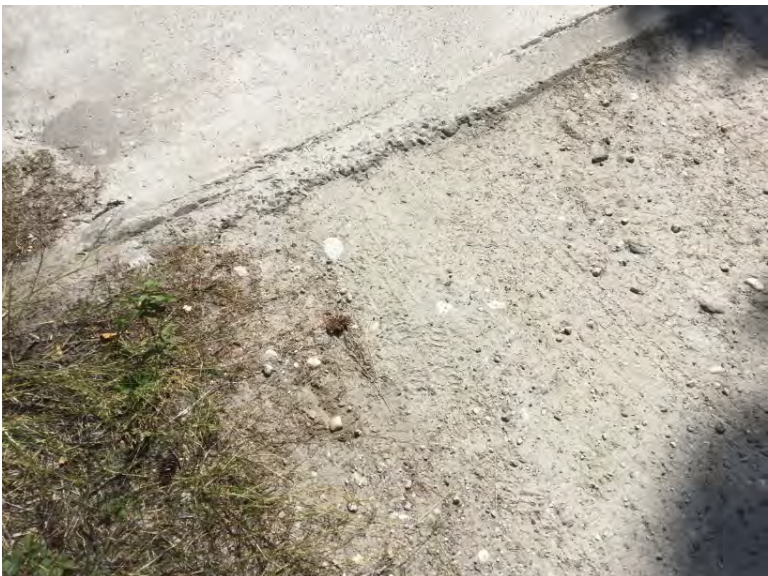
| Ballast Wall | Fair | Some wear on wheel path both approaches |

Wearing top of ballast wall right bank

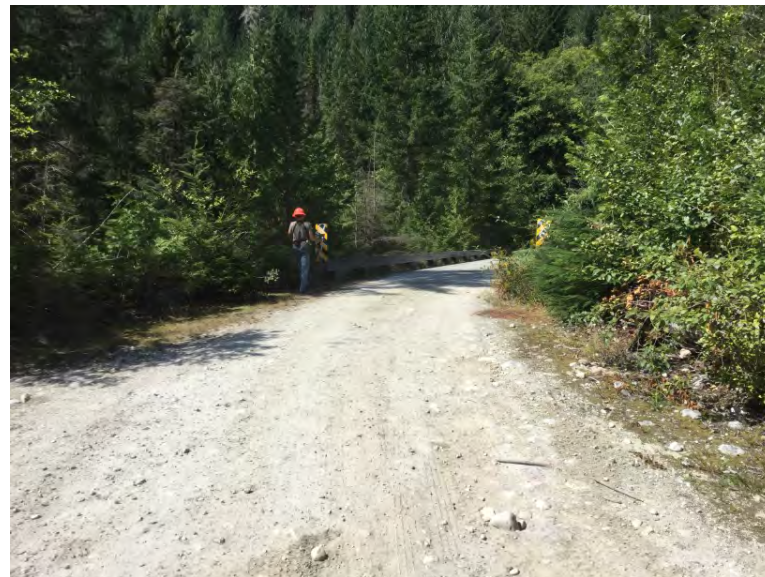
Approach from Left Bank when facing downstream

| Fender Condition | Fair | Rotting logs left approach |

| Item | Priority | Repair Description |
|---|---|---|
| 2 | Medium | replace log fender logs with minimum 600mm diameter x 6m length at left approach |

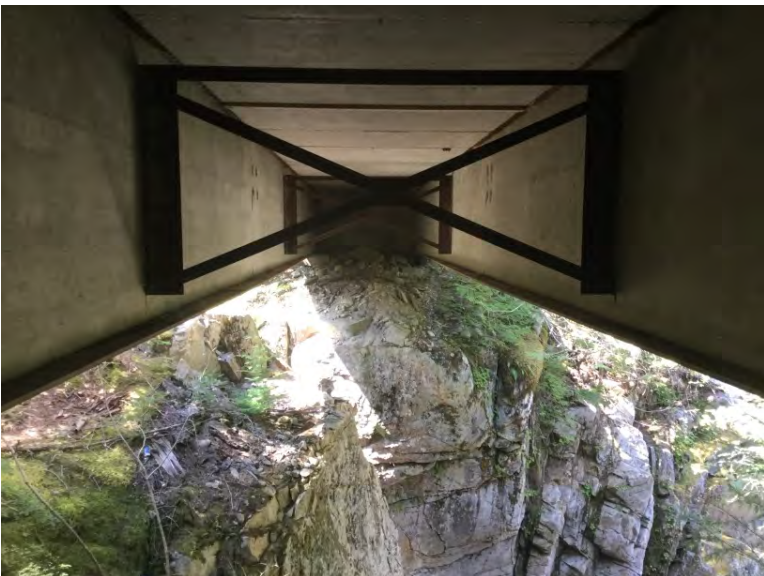
Superstructure

Composite with hairline cracks noted

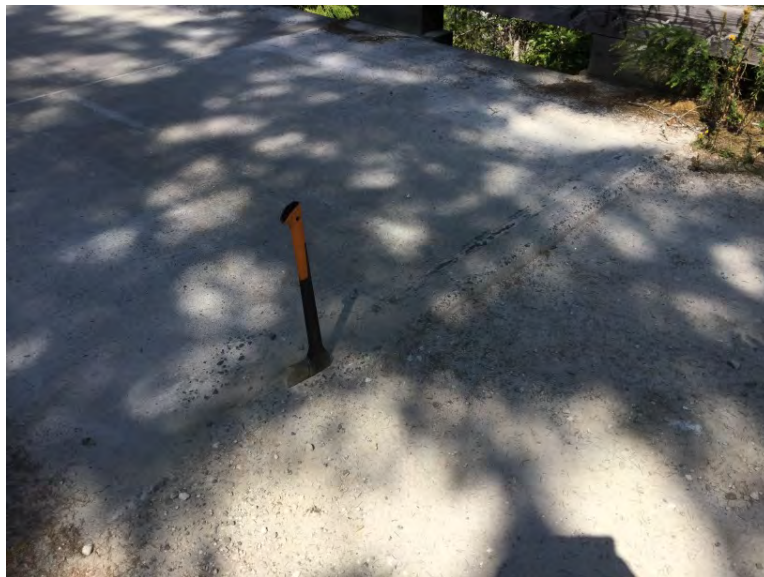
Ballast wall and first deck panel wearing

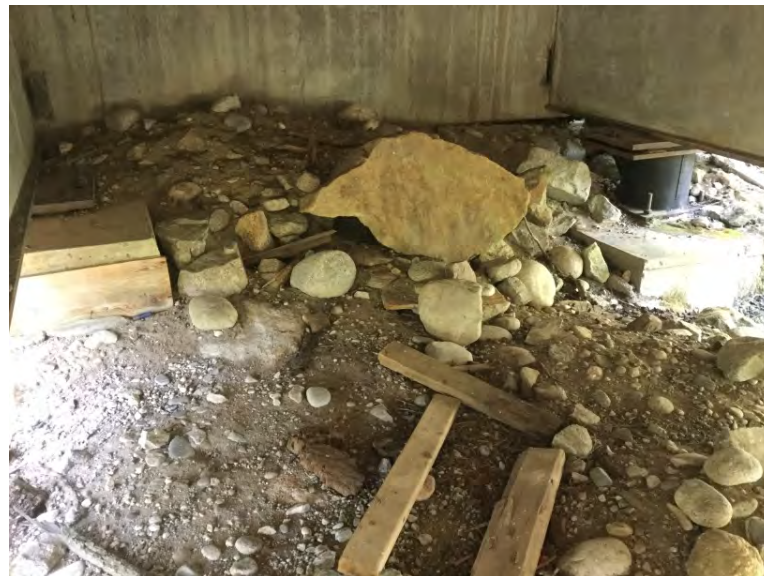
| Concrete | Good | Cast in place right bank |

CIP footings at right bank
