CK-2123

SHOVEL 7.6km

2019 Inspection

| Crossing Name | Pick Creek |

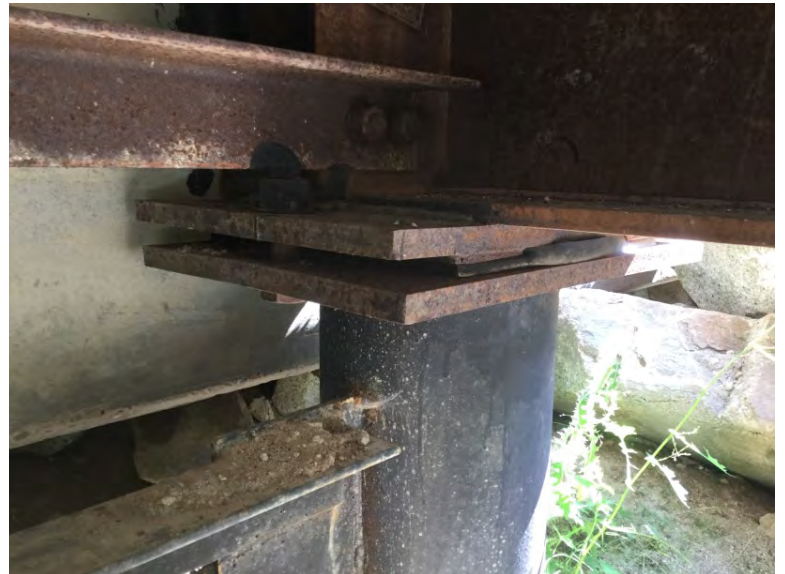
Bearings Good minor bulging

Rubber bearing slight bulge

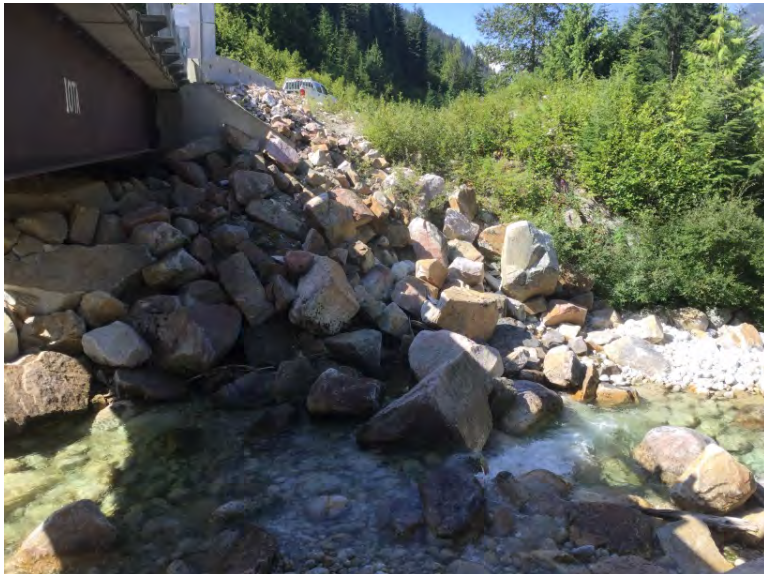
Riprap Fair Monitor down stream left bank scour

Comments    Rip rap scour left approach downstream

Down stream left bank rip rap scour

Monitor the downstream left bank riprap condition. The current load rating of BCL-625 or 63 tonnes to continue.

| Item | Monitor Description | Frequency |
|---|---|---|
| 1 | Down stream left approach rip rap | Routine Inspection |
