CK-2124

HARRISON EAST 60.5km

2019 Inspection

| Crossing Name | Spade Creek |

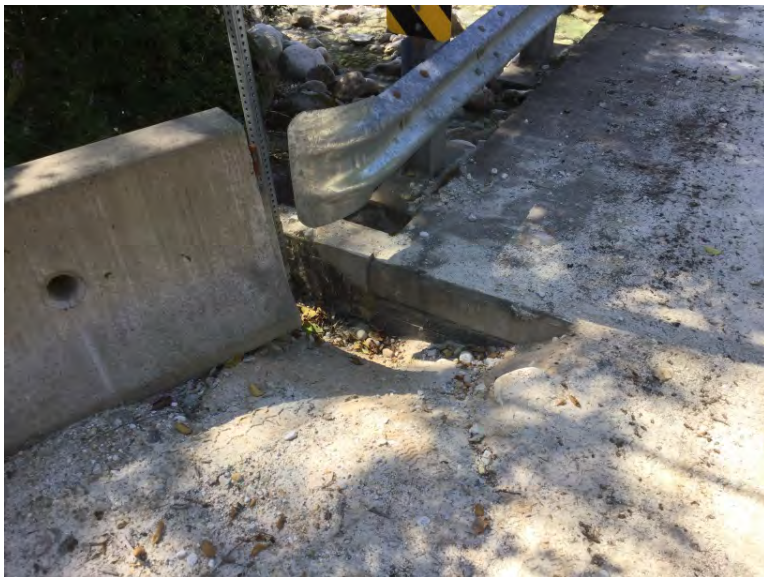
Fill Fair Upstream right approach erosion

Fill erosion upstream right approach

Monitor right approach road fills and upstream groin condition. The current load rating of BCL-625 or 64 tonnes to continue.

| Repair Item | Priority | Repair Description |
|---|---|---|
| 1 | Low | Wilderness road up stream right approach erosion |

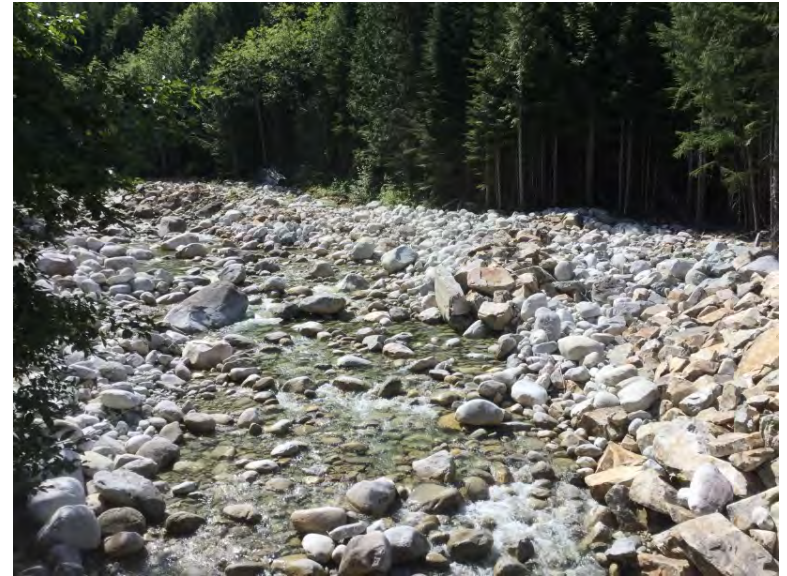
Comments Upstream spurs appear fully intact

Groins upstream left bank

| Item | Monitor Description | Frequency |
|---|---|---|
| 1 | Upstream groin riprap condition | Routine Inspection |

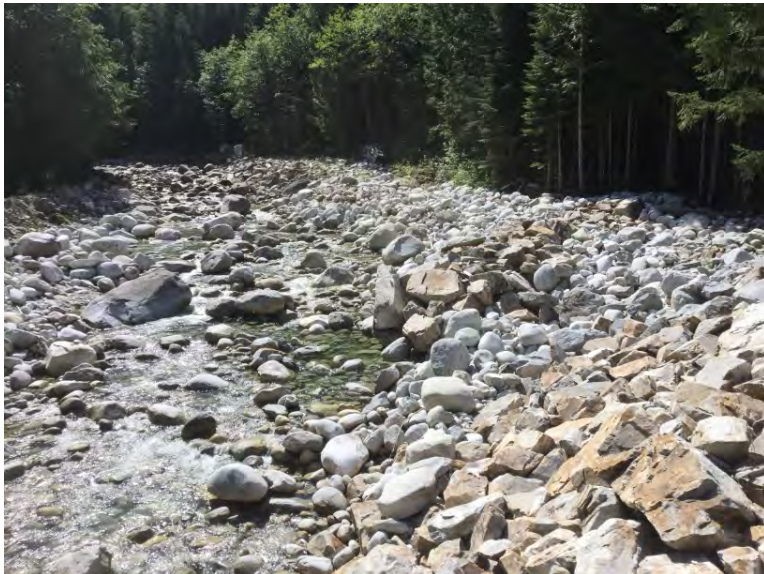
Groins upstream left bank

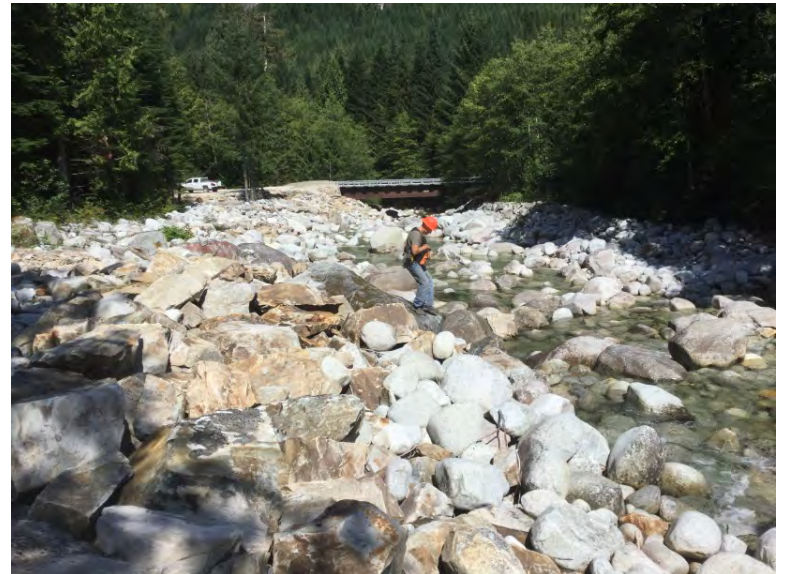
Upper groin left bank upstream

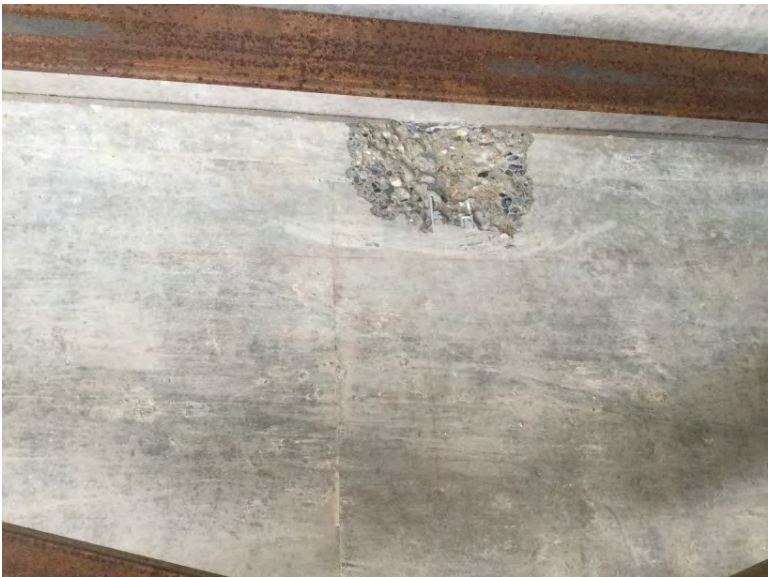
Ballast Wall Good Minor spall left ballast wall

Minor damage to left bank approach ballast wall
