CK-2125

SHOVEL 11.1km

2019 Inspection

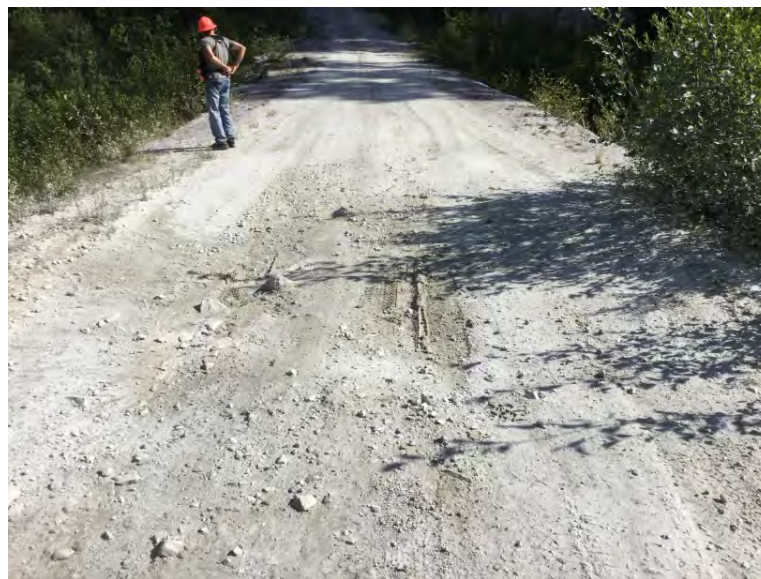
Road Surface Fair Potholes

Running surface

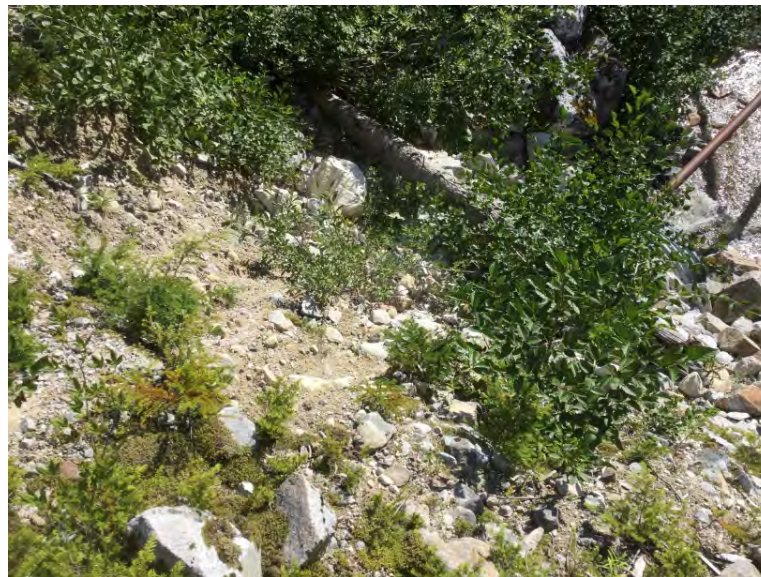
Minor inlet erosion upstream side

Fill slope upstream erosion at inlet

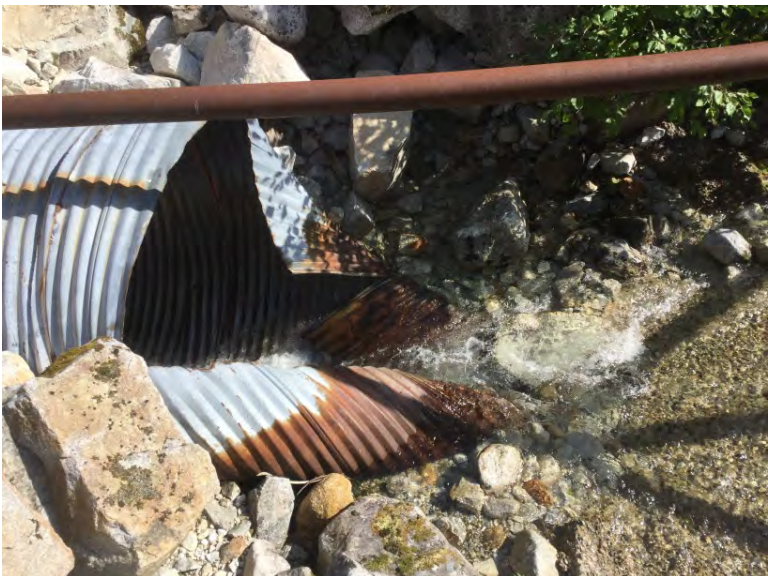
Damaged see picture

Monitor the inlet/trash rack condition. The current load rating of L150 or 136 tonnes to continue.

1 Inlet condition

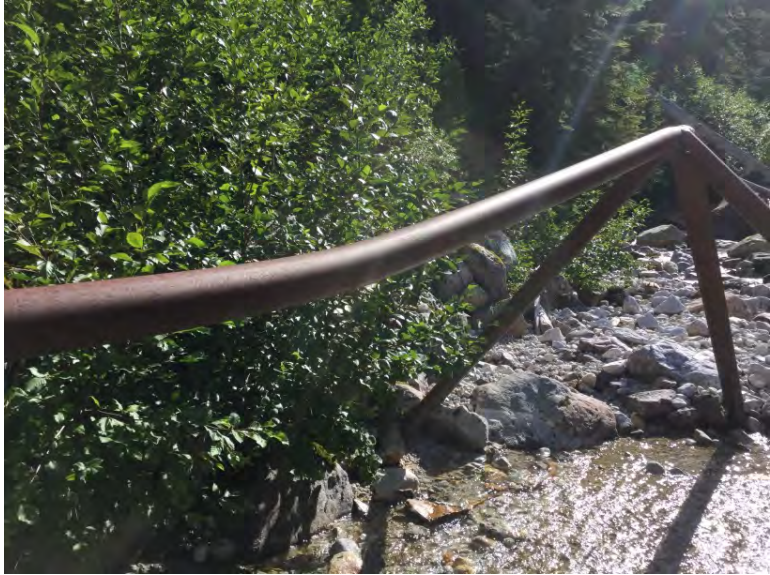
Horizontal beam round steel has slight bend see photo

Trash rack damage struck by

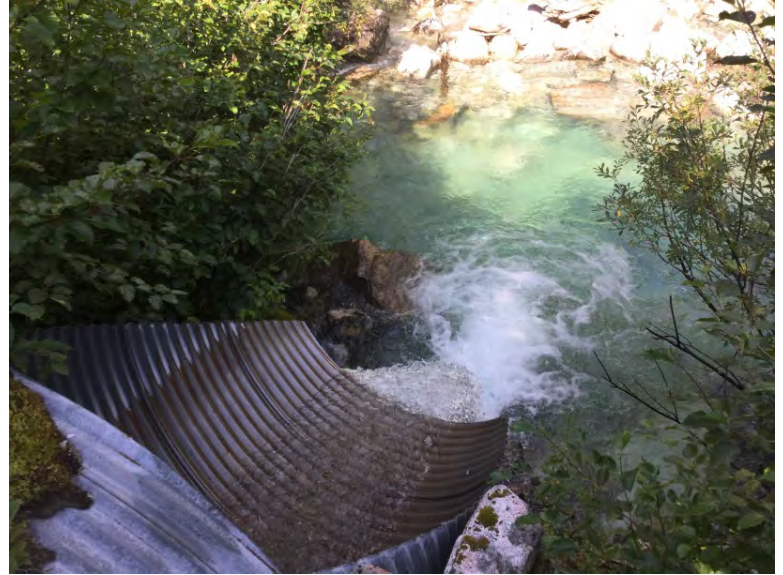
Outlet

1 m plunge pool minor local erosion +/- 1 m under culvert
