CK-2135

STS'AILES (WEST) 25km

2019 Inspection

| Crossing Name | Sunrise Creek |

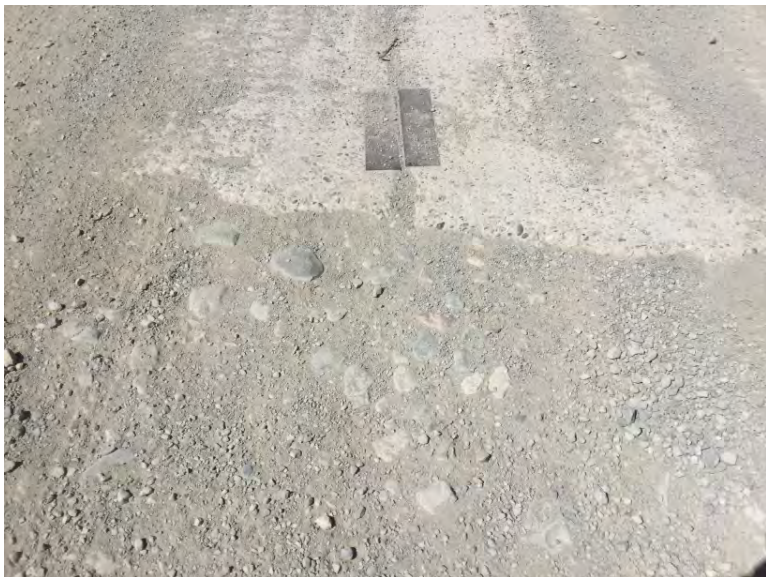
Minor damage to slab ends at right bank
