CK-2139

STS'AILES (WEST) 42km

2019 Inspection

| Crossing Name | Kirkland Creek |

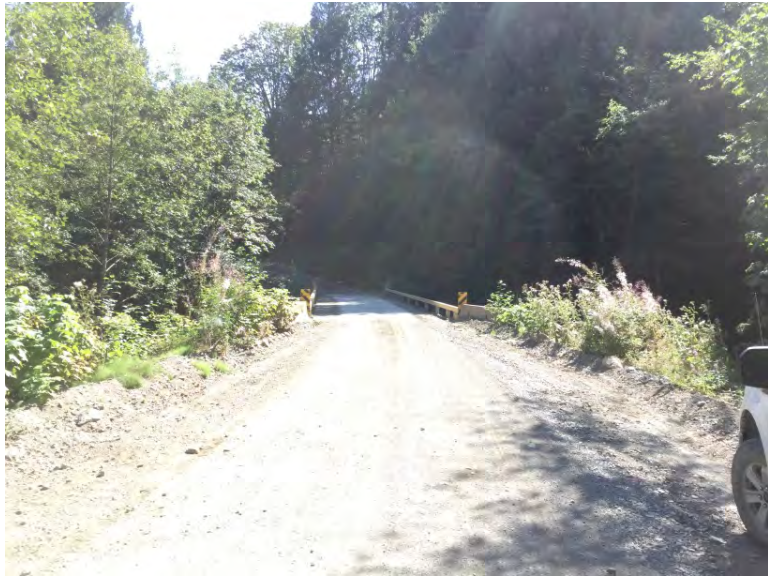
Approach from Left Bank when facing downstream

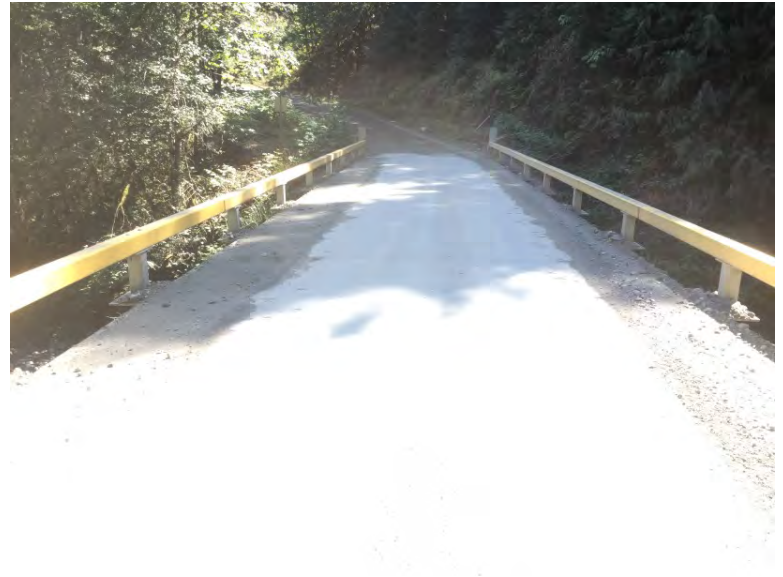
Deck

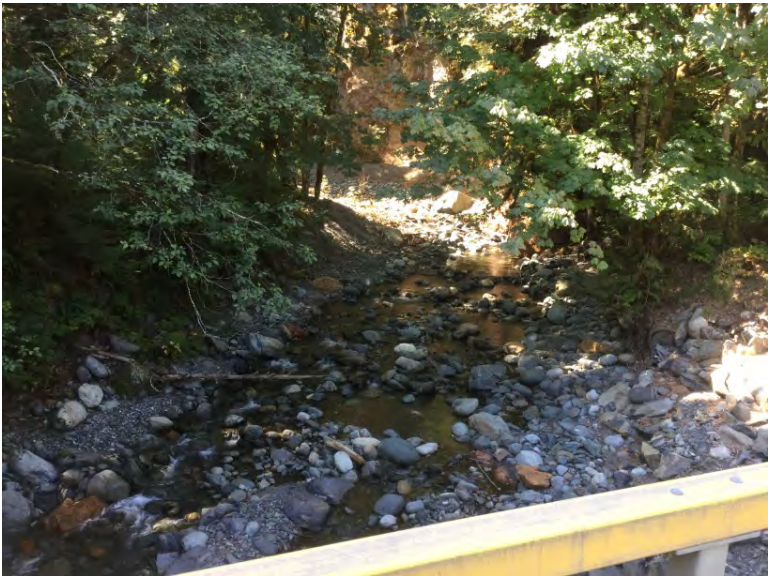
Upstream from Crossing

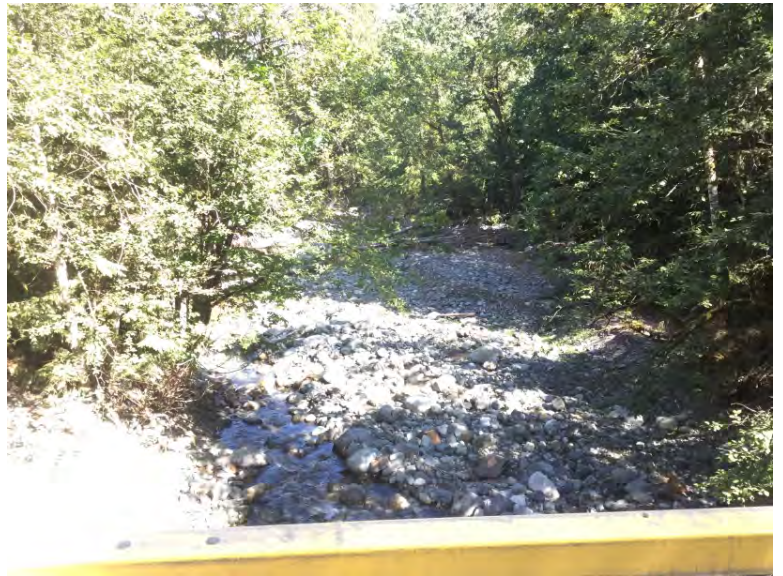
Downstream from Crossing

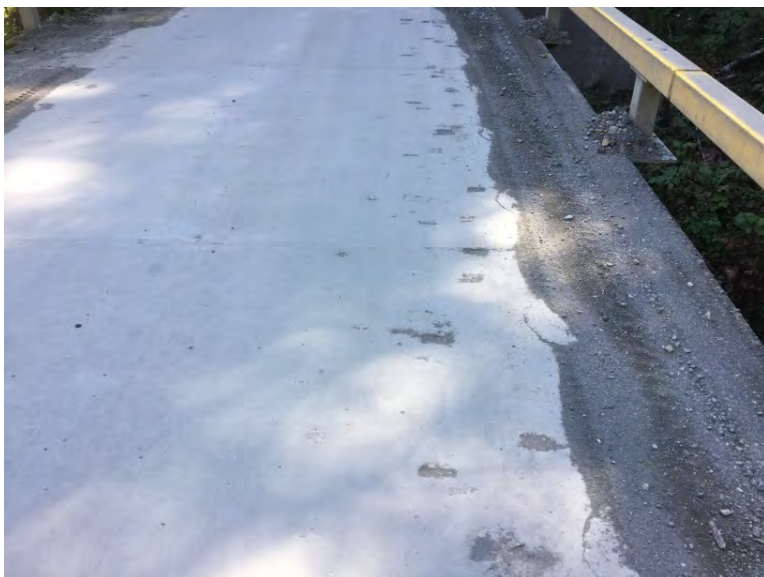
Concrete Deck      **Good**      Minor damage due to track equipment

Minor damage to deck from track equipment

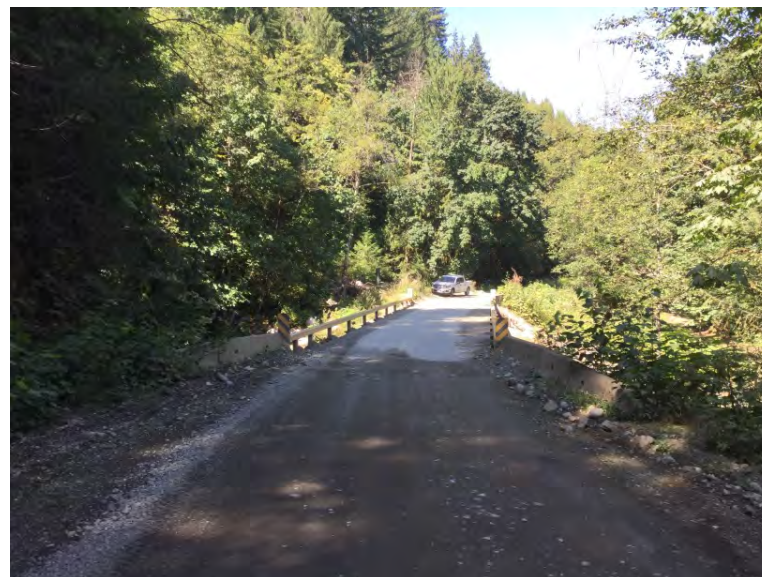
Approach from Right Bank when facing downstream

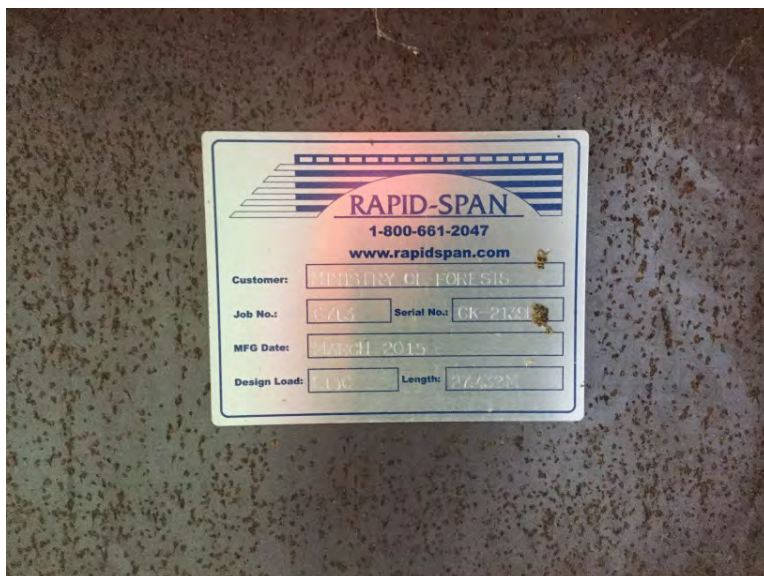
Structure ID

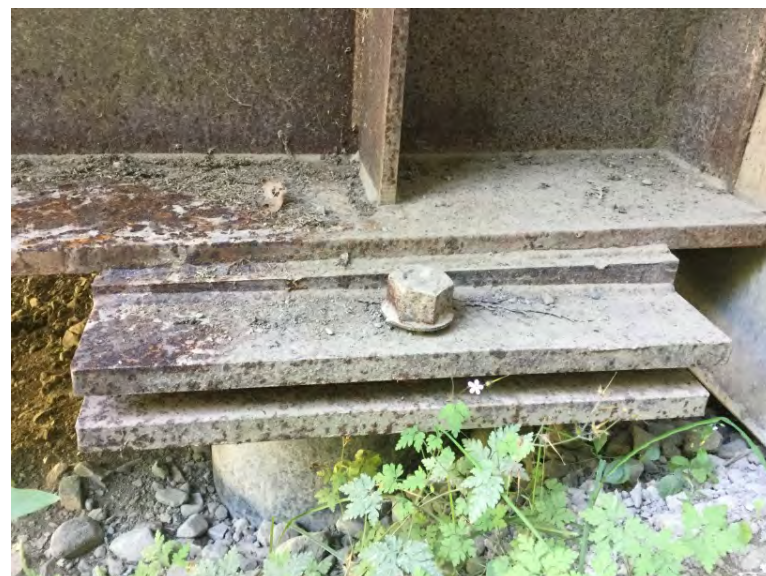
Bearing shim - typical

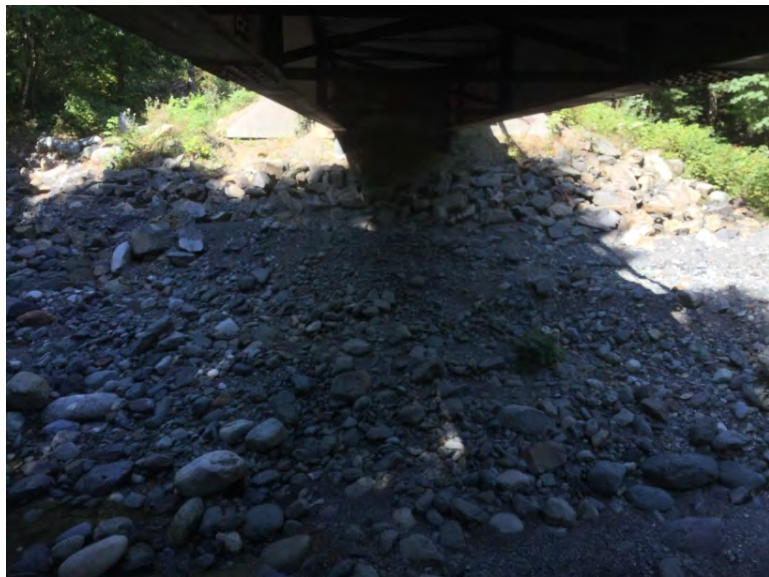
Left Bank Abutment when facing downstream

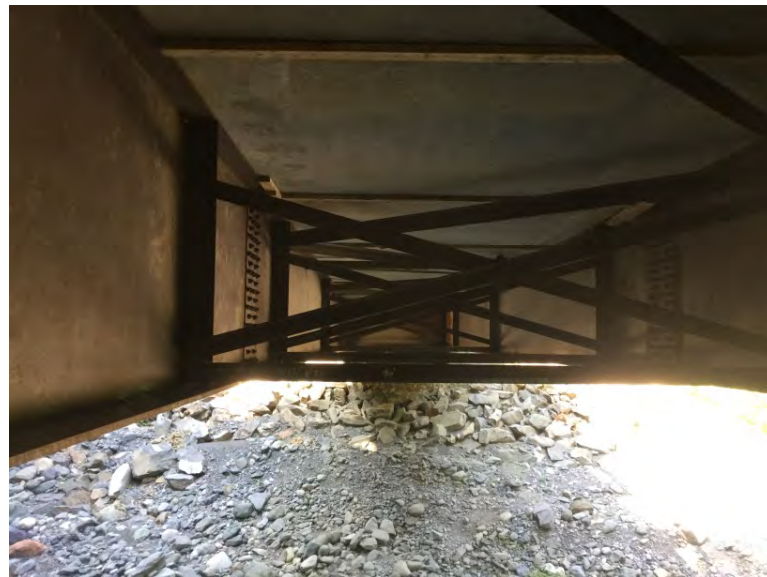
Superstructure

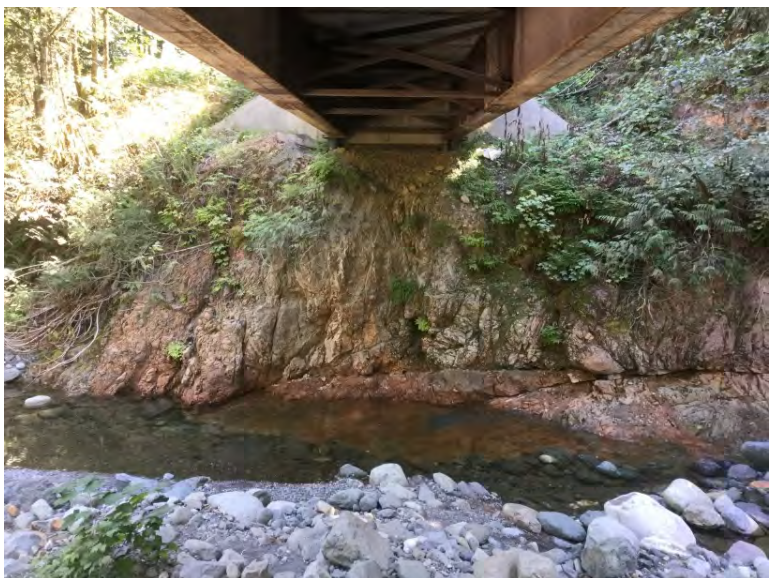
Right Bank Abutment when facing downstream

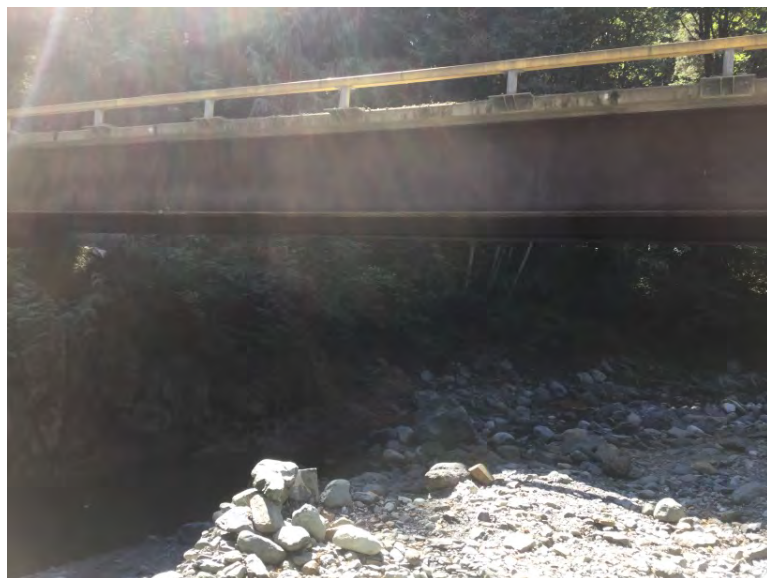
Downstream Profile

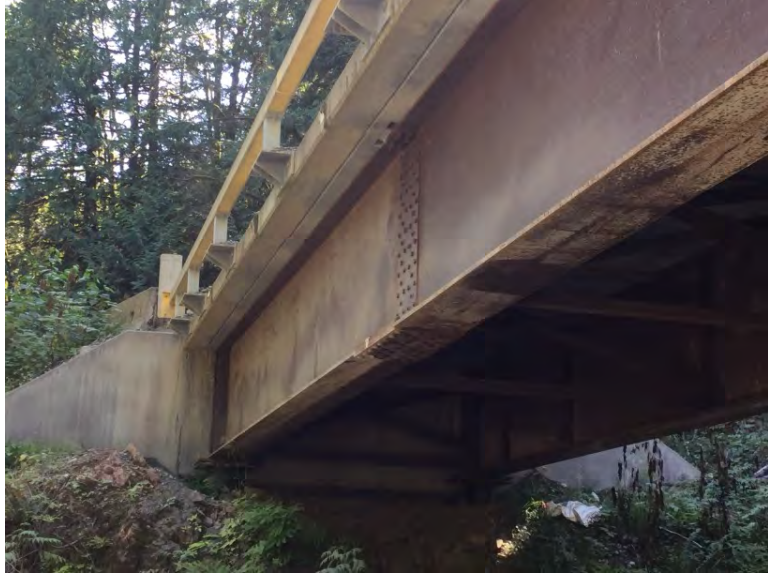
Splice plates
