CK-2140

STS'AILES (WEST) 46.5km

2019 Inspection

| Crossing Name | Davidson Creek |

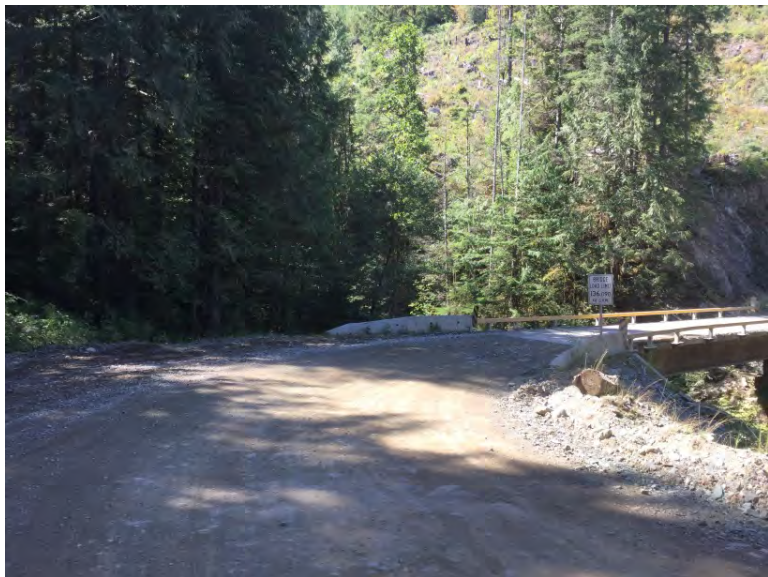
Approach from Right Bank when facing downstream

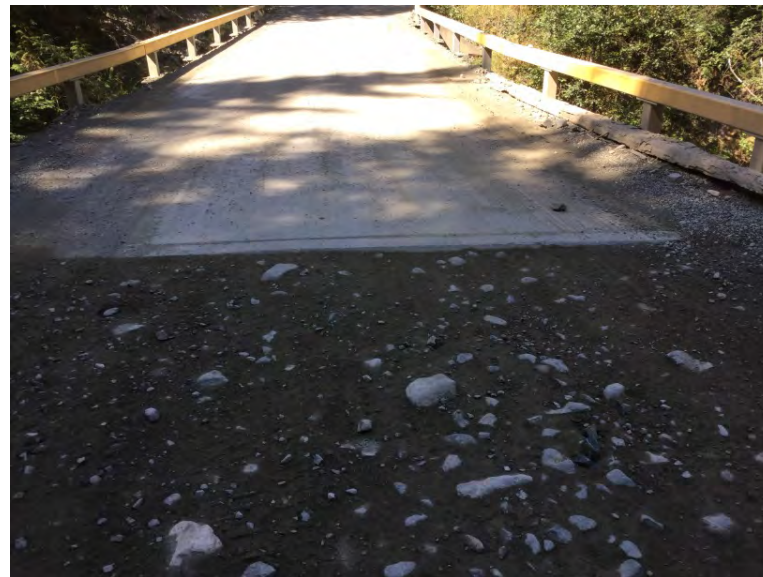
JC both approaches

Potholes at approaches

Grade approaches and repair the underside of left bank concrete deck panel consistent with the Concrete Repair Guide for Concrete Bridge Components (MoFLNRO 2017). The current load rating of L150 or 136 tonnes to continue.

| 1 | Medium | Grade approaches |

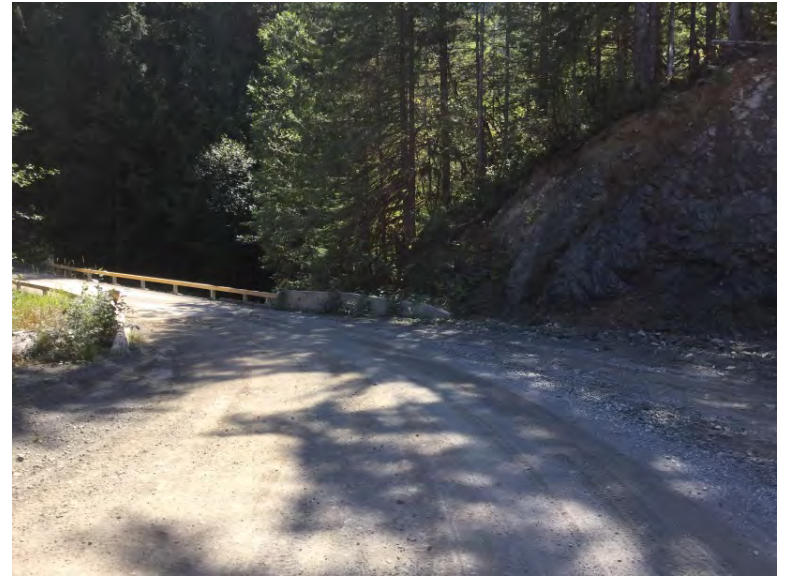
Approach from Left Bank when facing downstream

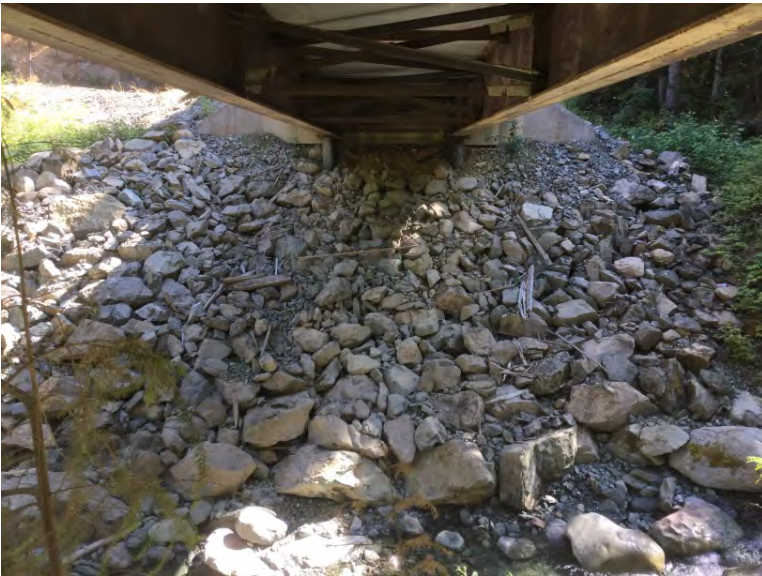
Right Bank Abutment when facing downstream

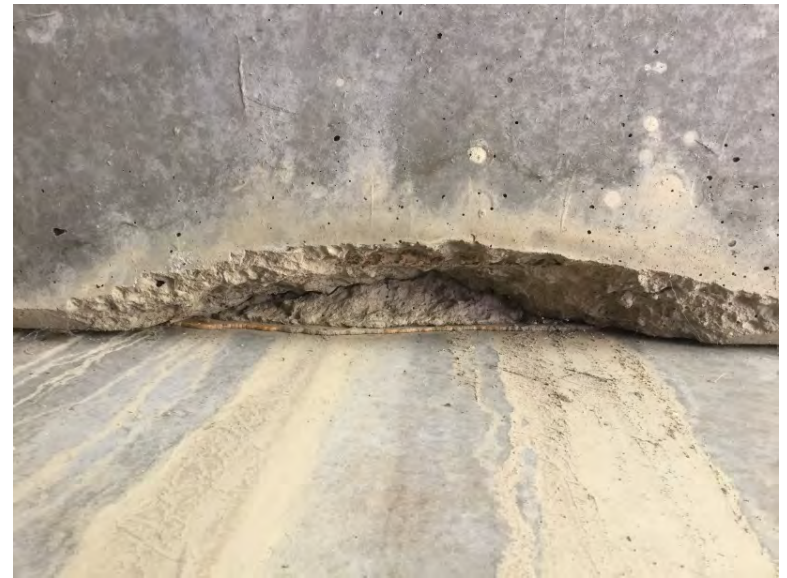
Left bank panel 1 damage

| 2 | Low | Repair damage to concrete panel |

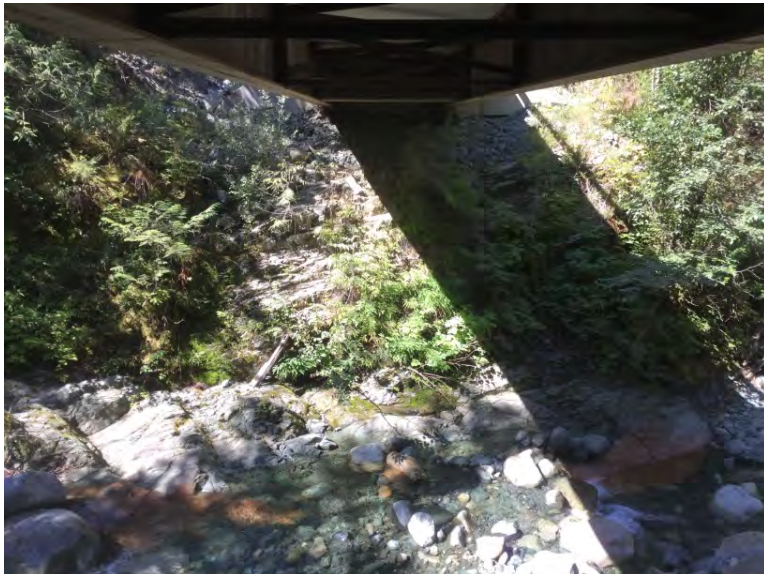
Left Bank Abutment when facing downstream
