CK-2147

STS'AILES (WEST) 66km

2019 Inspection

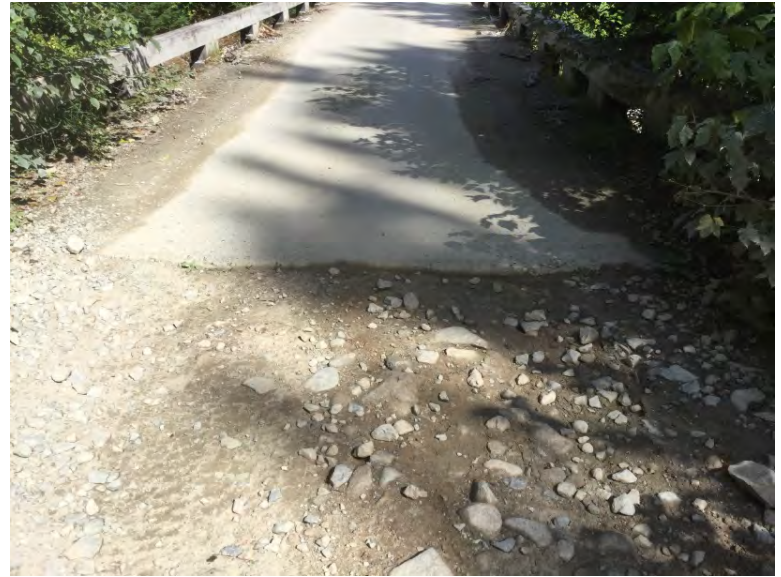
Potholes right approach

| 2 | Medium | Brush and grade approaches |

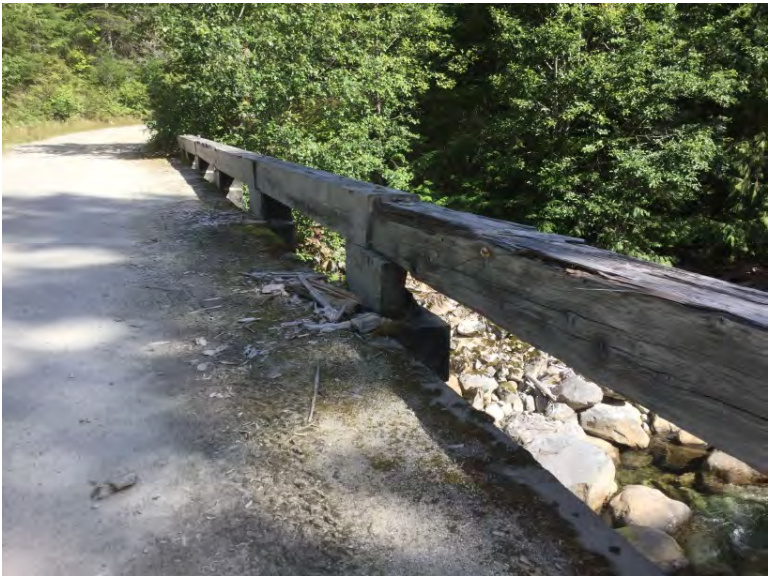
| Curb Rail/Blocks/Posts | Poor | Rotten risers and blocks |

| Overall Deck Condition | Poor | Due to rail condition |

Guardrail condition

| 1 | Medium | Replace guardrail, risers and blocks |

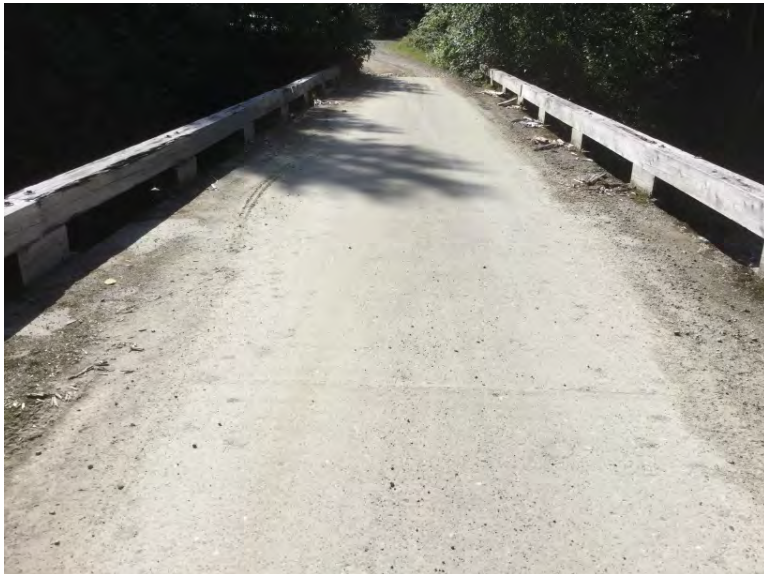
| Concrete Deck | Fair | Minor wear on wheel path due to track equipment |
