CK-2157

HUNTER 2.2km

2019 Inspection

| Road Name | HUNTER | | |

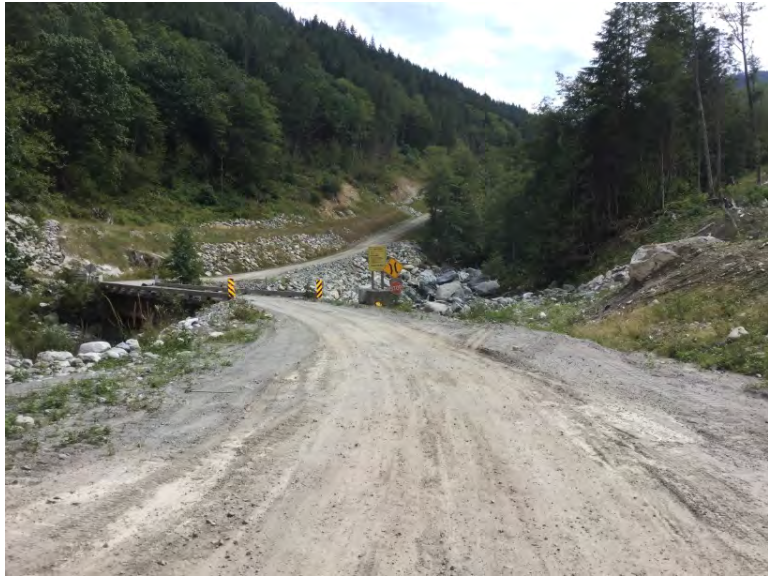
Approach from Left Bank when facing downstream

Fender Condition Poor

| 2 | Medium | Replace missing fender logs at both approaches |

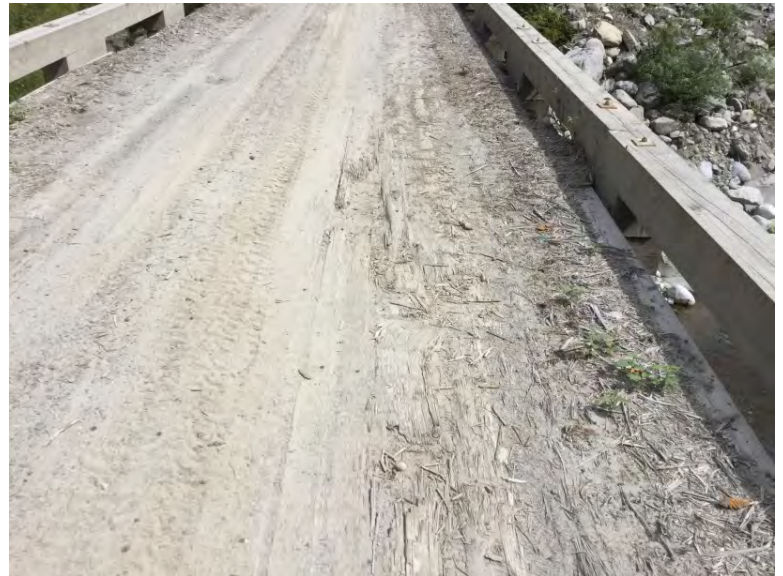
Rotting with holes on wheel path

Plank condition

| Item | Priority | Repair Description |
|---|---|---|
| 1 | Medium | Replace running planks if sustained industrial traffic required |

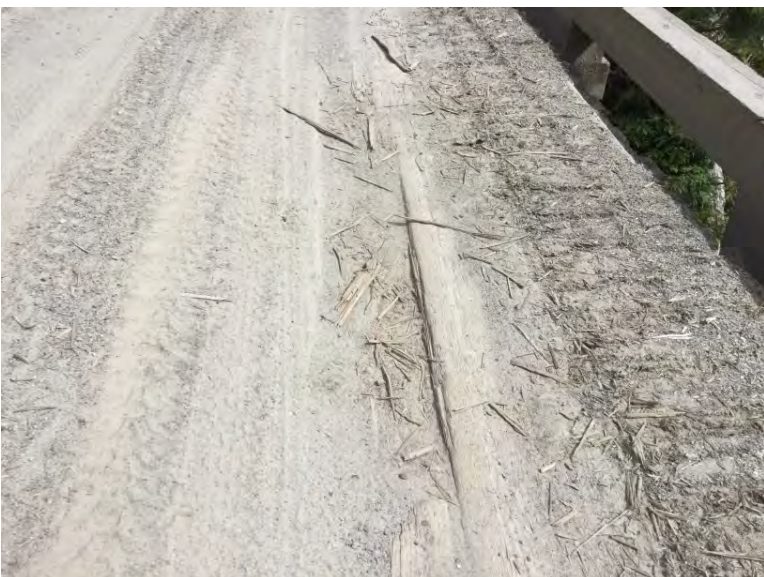
Poor

Due to plank condition

Poor plank condition throughout

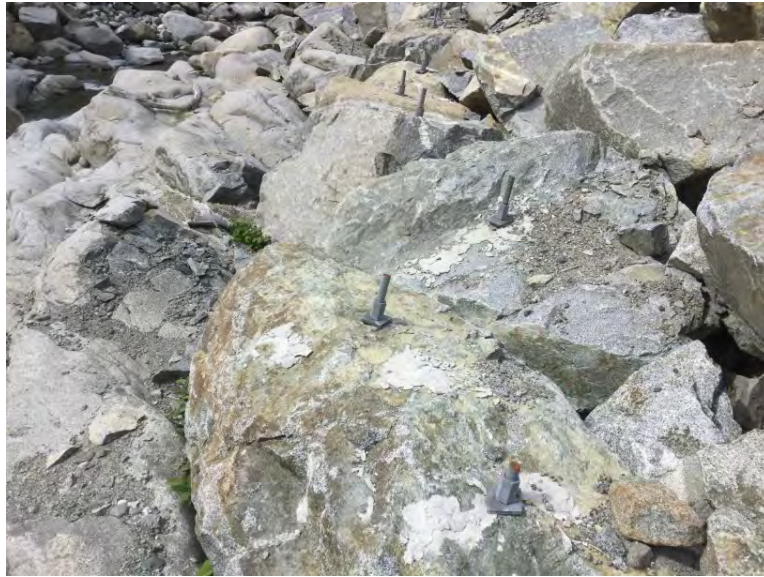
Large round rock used at left bank, 1:1 slope

Riprap bolting upstream

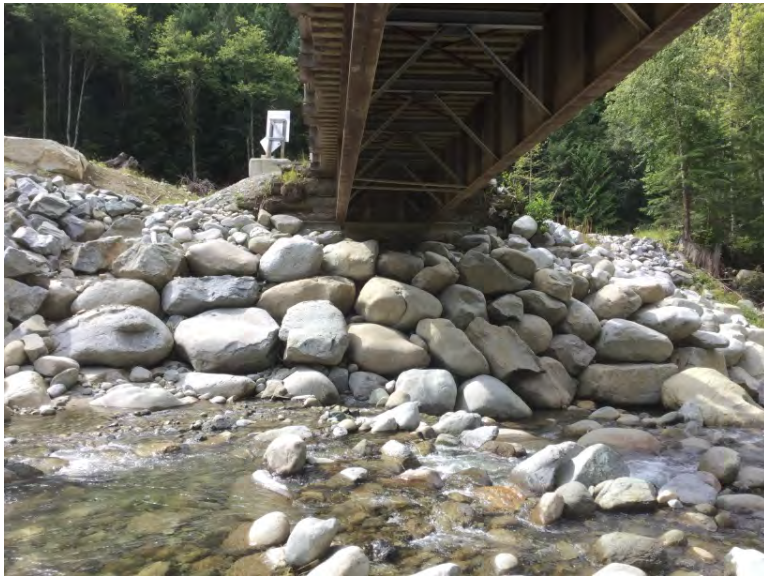
Left Bank Abutment when facing downstream

Log/Timber Cribs Fair Only 2 face logs visible both banks with up to 40mm sap rot

| Item | Monitor Description | Frequency |
|---|---|---|
| 1 | Log crib and timber deck condition | Routine inspection |

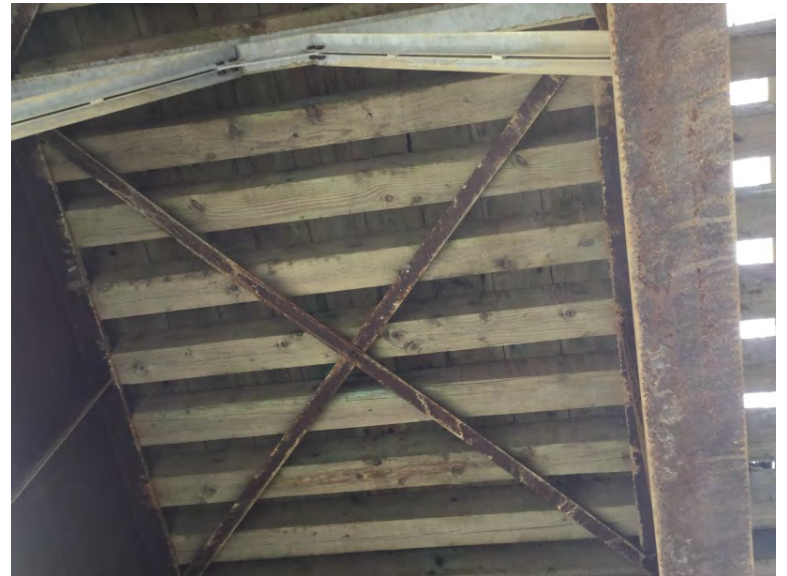
Treated - appears to be in fair condition from below

Deck from underneath

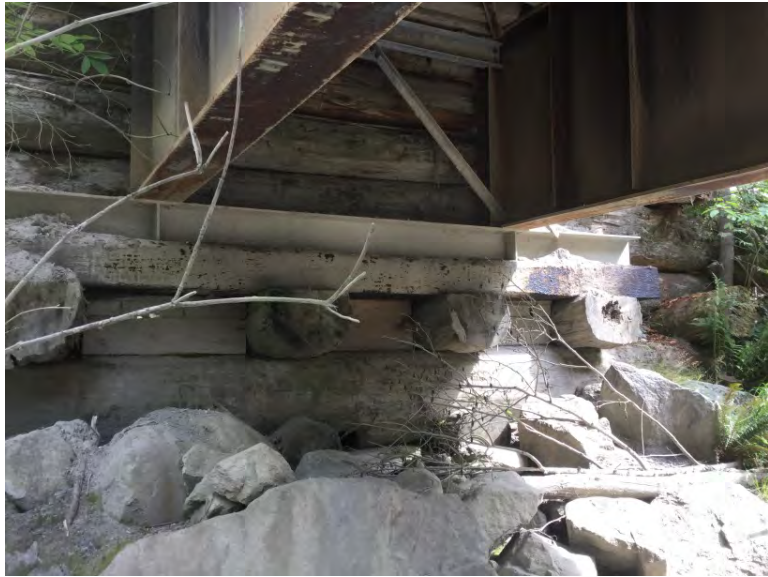
Fair

Right bank bearing

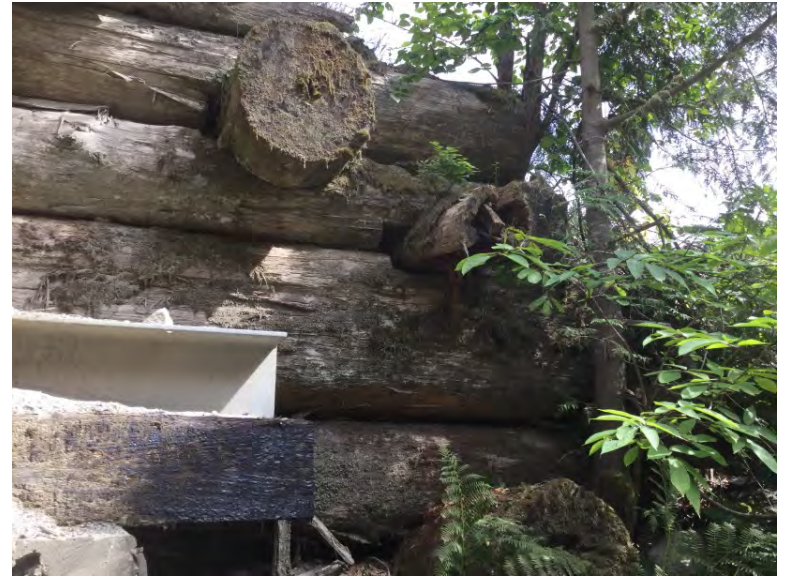
End splitting - Tiebacks under girders appear in fair condition, tiebacks outside of girders in poor condition

Right bank fill retention tieback log condition
