CK-2158

HUNTER 4.9km

2019 Inspection

| Crossing Name | East Fork Hunter Creek | | |

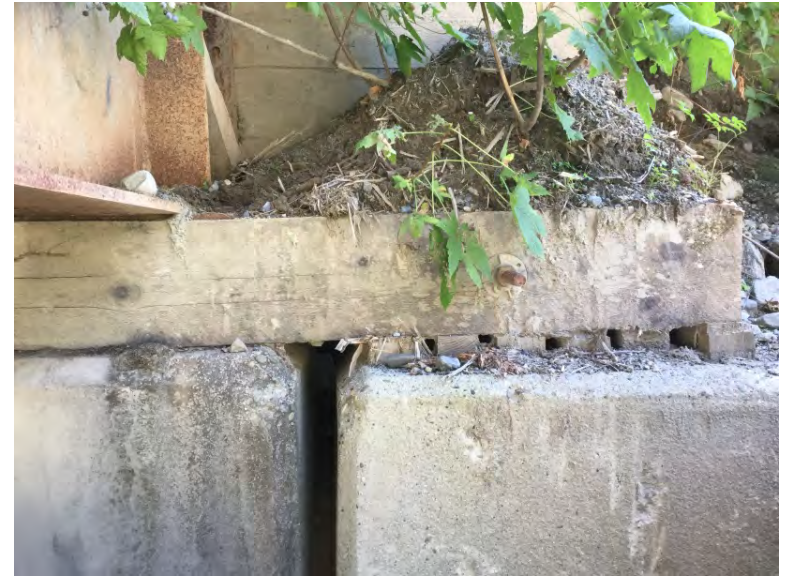
The downstream left abutment lock block has settled up to 75mm. In speaking with the primary road user at the time of inspection the timber sill at the left bank was shimmed in 2017 to ensure no gap between the timber sill and lock block footing, and the lock block does not appear to have settled any further since then. The fill under the lock blocks needs to be monitored to ensure no further settlement occurs.

Down stream left abutment shim

Monitor the left bank lock block and fill condition. Monitor the left bank riprap and timber sill condition. The current load rating of L75 or 68 tonnes to continue. Inspect again in 2020.

| Item | Monitor Description | Frequency |
|---|---|---|
| 1 | Monitor downstream left bank lock block settlement and fill condition | Routine Inspection |

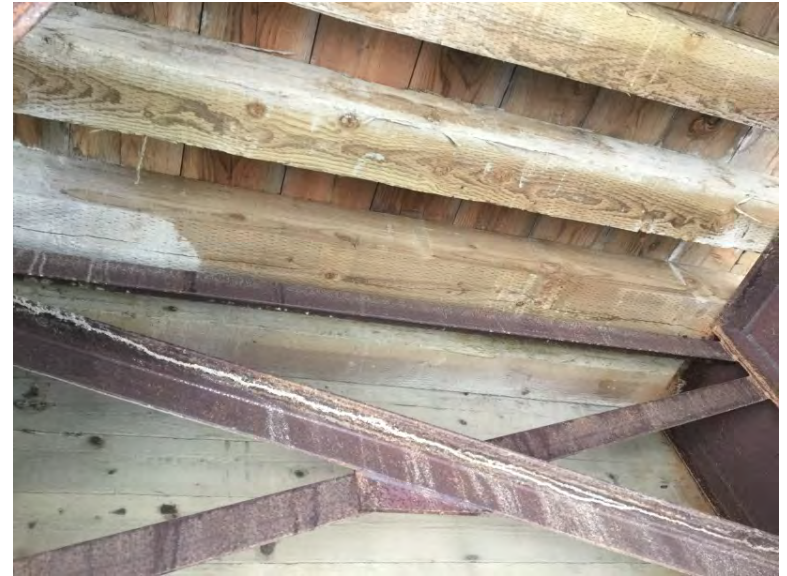
Treated, single tie at downstream right bank has damage at riser connection, 300mm long x 30mm thick piece sheared off and minor checking of tie between girders

2nd tie right bank has minor check girder to girder

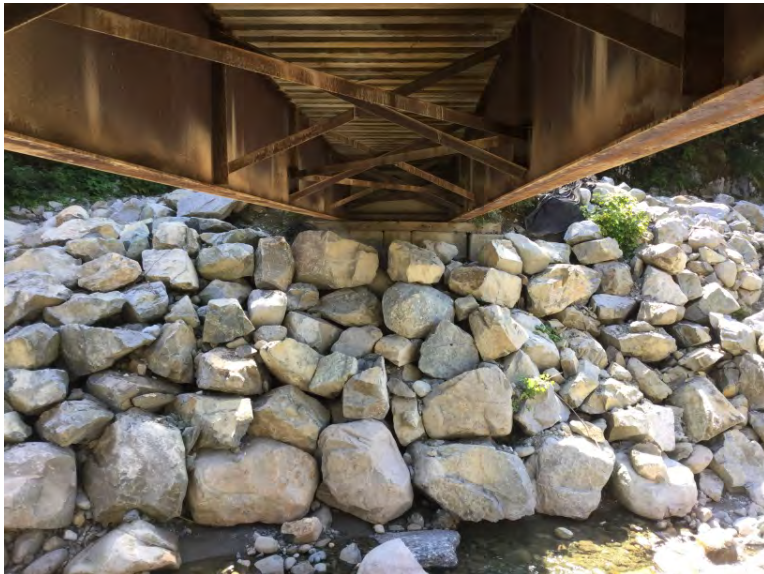
Lockblocks on left bank downstream block settled - monitor. CIP on right bank is good

Left bank timber sill has a small conk noted and 10mm sap rot. Approx 5mm Crushing under bearing plates. Right bank-treated sill and in good condition

Left Bank Abutment when facing downstream

| Item | Monitor Description | Frequency |
|---|---|---|
| 2 | Monitor left bank timber sill condition | Routine Inspection |

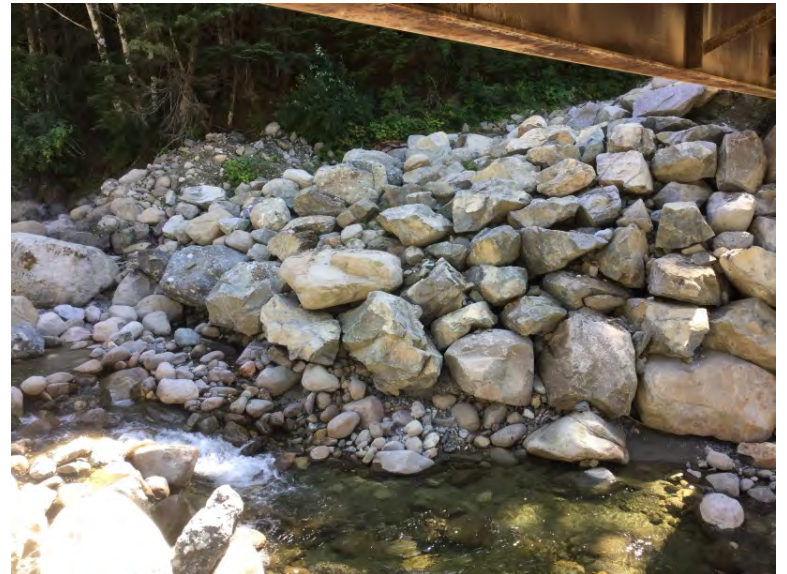
up stream left bank scoured

Upstream left bank riprap starting to scour - monitor

Upstream Left bank rip rap scour

| Item | Monitor Description | Frequency |
|---|---|---|
| 3 | Monitor left bank riprap condition | Routine Inspection |

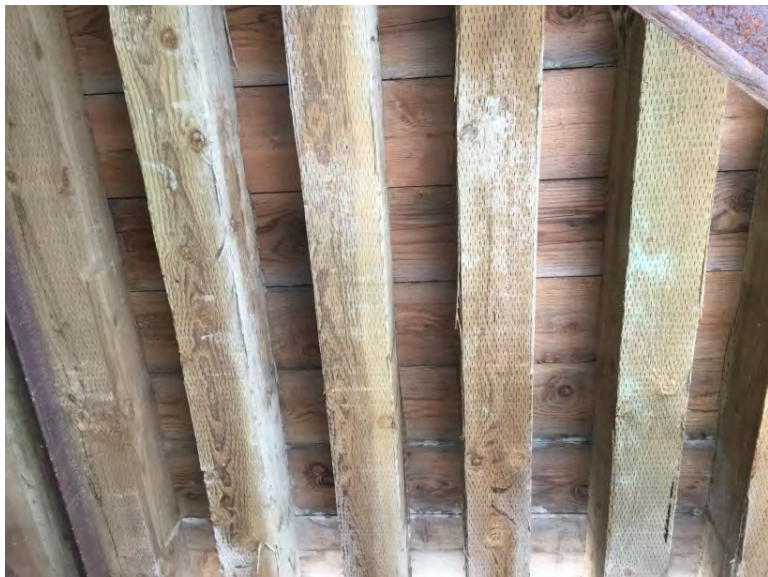
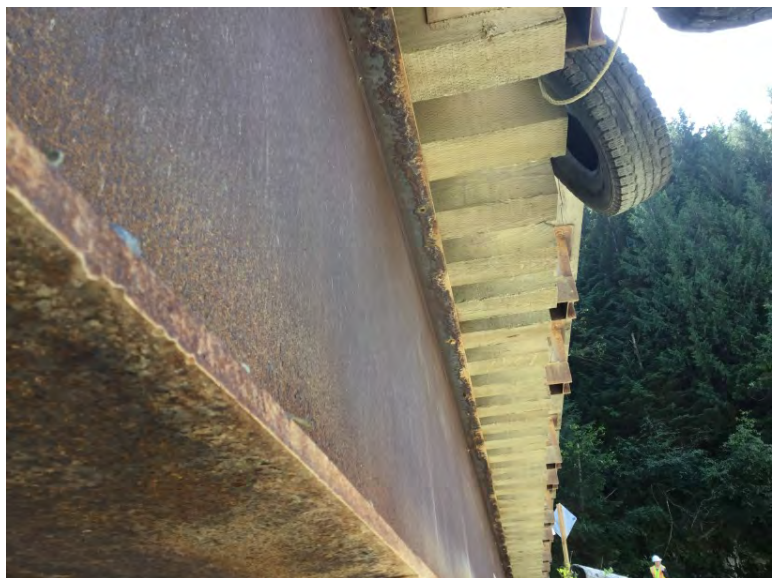
30 - 40% missing. No movement in deck apparent

Timber deck to girder connection

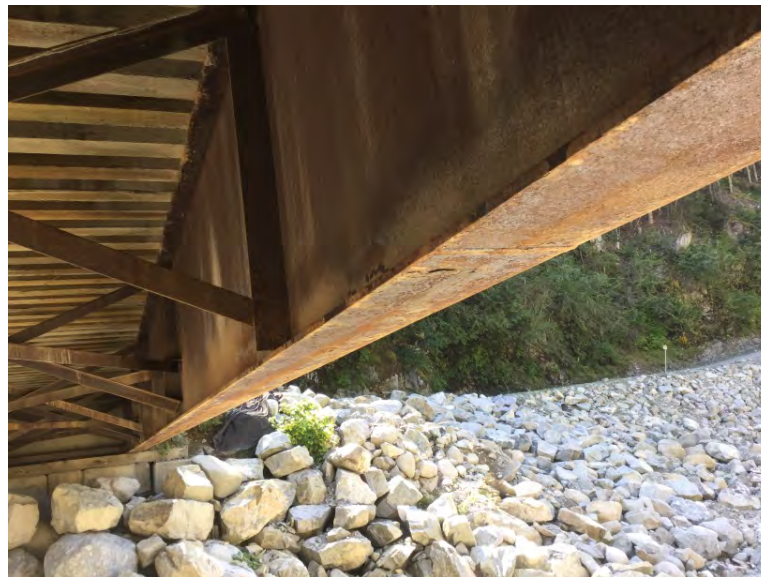
Minor Corrosion noted

6 welded bays with some corrosion

Corrosion
