CK-2161

HUNTER 4700 5.8km

2019 Inspection

| Structure Class | Temporary Bridge |

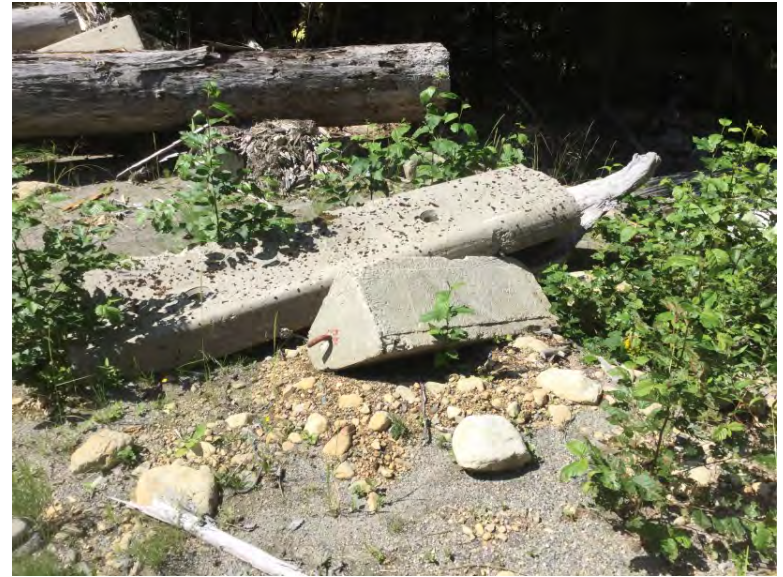
Lock blocks right approach and unconnected no post barriers left approach

Transition and bullnose not attached upstream left approach

| Item | Priority | Repair Description |
|---|---|---|
| 3 | Medium | Reconnect no post barriers |

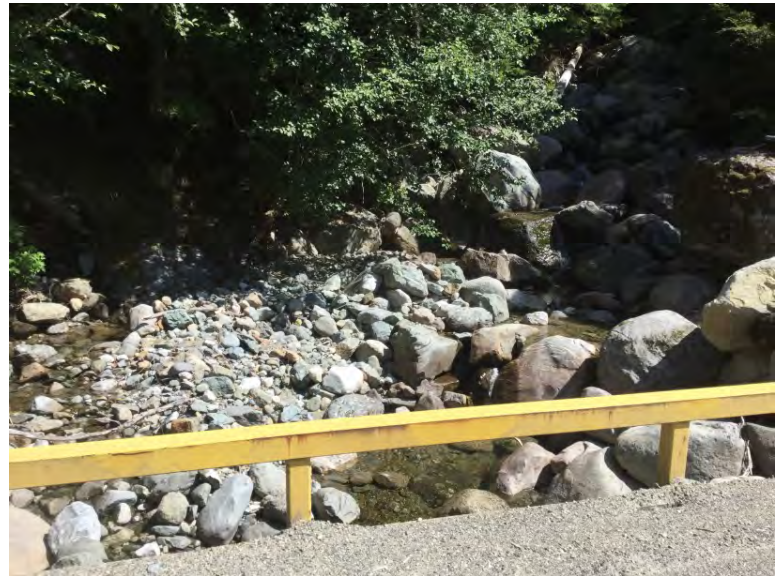
Upstream from Crossing

Stream is aggrading at the inlet

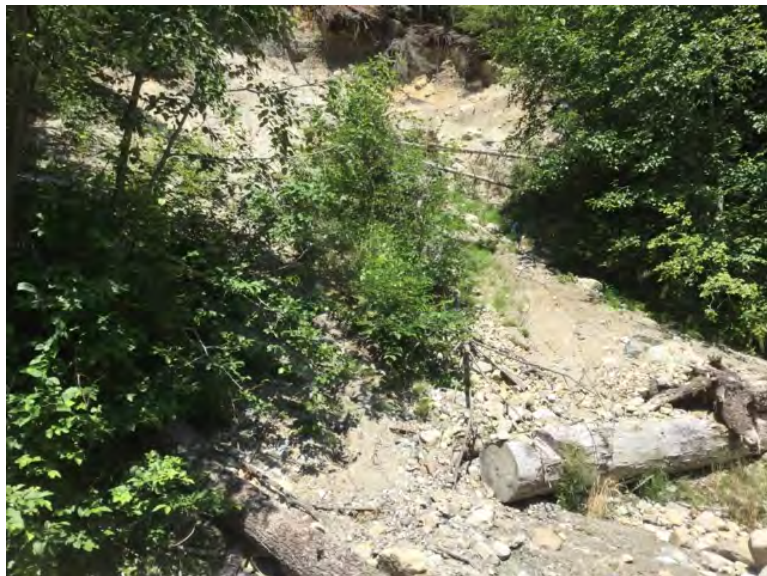
Ravelling cutbank at right approach

| Item | Priority | Repair Description |
|---|---|---|
| 1 | Medium | Clear road prior to operations |

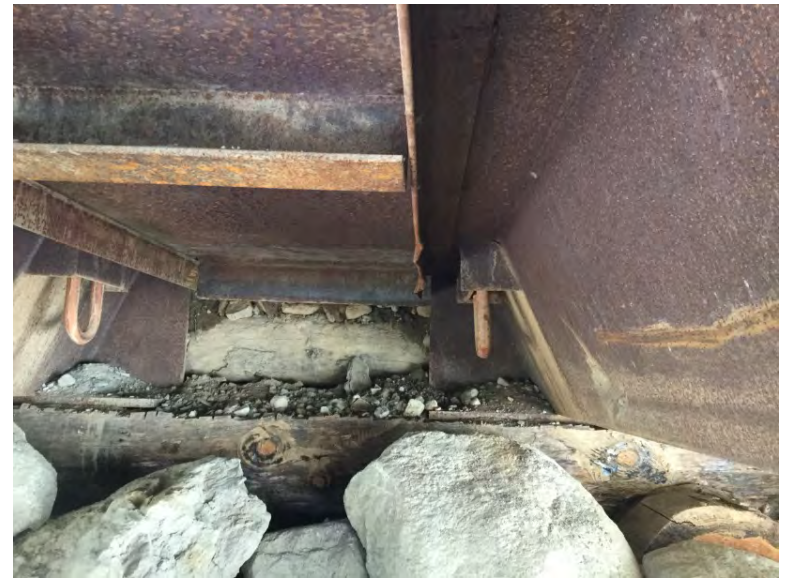
Bridge guide angle deformed at upstream right bank

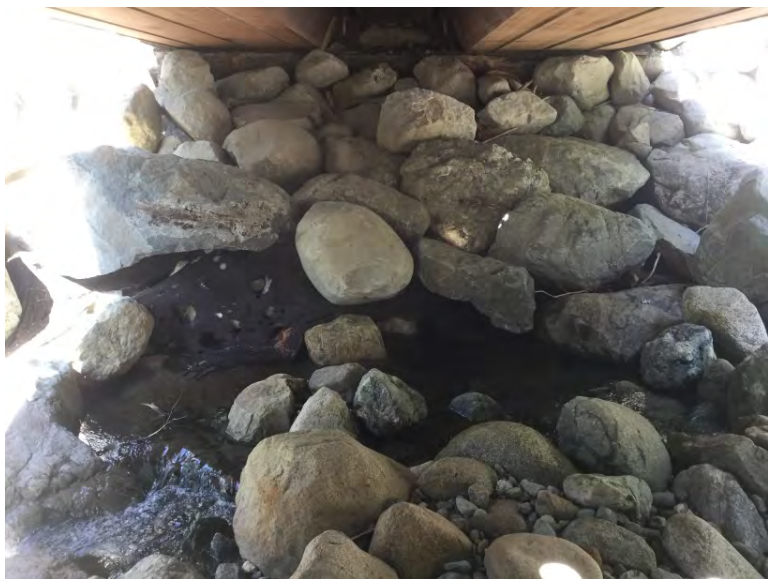
Scour noted at right bank

All riprap is rounded, scour already noted at right bank - monitor

Right Bank Abutment when facing downstream, scour noted

| Item | Monitor Description | Frequency |
|---|---|---|
| 1 | Riprap condition as scour is noted | Routine Inspection |

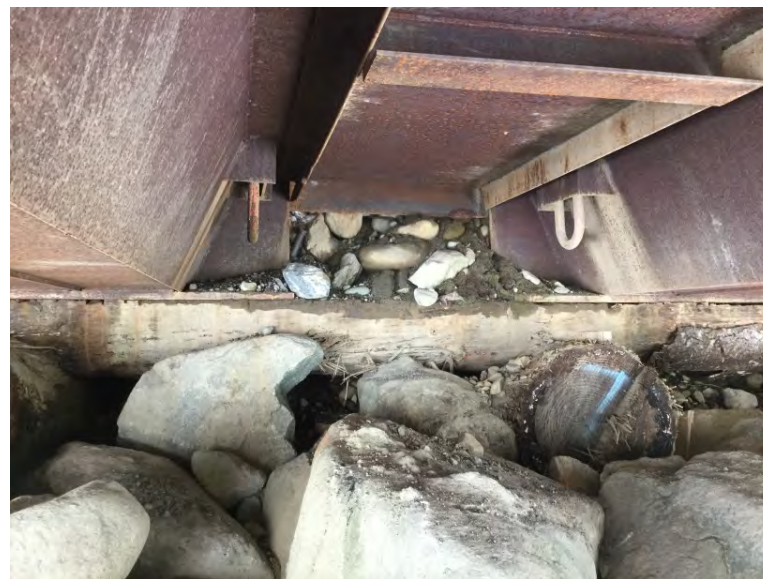
Left bank wall not tight to girders leaving gap and sediment falling through, no wall right bank

No ballast wall at left bank

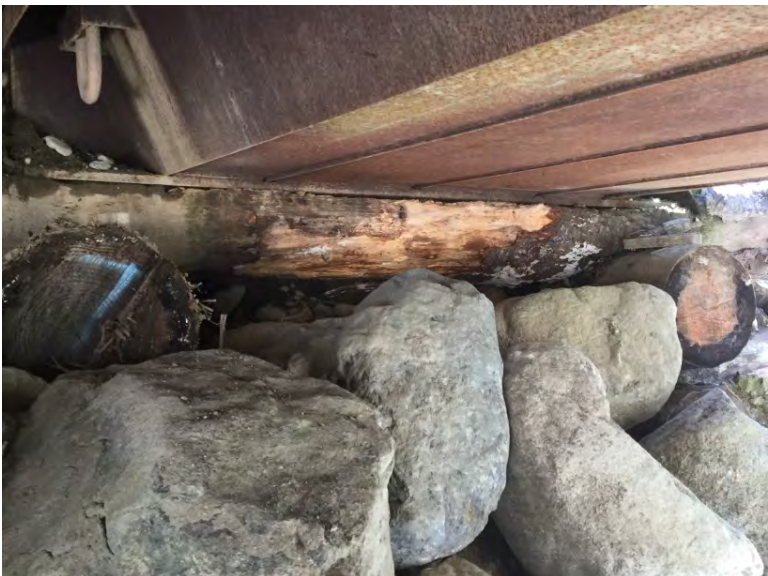
3x face logs, open face - face logs not completely peeled

Face logs were never completely peeled and minor sap rot noted

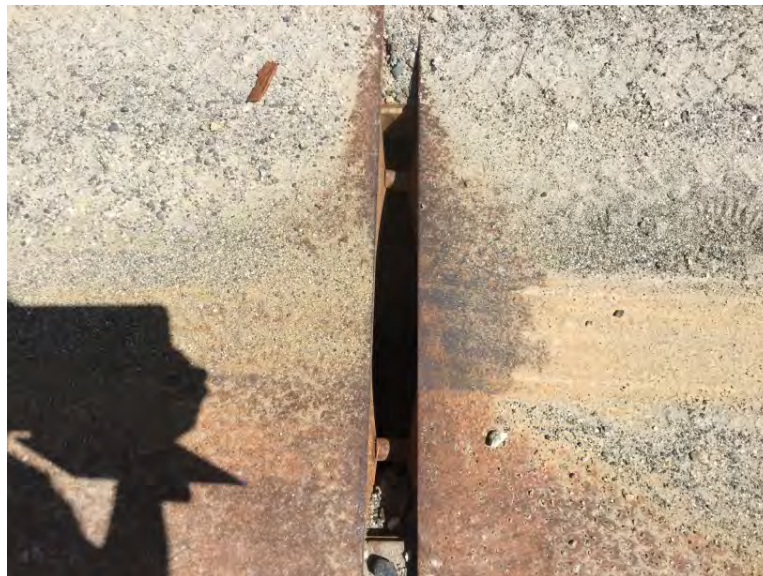
Spacer plate is constructed in 2 pieces and steel at joint has started to deform, no timber blocking

| Item | Priority | Repair Description |
|---|---|---|
| 4 | Medium | Replace timber blocking on steel spacer plate |
