CK-2165

LOST CREEK 2.2km

2019 Inspection

| Crossing Name | Murdo Creek |

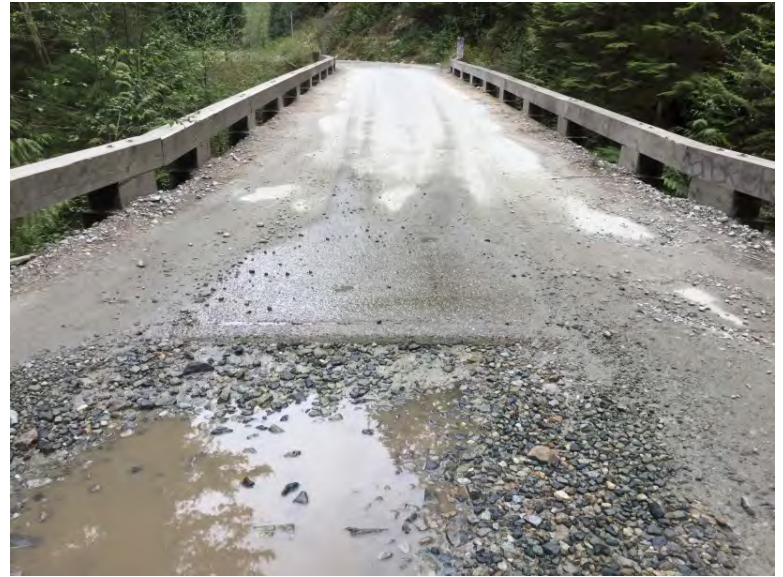
Potholes at approaches

Potholes at left approach

Clean the bearing plates and girders at bearing locations. Replace delineators and post bridge ahead signs. Grade approaches. Monitor the steel delamination. The current load rating of L75 or 68 tonnes to continue.

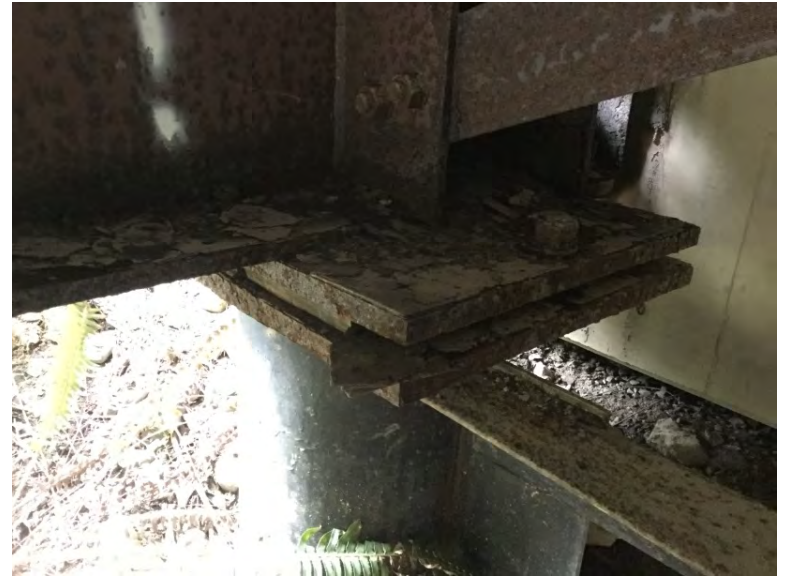
Minor delamination of bearing plates and bottom flange around bearing locations

| Repair Item | Priority | Repair Description |
|---|---|---|
| 2 | Low | Clean bearing plates and girders at bearing locations |

| Item | Monitor Description | Frequency |
|---|---|---|
| 1 | Steel delamination | Routine Inspection |

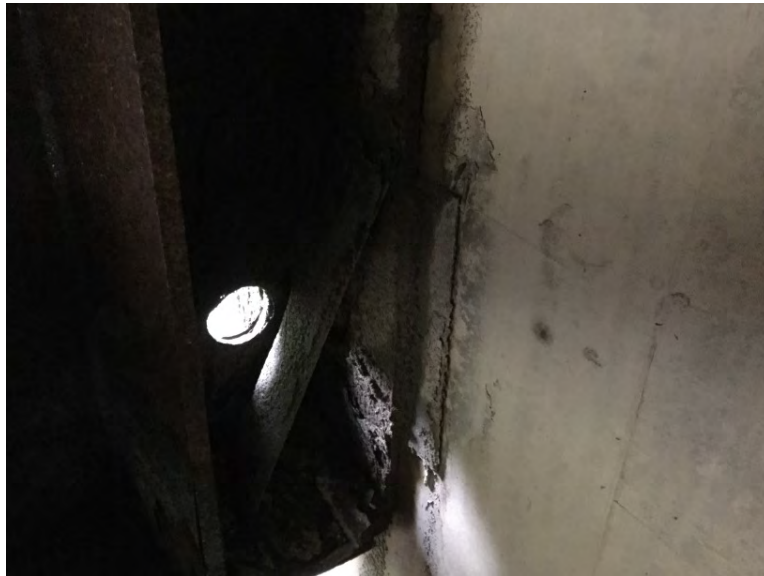
Minor steel delamination of end plates

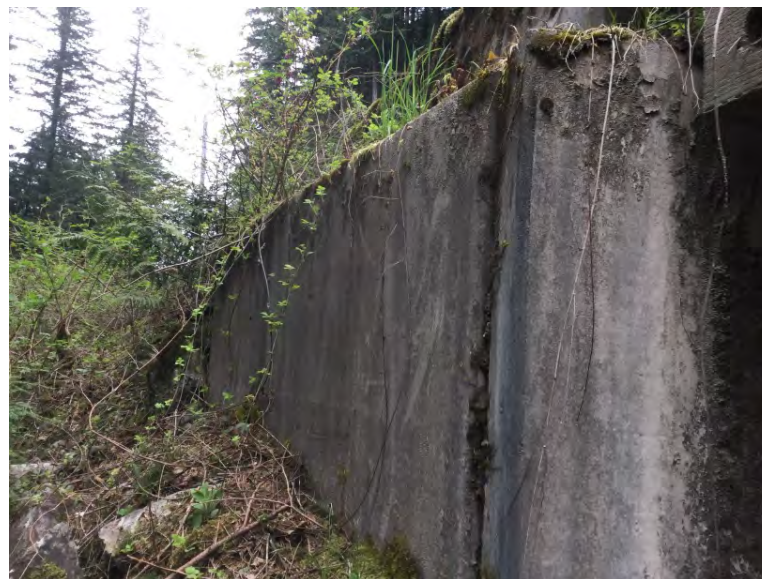
Concrete wingwall only at downstream locations

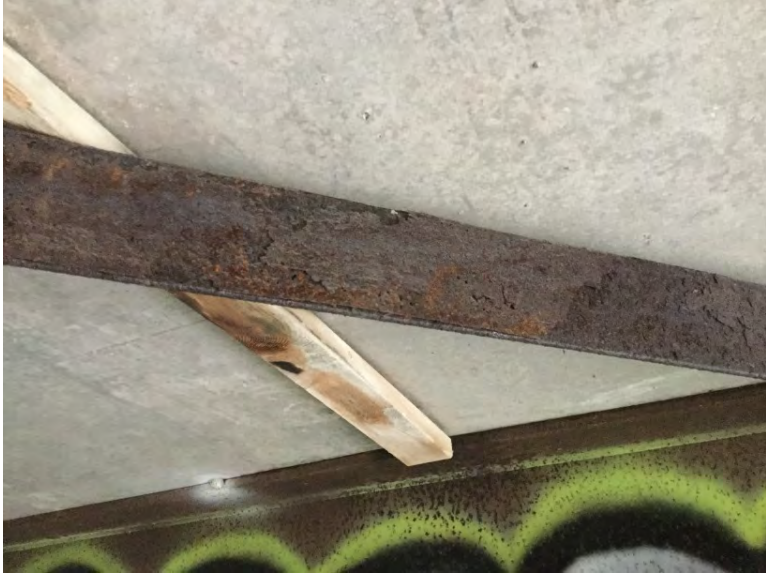
Minor steel delamination on plan bracing
