CK-2166

LOST CREEK 5km

2019 Inspection

| Crossing Name | Weatherhead Creek |

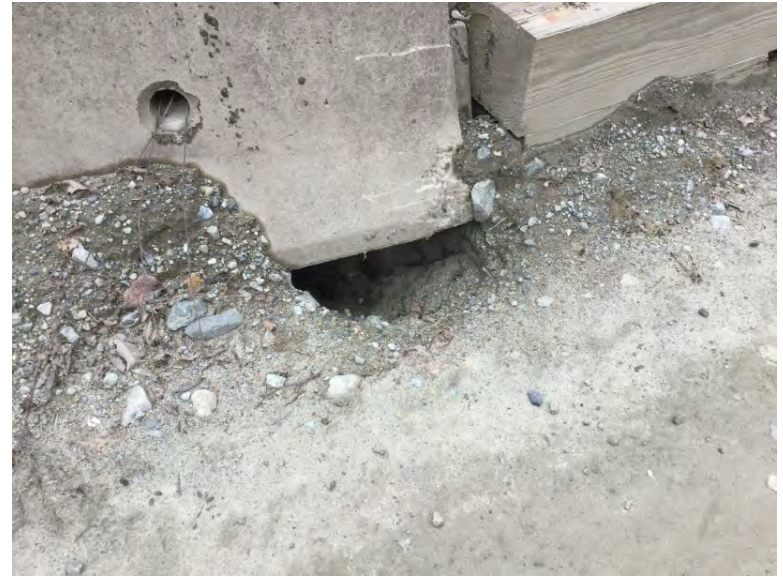
Loosing fill downstream left approach, rotten log retaining fill

Fill erosion noted downstream left approach

| 3 | High | Replace log retaining fill at downstream left bank |

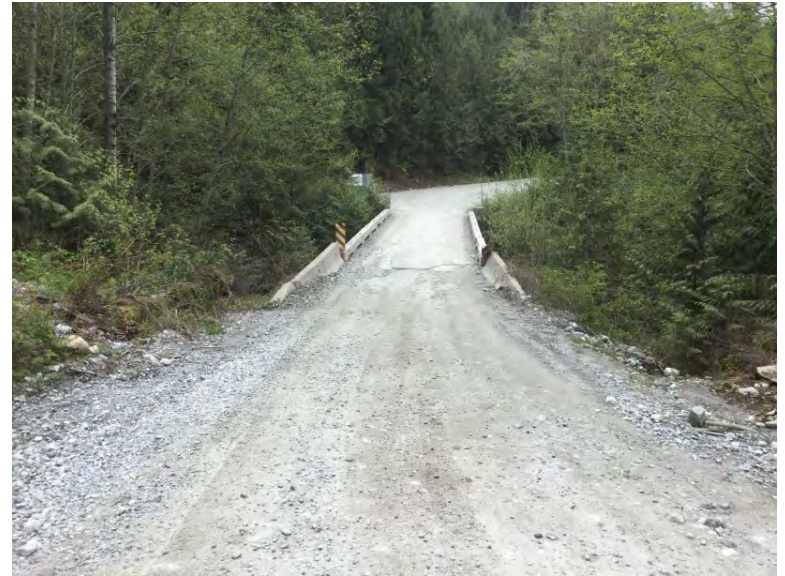
Approach from Right Bank when facing downstream

Heavy VC right approach

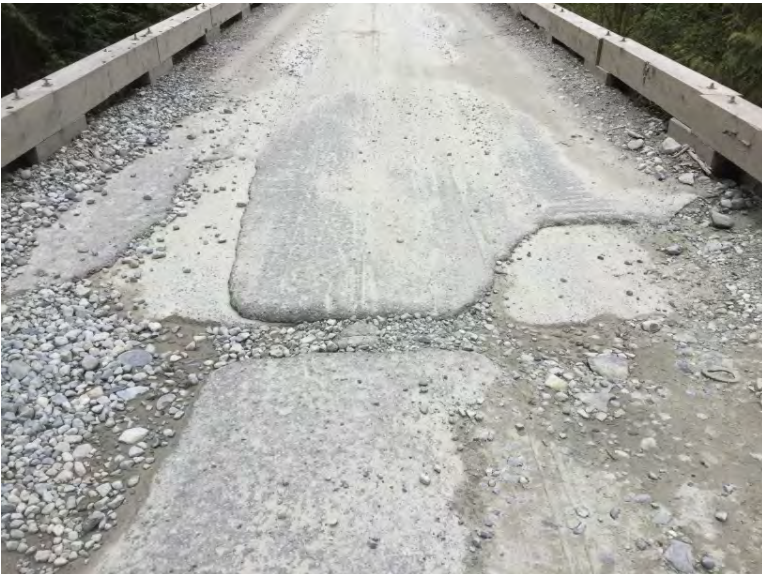
Asphalt overlay is wearing extensively at right approach

Asphalt overlay is wearing at right approach

| 1 | Asphalt overlay condition | Routine Inspection |

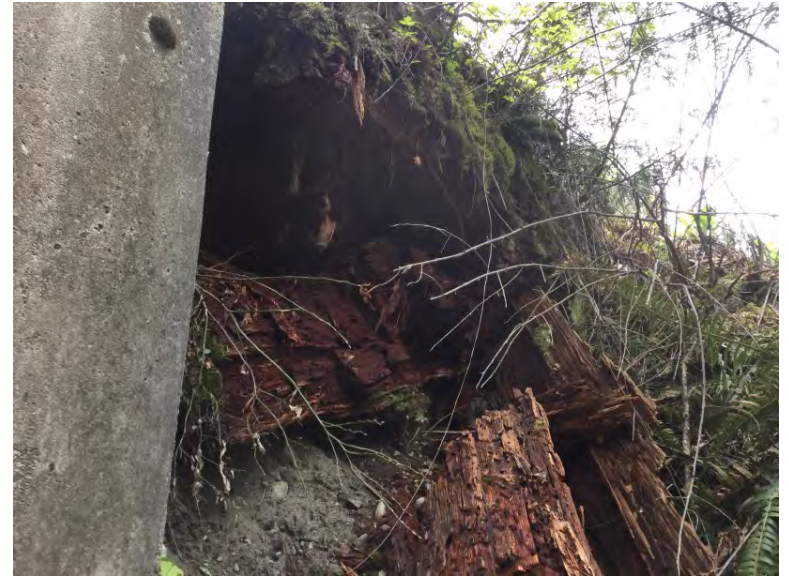
Rotten log retaining fill downstream left bank

Replace the log retaining fill at downstream left approach; replace all the delineators and remove the sediment from the deck. Monitor the asphalt overlay condition. The current load rating of L60 or 54 tonnes to continue.
