CK-2168

LOST CREEK 8.6km

2019 Inspection

| Crossing Name | Twin Lakes Creek |

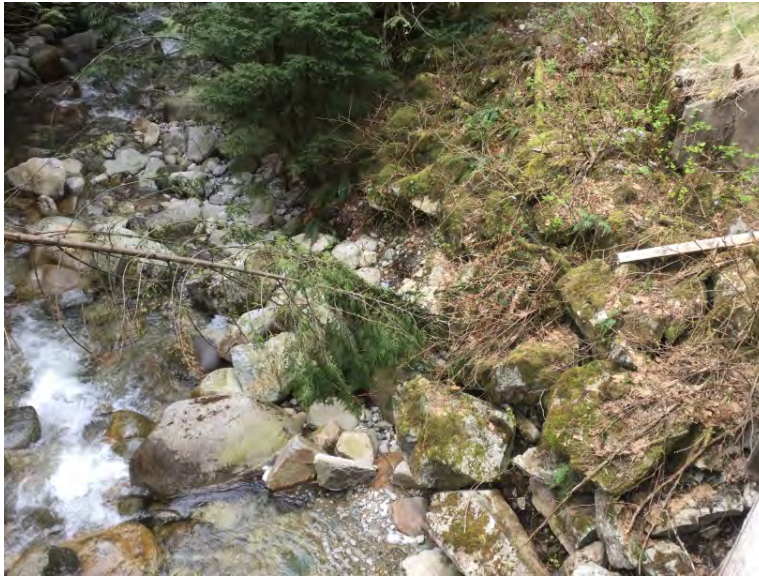
Downstream right bank has sustained minor scour

Riprap scour noted downstream right bank

| Item | Monitor Description | Frequency |
|---|---|---|
| 1 | Riprap scour noted downstream right bank | Routine Inspection |

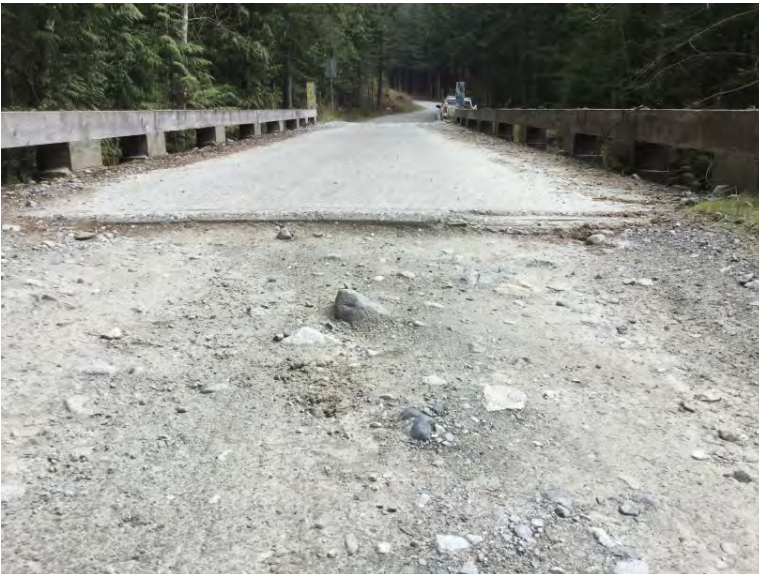
Road Surface Poor

Large Potholes

Requires surfacing at both approaches

| Repair Item | Priority | Repair Description |
|---|---|---|
| 3 | High | Grade approaches |

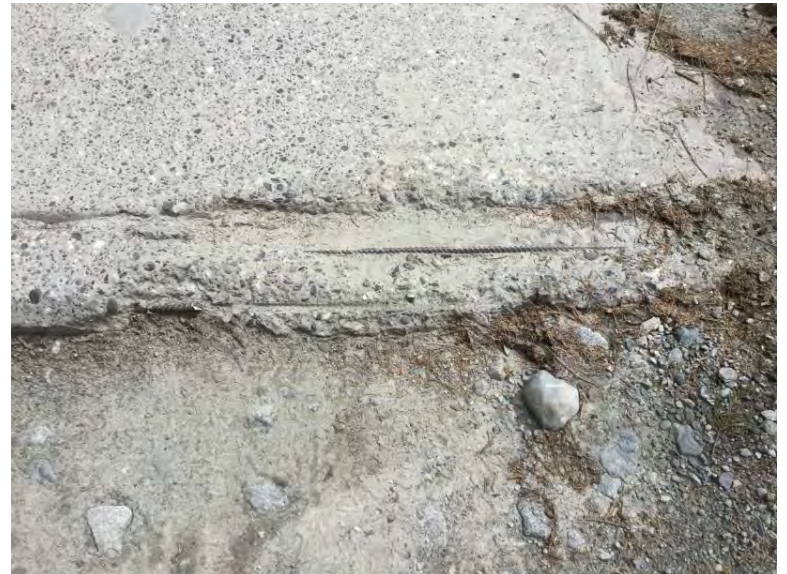
Ballast Wall Poor

Top surface of right bank has significant damage

Right abutment top ballast wall condition

Repair the damage noted to the top of the right bank ballast wall and adjacent deck panel consistent with the Concrete Repair Guide for Concrete Bridge Components (MoFLNRO, 2017); replace the missing bridge ahead sign; and grade approaches. Monitor the riprap scour noted at downstream right bank. The current load rating of L75 or 68 tonnes to continue.

| Repair Item | Priority | Repair Description |
|---|---|---|
| 2 | High | Repair damage to right bank ballast wall and panel 1 |

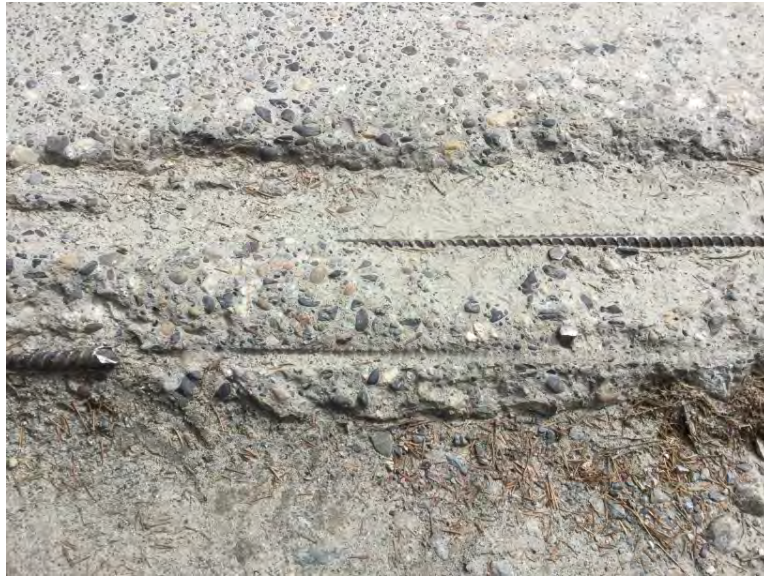
Missing rebar on right bank ballast wall

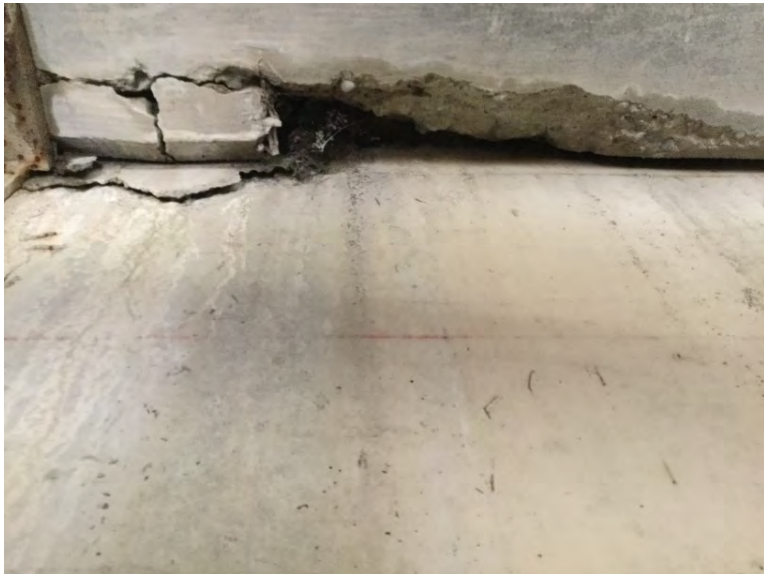
Right bank panel 1 damage

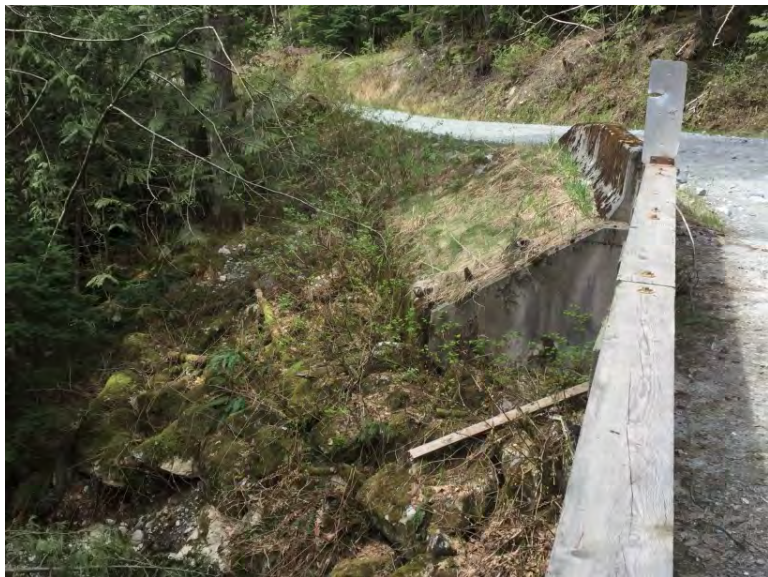
Upstream left bank and downstream right bank have lock blocks retaining fill

Downstream right bank fill retaining blocks

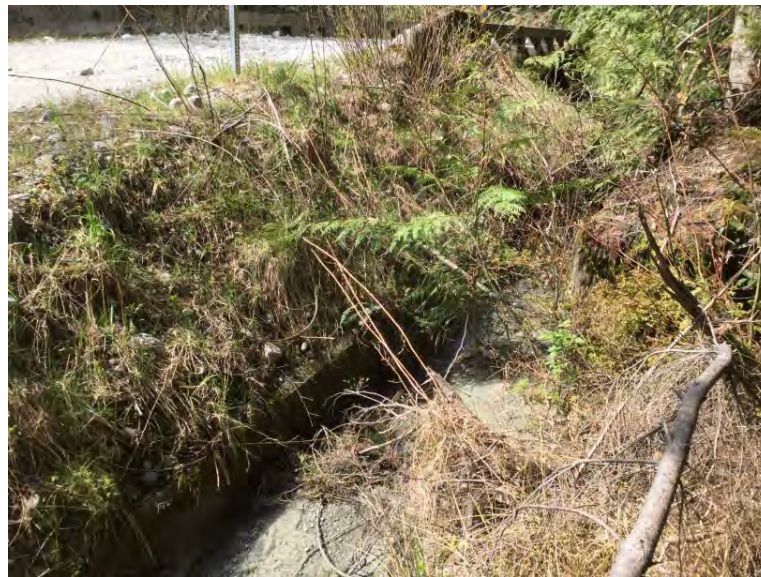
Upstream left bank fill retaining blocks
