CK-2169

LOST CREEK 14.6km

2019 Inspection

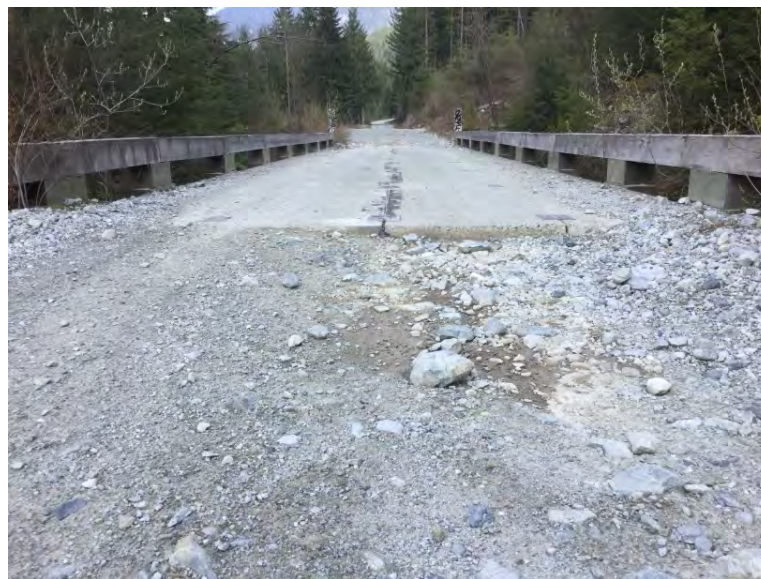
Road Surface Poor Large potholes

Approaches require surfacing

| Repair Item | Priority | Repair Description |
|---|---|---|
| 3 | High | Add surfacing to approaches |

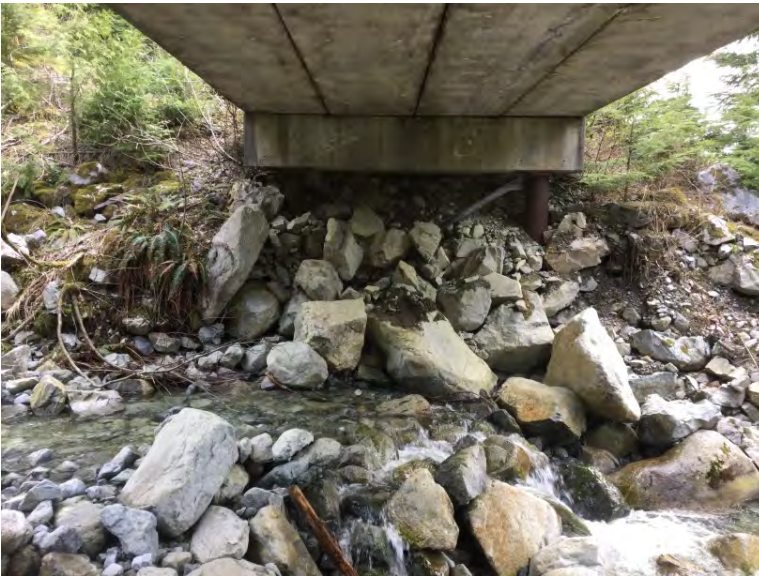
Left Bank Abutment when facing downstream

Riprap Poor Scoured both approaches

| Repair Item | Priority | Repair Description |
|---|---|---|
| 2 | Medium | Consider repairing riprap at both approaches |

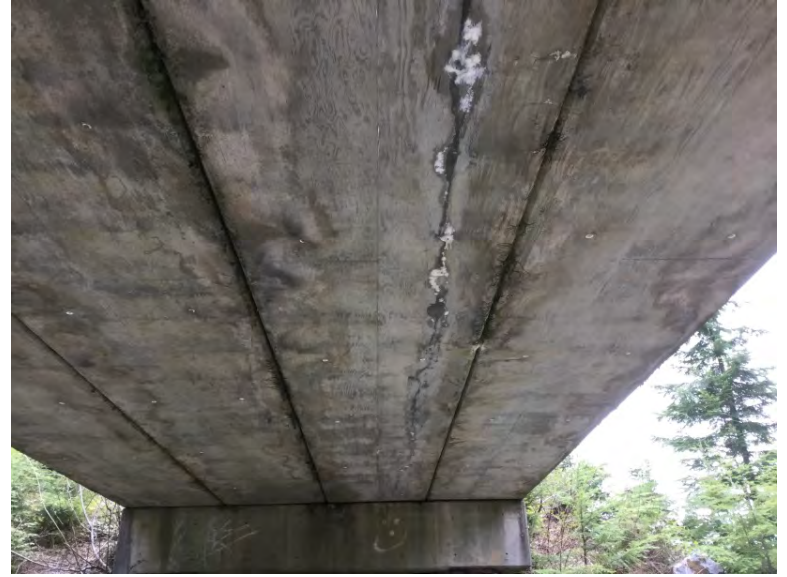
Sounded slab 3 and no distortion noted

Appears as though slab was repaired (grouted noted at surface) a number of years ago

Efflorescence on slab 3

| Item | Monitor Description | Frequency |
|---|---|---|
| 2 | repaired crack condition in 3rd girder | Routine Inspection |
