CK-2170

LOST CREEK 17.1km

2019 Inspection

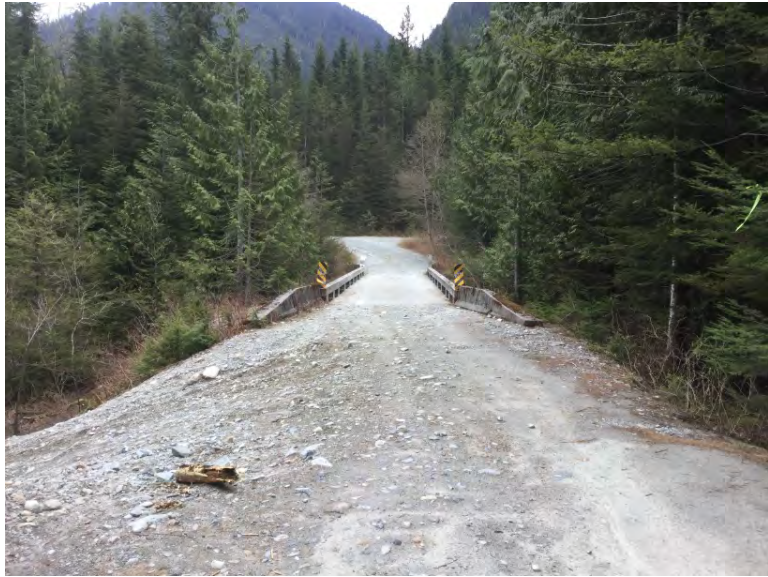
Approach from Right Bank when facing downstream

Road Surface Poor

Large potholes

| 1 | High | Add surfacing to approaches |

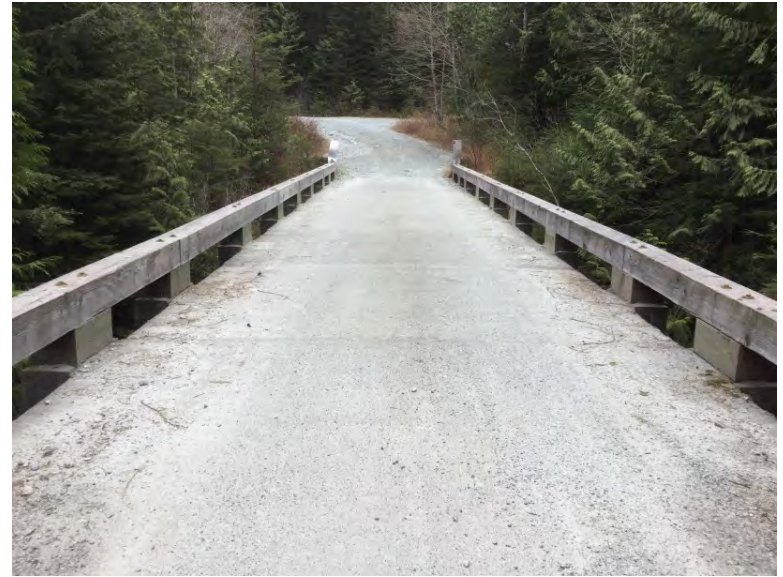
Overall Deck Condition      **Good**
