CK-2189

TEREPOCKI 2km

2019 Inspection

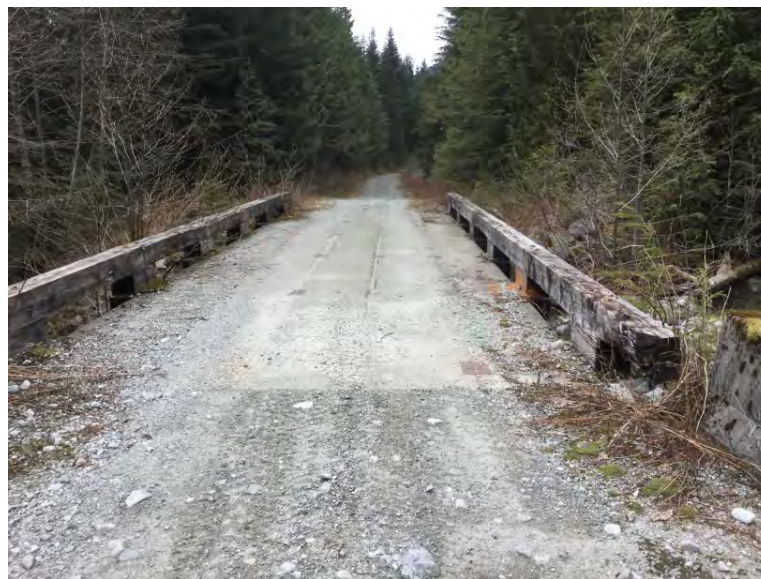
Curb Rail/Blocks/Posts      **Poor**      **Rotten**

Hardware      **Poor**      Loose rail boltsOverall Deck Condition      **Poor**      Due to rail condition

| Repair Item | Priority | Repair Description |
|---|---|---|
| 1 | High | Replace guardrail, risers and blocks and place delineators |
| 2 | Medium | Replace paraseal between concrete slabs |

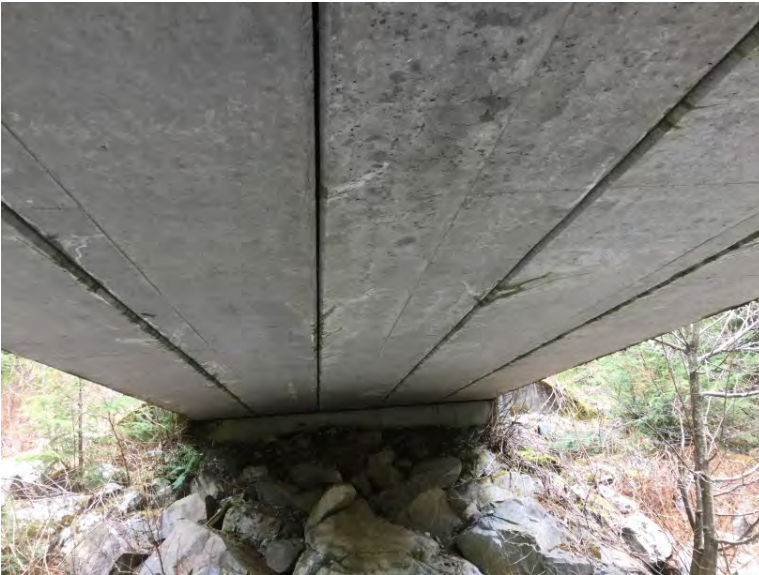
Superstructure

Girders Good 5 concrete slabs
