CK-2190

TEREPOCKI 2.2km

2019 Inspection

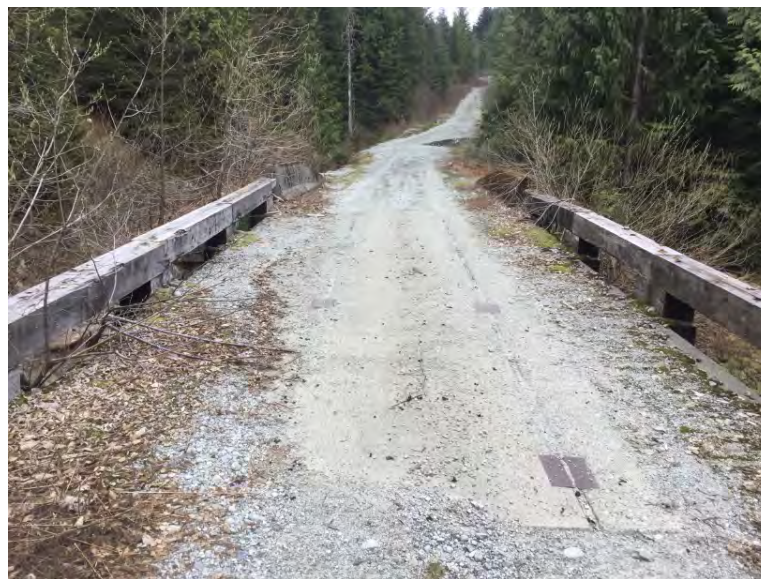
Curb Rail/Blocks/Posts      **Poor**      **Rotten**

Hardware      **Poor**      **Loose rail**Overall Deck Condition      **Poor**      **Due to rail condition**

| 1 | High | Replace guardrail, risers and blocks and place delineators |

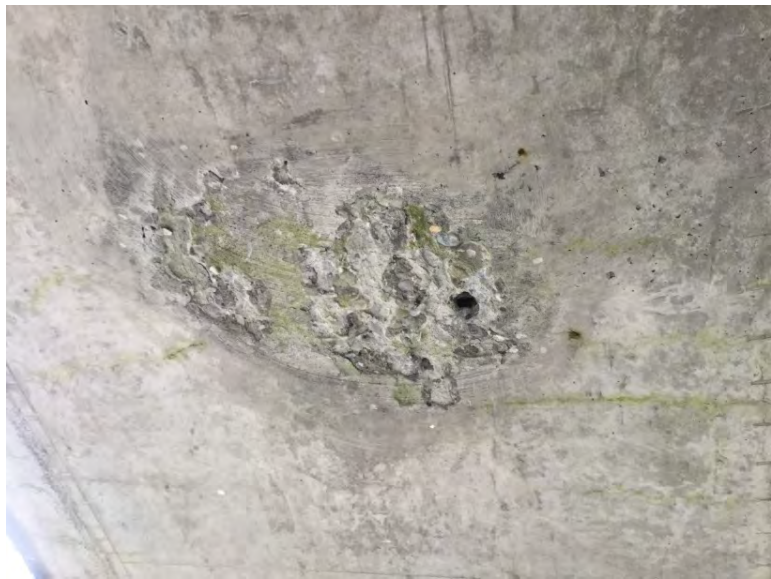
Sounded slab 3 at spall location and no distortion

Spalling on concrete slab 3

| 2 | Medium | Replace paraseal between concrete slabs and repair spalled slab 3 |

| 1 | Condition of slab 3 | Routine Inspection |
