CK-2191

TEREPOCKI 2.5km

2019 Inspection

| Superstructure | Concrete Slab Girders |

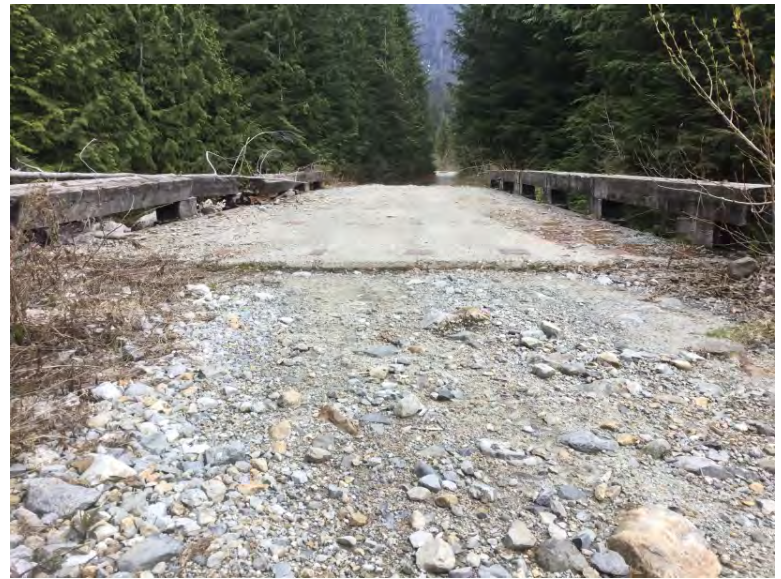
Requires surfacing material at approaches

Requires surfacing material

| Item | Priority | Repair Description |
|---|---|---|
| 3 | Medium | Brush and grade approaches and post bridge ahead signs |

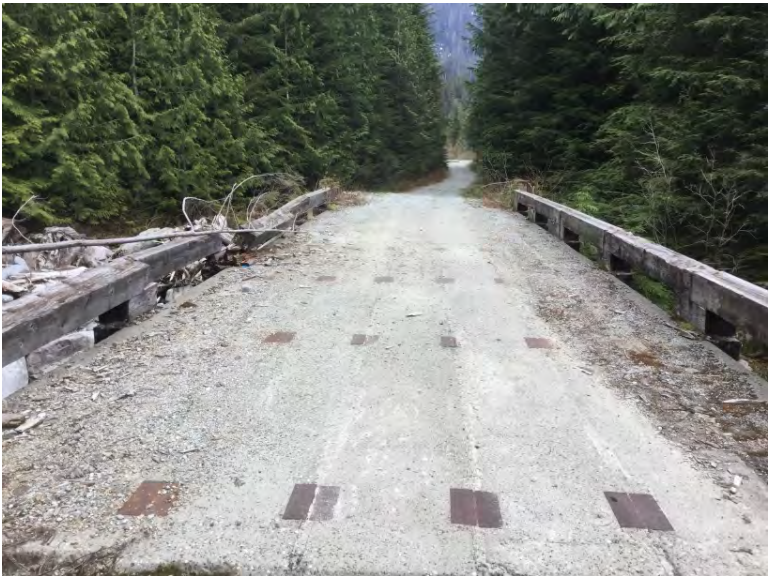
| Curb Rail/Blocks/Posts | Poor | Rotten |

| Hardware | Poor | Loose rail bolts |

| Overall Deck Condition | Poor | Due to rail condition |

| Item | Priority | Repair Description |
|---|---|---|
| 1 | High | Replace guardrail, risers and blocks and place delineators |

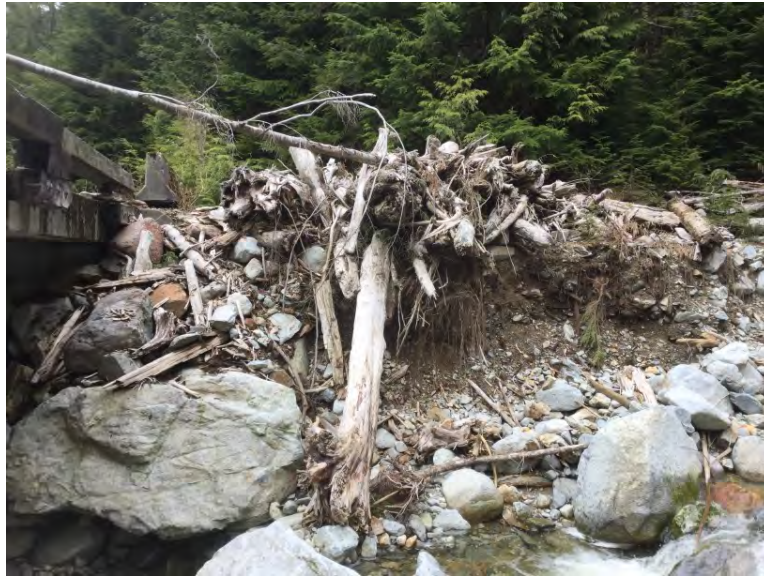
debris accumulations upstream right bank

Debris accumulations at inlet

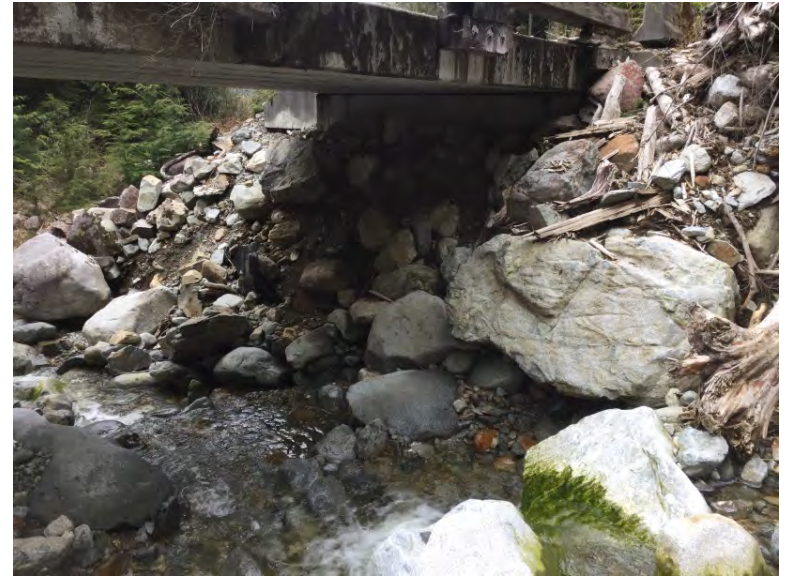
Riprap Poor Right bank completely gone

Riprap completely scoured at right abutment

| Item | Priority | Repair Description |
|---|---|---|
| 2 | High | Repair riprap to both abutments, repair damage to the upstream concrete slab and replace missing paraseal joints |

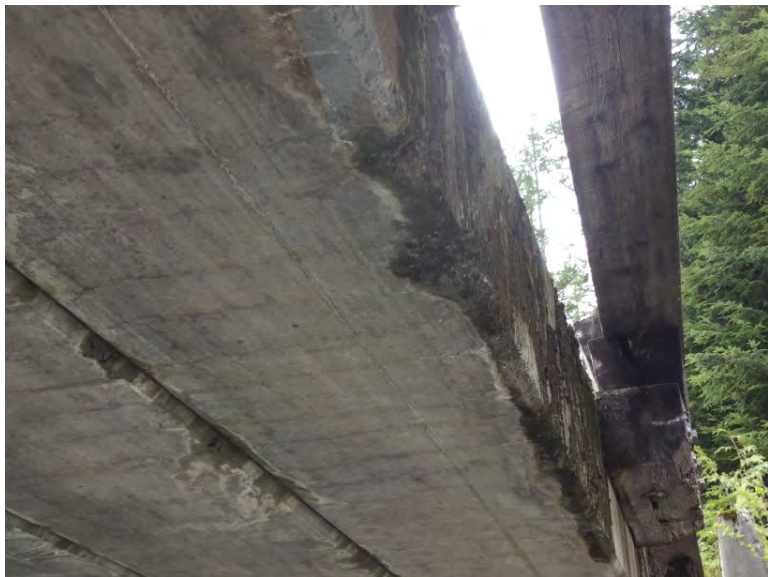
Damage noted to upstream slab
