# BC Ministry of Forests, Lands, and Natural Resource Operations

## Log Stringer Bridge Inspection Report

| Structure #: | CK-2200 | Site #: | CK-2200 | Road Name: | KOOKIPI | Inspection Date: | 2019/08/28 |
| KM: | 0.10 | User km: | 0.10 | Crossing Name: | Nahatlatch River | Next Inspection Date: | 2021/08/28 |

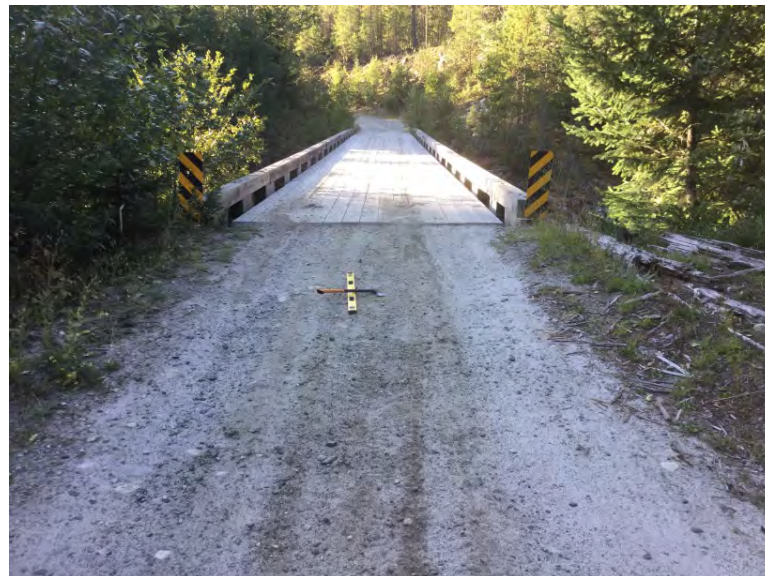
| Fender Condition | Poor | Rotten, undersized or missing |

Fender logs rotten or missing at left bank

| | 1 | Required | Medium | \$ | Replace fender logs at all corners of bridge | | | | | |
| <b>GENERAL</b> | <b>PEng's Comment:</b> | Replace the guardrail and risers. Replace all log fenders with new ones with minimum 600mm diameter x 6m length or with concrete no post barriers. Brush approaches. Monitor the condition of the pier piles, the bearings at right abutment, and the condition of the ballast walls. The current load rating of L60 or 54 tonnes to continue. | | | | | | | | |

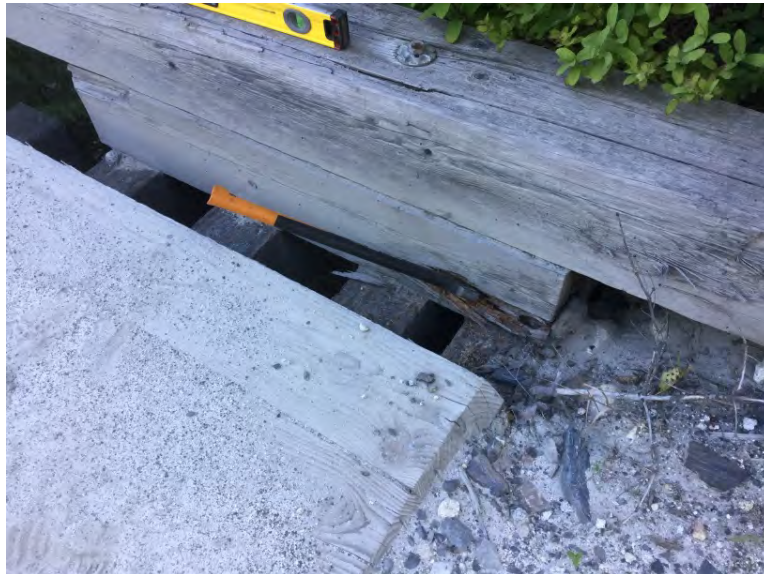
| Curb Rail/Blocks/Posts | Poor | Some risers visibly rotten and others rotting from the inside, all hardware loose |

Some risers in poor condition and all hardware loose

| | 2 | Required | Medium | \$ | Replace guardrail and risers | | | | | |

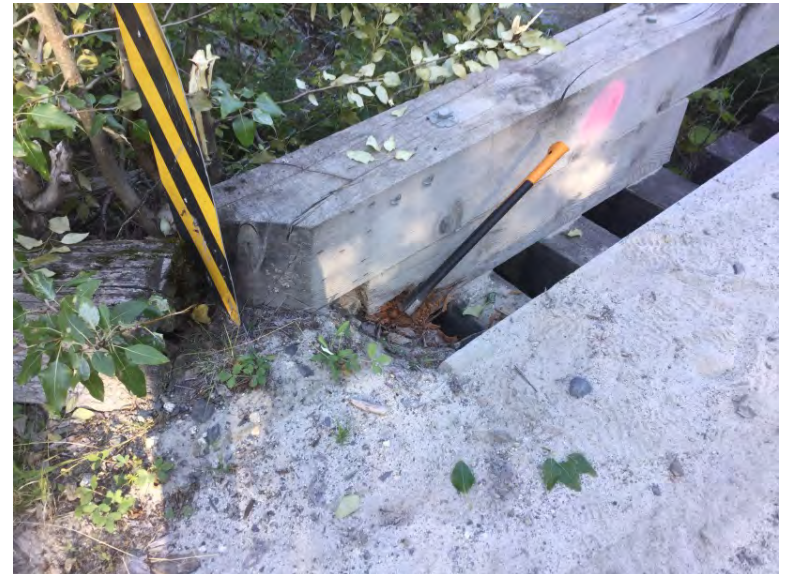
| Curb Rail/Blocks/Posts | Poor | Some risers visibly rotten and others rotting from the inside, all hardware loose |

Rotten risers and hardware loose

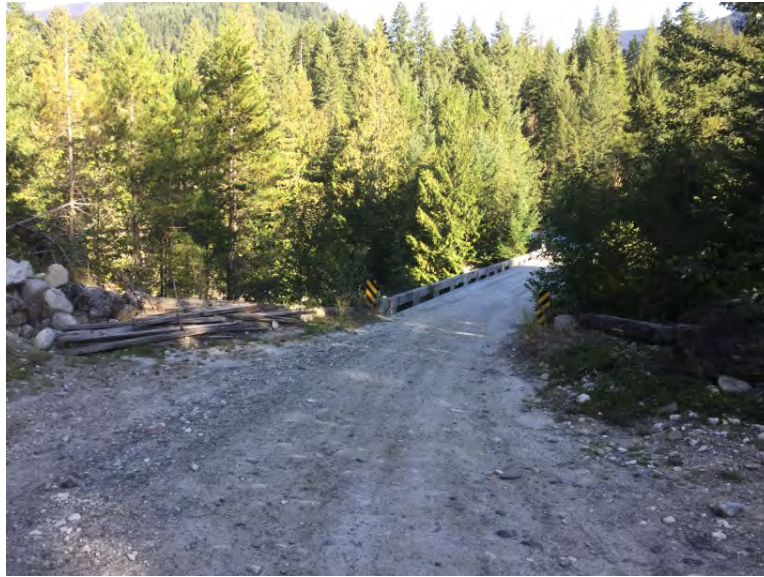
Approach from Right Bank when facing downstream

| Alignment | Fair | HC and VC right approach |

| | 3 | Required | Medium | \$ | Brush approaches | | | | | |

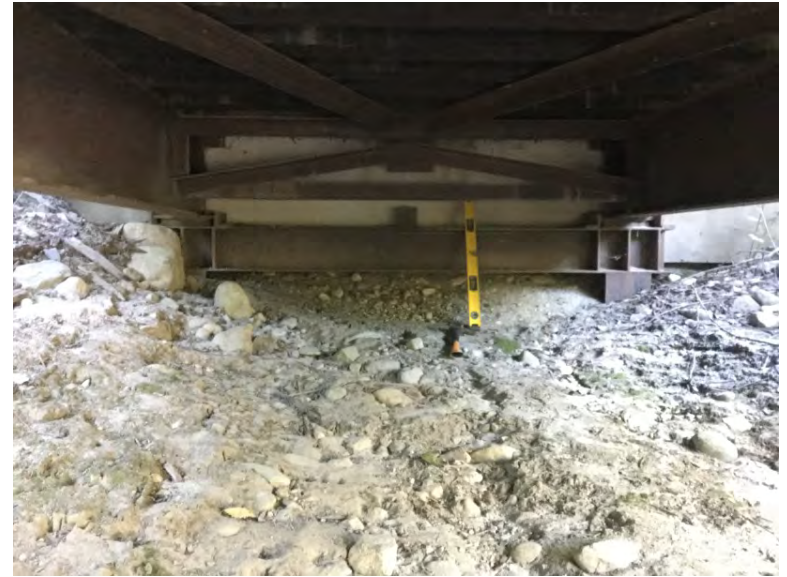
Right bank bearing

| Bearings | Fair | Fair to poor, deforming rubber pads with cracks at right bank |

| | 2 | right bank bearings | | | | | | | | |

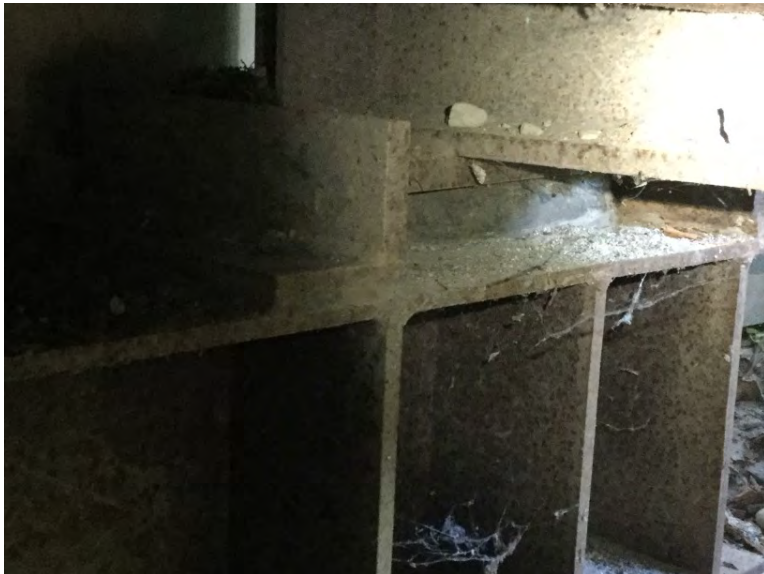
Upstream right bank bearing, rubber bearing pad deformation

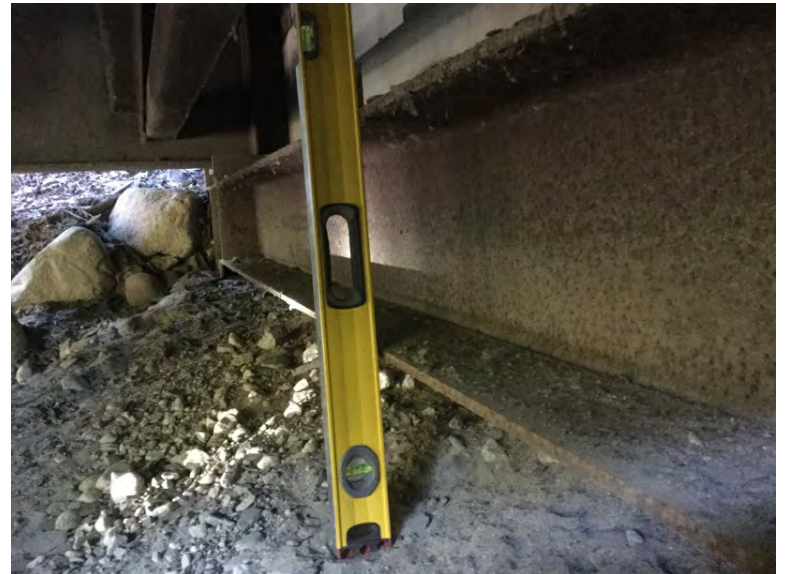
| Caps or Sills | Fair | Steel cap H beam, leaning to stream side at right bank |

Right bank cap leaning towards stream

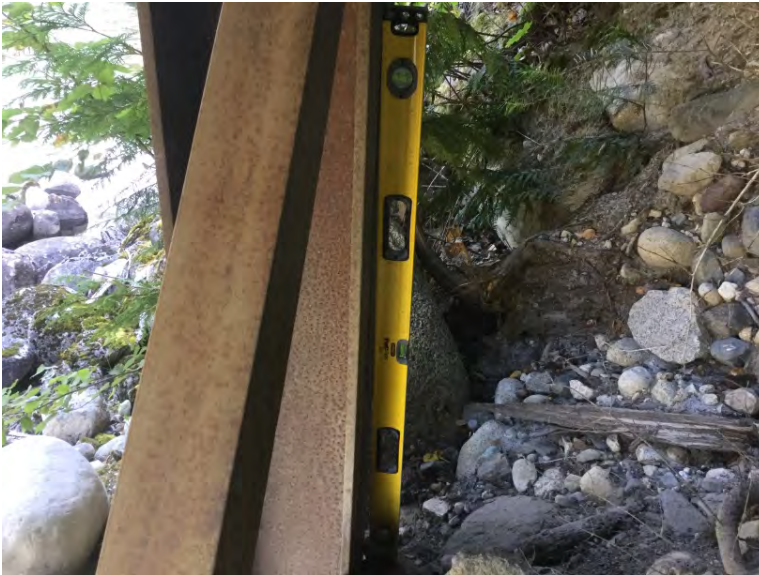
Downstream Pier pile is leaning slightly towards right bank (into fill)

| | 1 | Pier pile deformation | | | | | | | | |

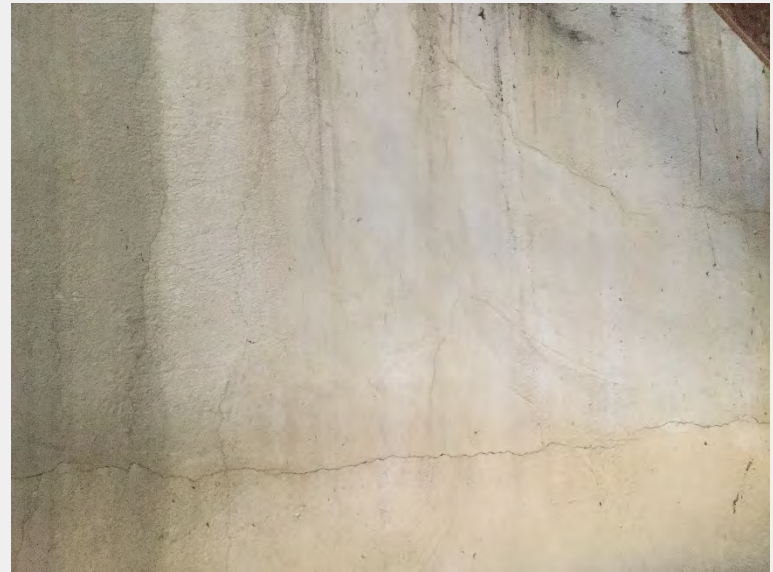
| Ballast Wall | Fair | Minor transverse hairline cracks noted at both banks, more prevalent at left bank |

Left bank ballast Wall Condition

| | 3 | Ballast wall condition | | | | | | | | |
