CK-2207

MOWHOKAM 15.7km

2019 Inspection

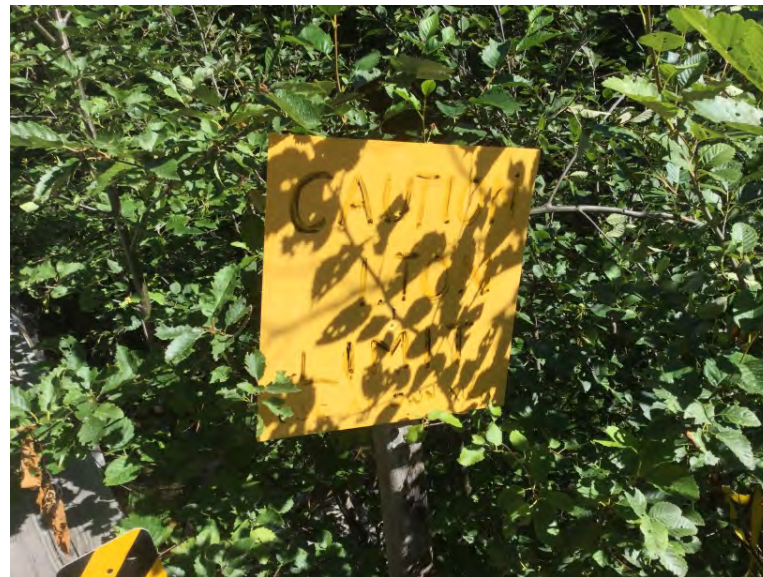
Load Rating Sign

Posted Load Rating 1

| Item | Priority | Repair Description |
|---|---|---|
| 1 | High | Update load rating sign |

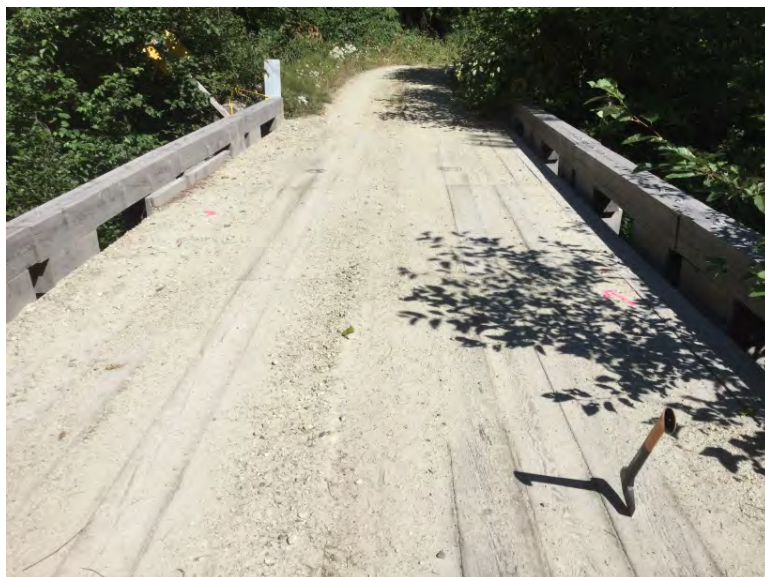
Deck

Running Planks      Fair      Signs of decay starting on underside

Ties      Fair      Signs of decay starting on underside

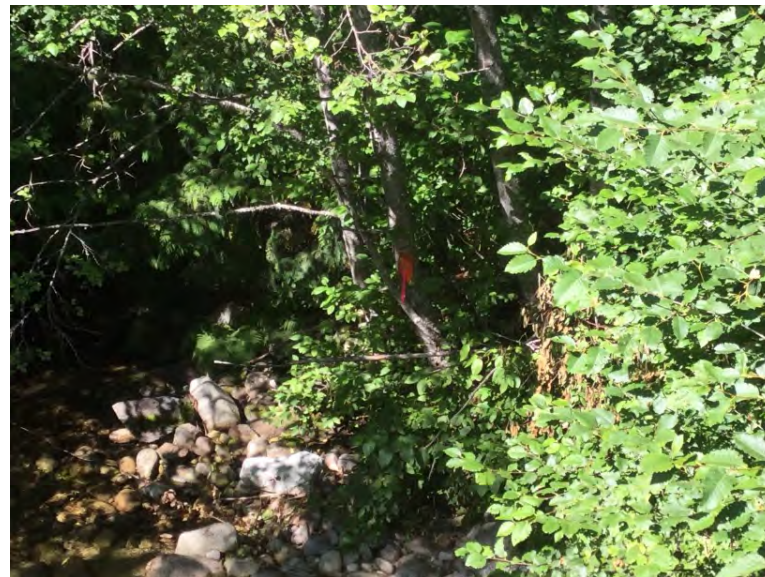
The site appeared to be recently surveyed as Bench Marks were noted.

BMs noted

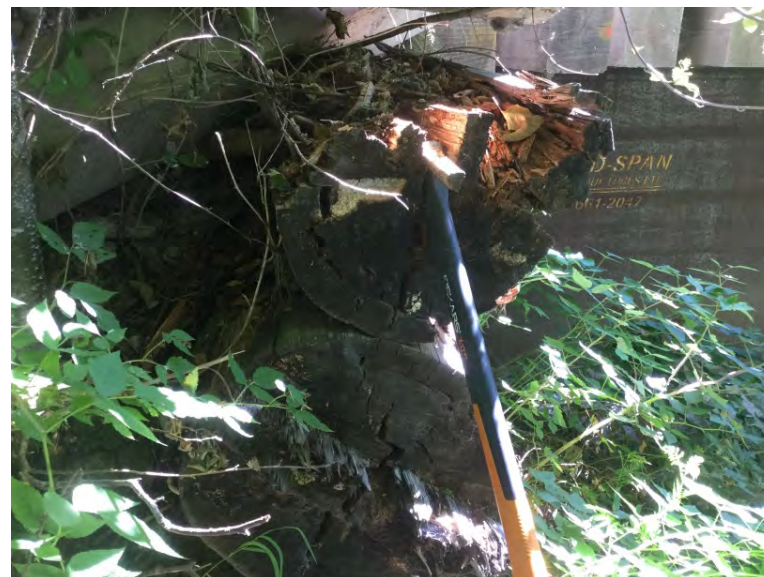
Ballast Wall Poor

Rotten

Ballast wall condition for steel girders

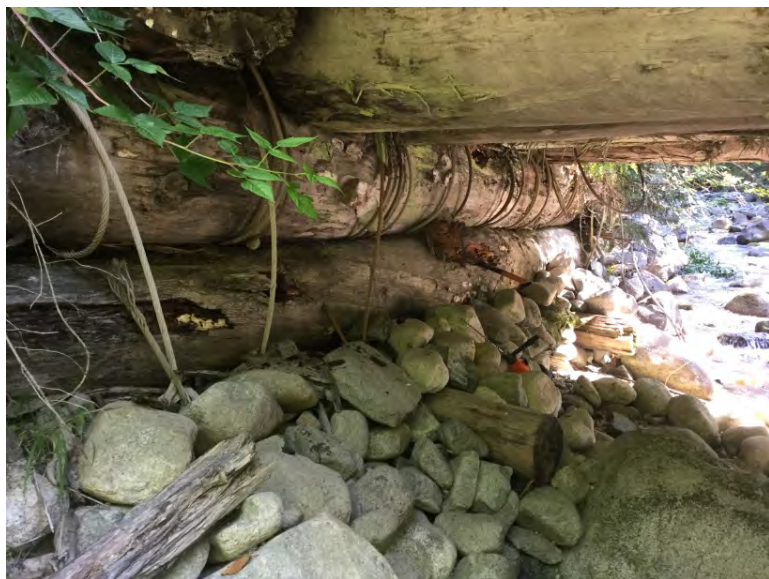
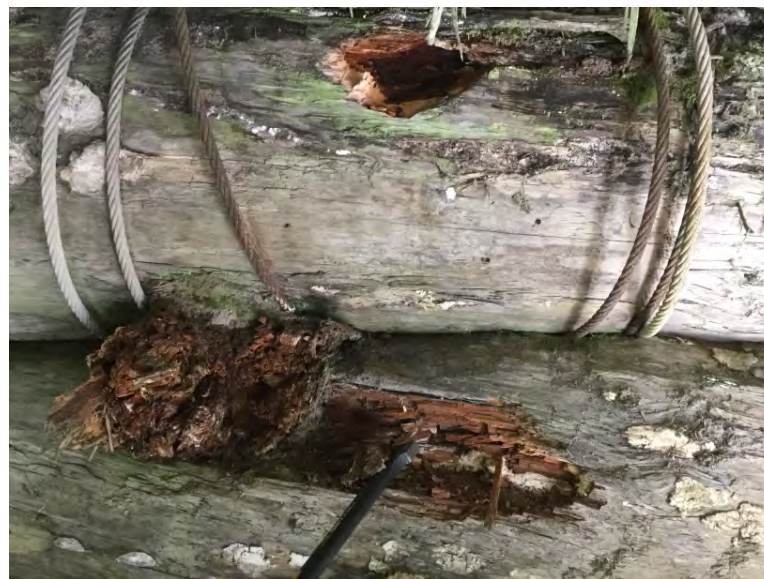
Right Bank Abutment when facing downstream

Log/Timber Cribs Poor

Log crib supports log stringer structure plus log sills that supports the steel girder structure, 200mm sap rot in bottom crib log, 50mm sap rot in top crib log

Tie Backs Poor

All rotten

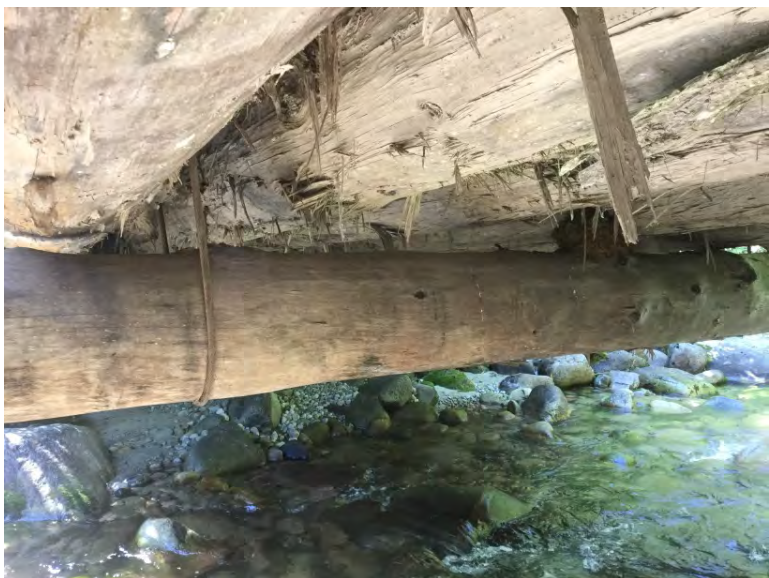
Needle beam condition

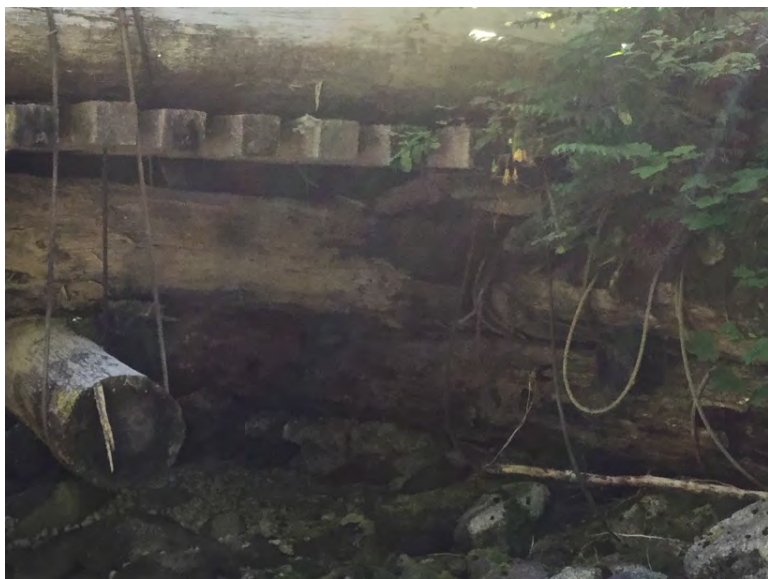
The timber deck and steel girder structure is supported by a log stringer bridge underneath. All the log stringers are rotten and a risk to failure. Also, the log stringer structure may be affected by high stream flows which puts the steel girder and timber deck bridge at risk.

Downstream log stringer condition at left bank

| Item | Priority | Repair Description |
|---|---|---|
| 2 | High | Remove existing structures and replace or block access |

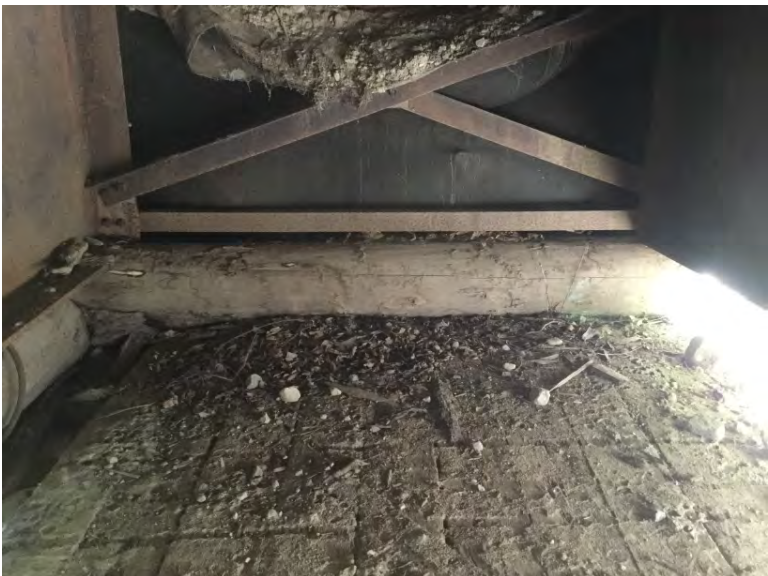
Caps or Sills Fair

Right bank sill for steel girders

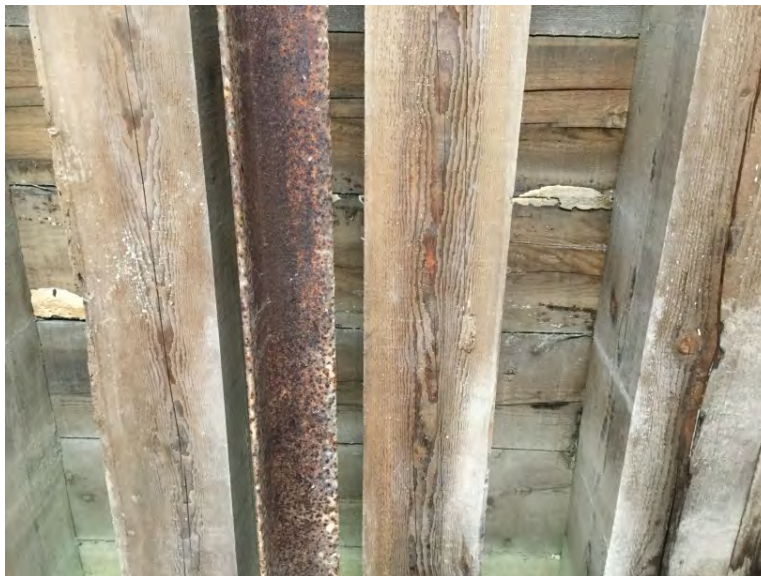
Timber deck condition
