CK-2218

PITT RIVER 8km

2019 Inspection

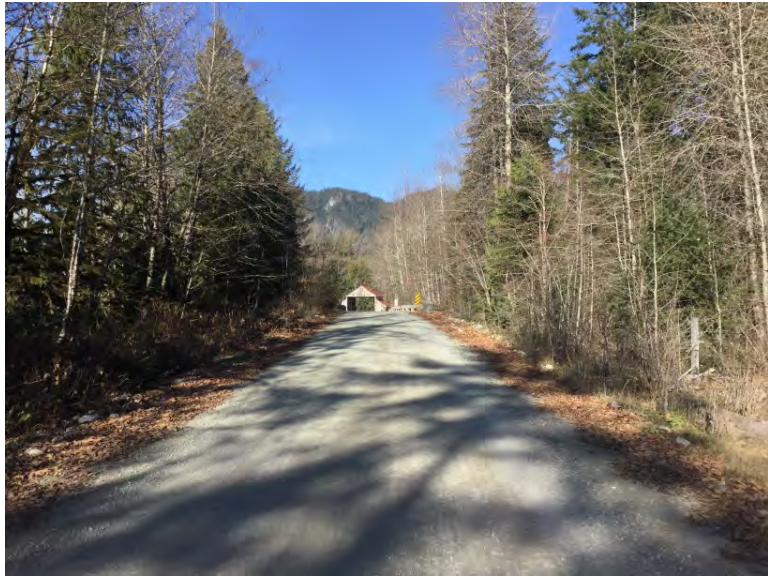
Approach from Left Bank when facing downstream

Bridge Ahead Signs  
Missing ☐ 0 ☐ 1 ☒ 2

| 1 | Low | Post bridge ahead signs |

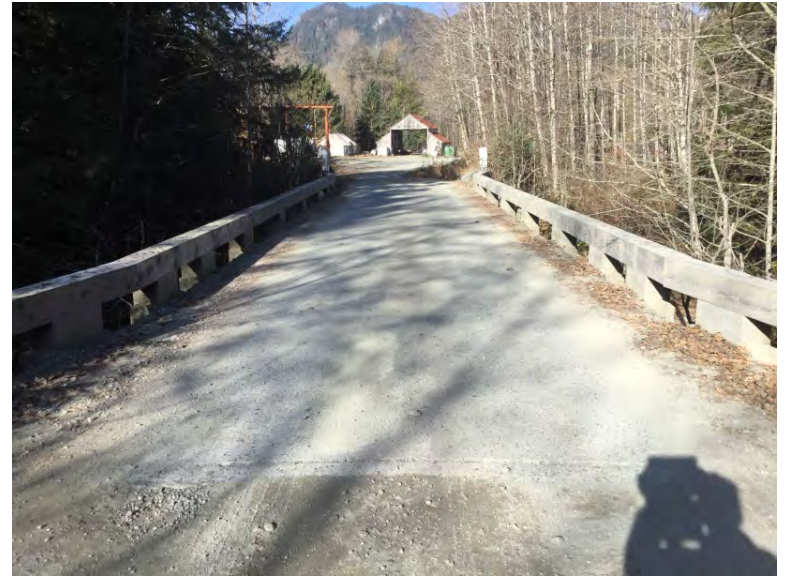
Concrete Deck      **Good**      Typical wear on wheel pathGrout Pockets      **Good**Deck Joints      **Good**

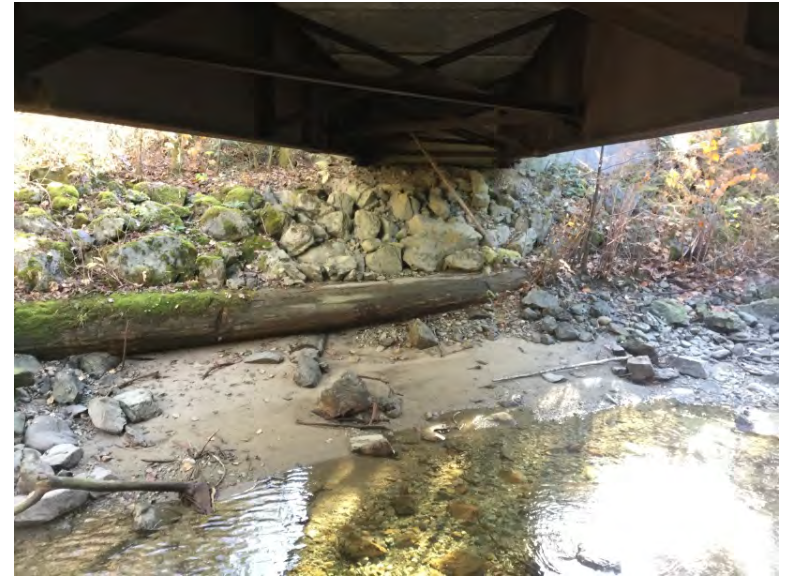
Left Bank Abutment when facing downstream

Bearings Fair
