CK-2225

PITT RIVER 24.6km

2019 Inspection

Crossing Name Blue Creek

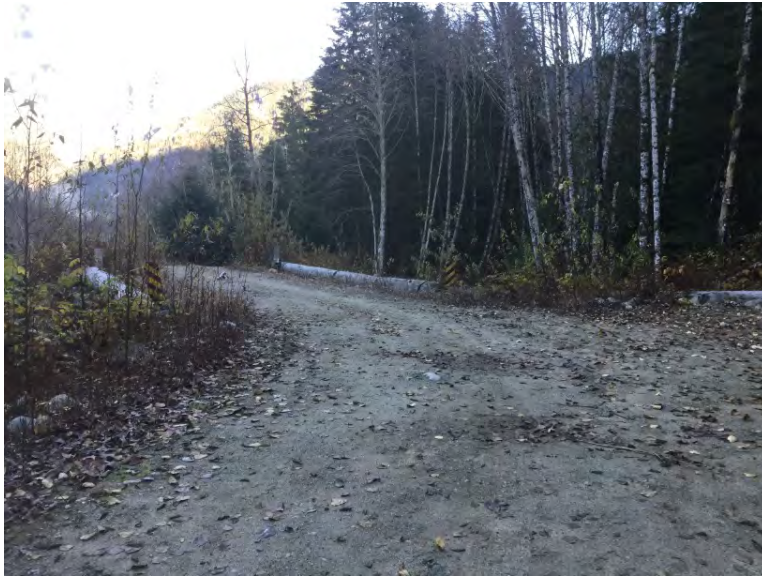
Approach from Left Bank when facing downstream

Low on left approach

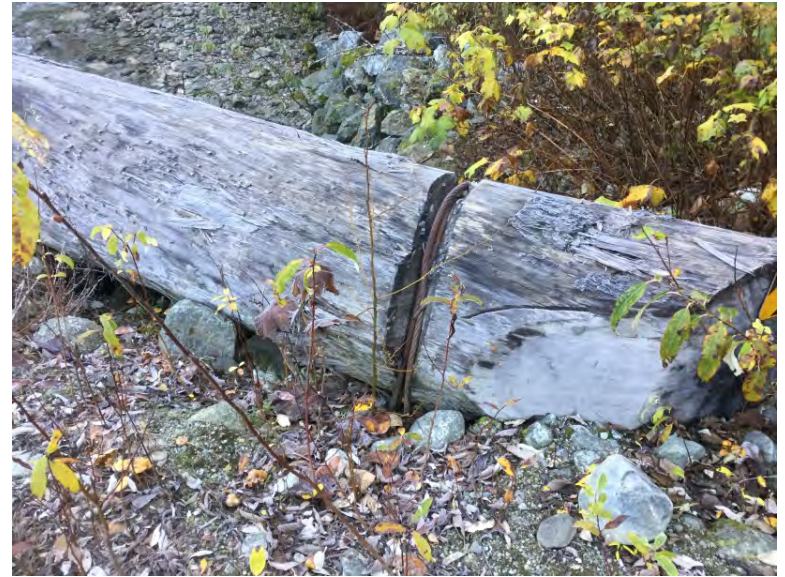
Curb logs nicely lashed

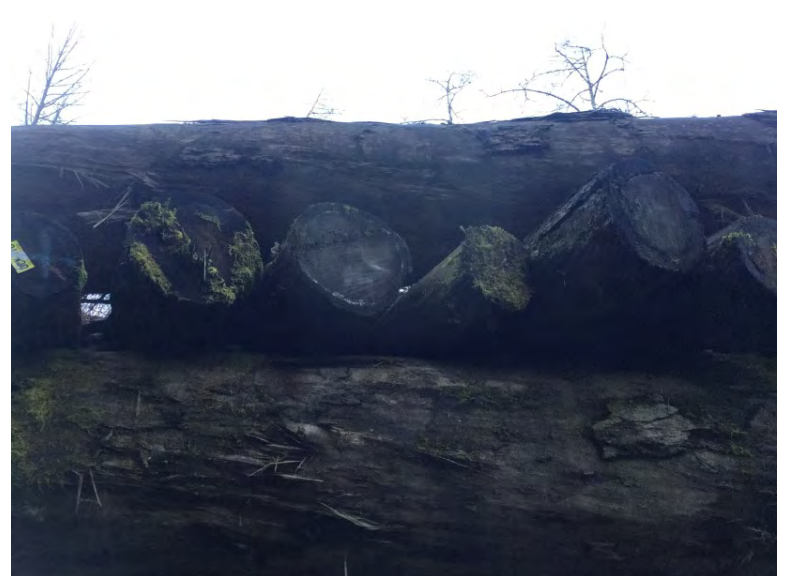
No change in general condition of structure  
 Puncheon diameter ranges from 200mm to 400mm diameter (hemlock)

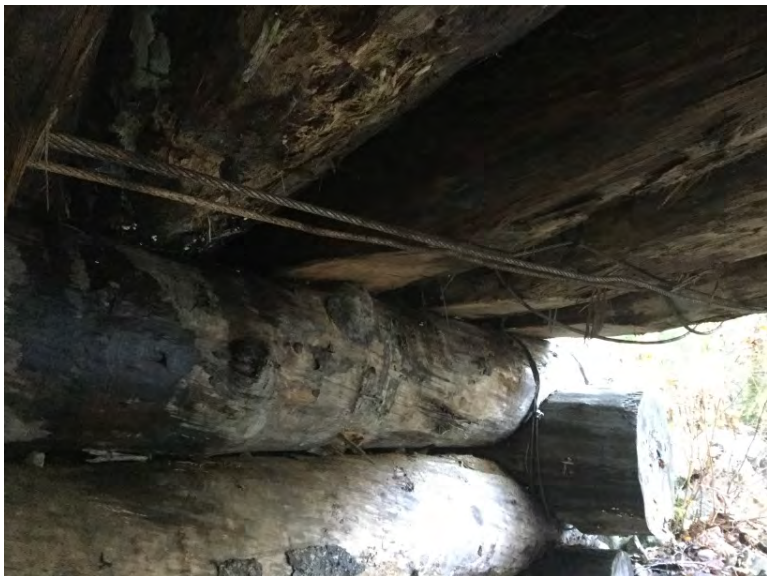
Stringers nicely dapped
