## Permanent Bridge Inspection Report

| Structure #: | CK-2226 | Site #: | CK-2226 | Road Name: | BOISE | Inspection Date: | 2019/11/06 |
| KM: | 0.30 | User km: | 0.30 | Crossing Name: | Pitt River | Next Inspection Date: | 2022/11/06 |

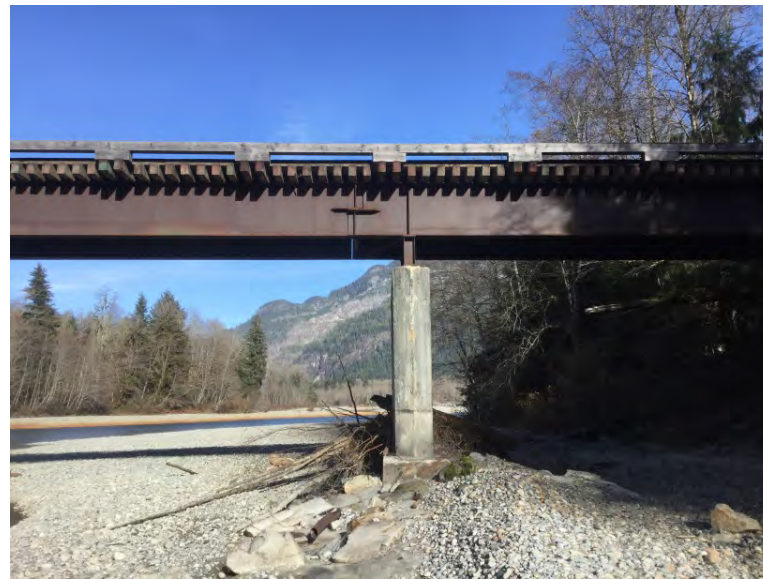
Left Pier and girder connection

| Piles or Posts | Good | H columns on top of CIP Concrete Pier |

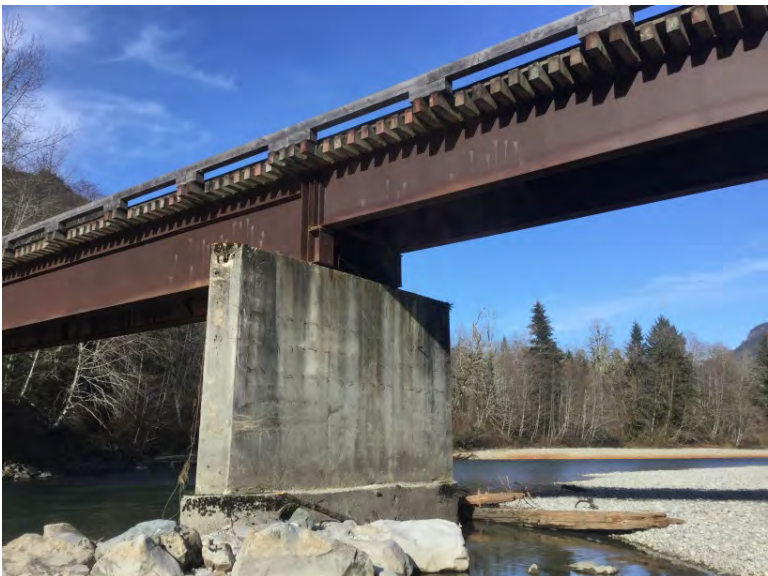
Span 2 from left bank at Pier 2

| Piles or Posts | Not Applicable | CIP Concrete Pier |

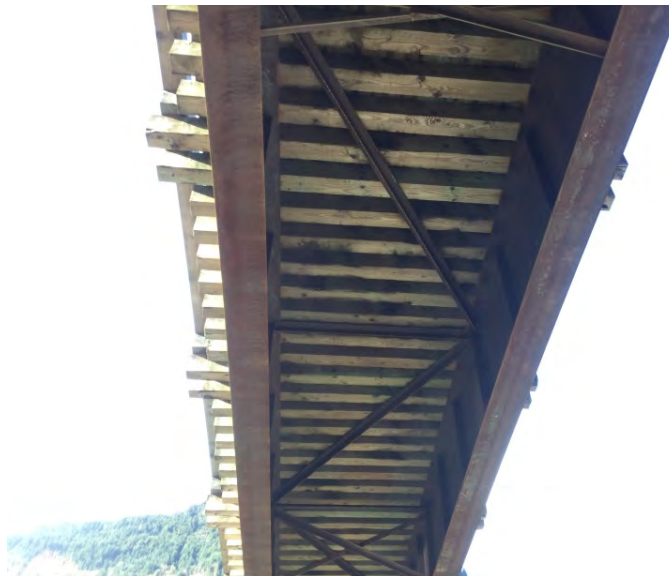
Span 2 from left bank superstructure

| Bracing | Good | minor corrosion |

| Diaphragms | Good | minor corrosion | | | | | | | | |
| Girders | Good | minor corrosion | | | | | | | | |

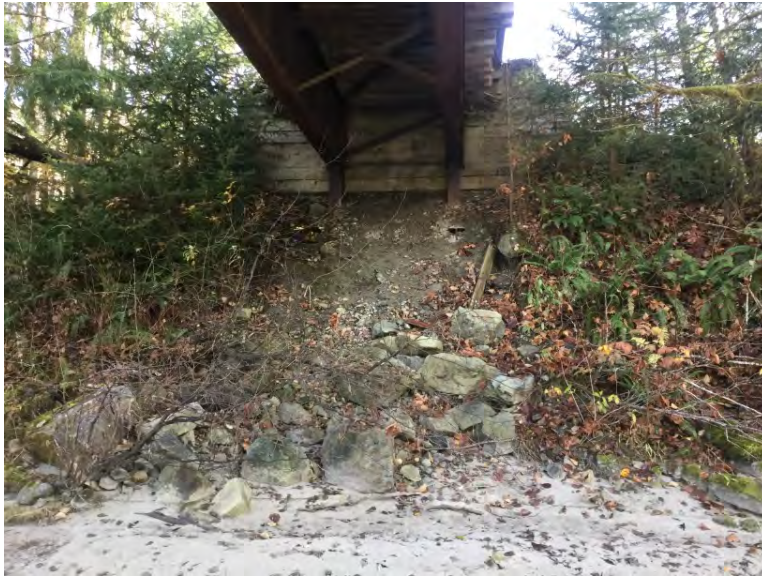
Left Bank Abutment when facing downstream

| Fill | Fair | |
| Piles or Posts | Good | H columns |
| Riprap | Fair | |

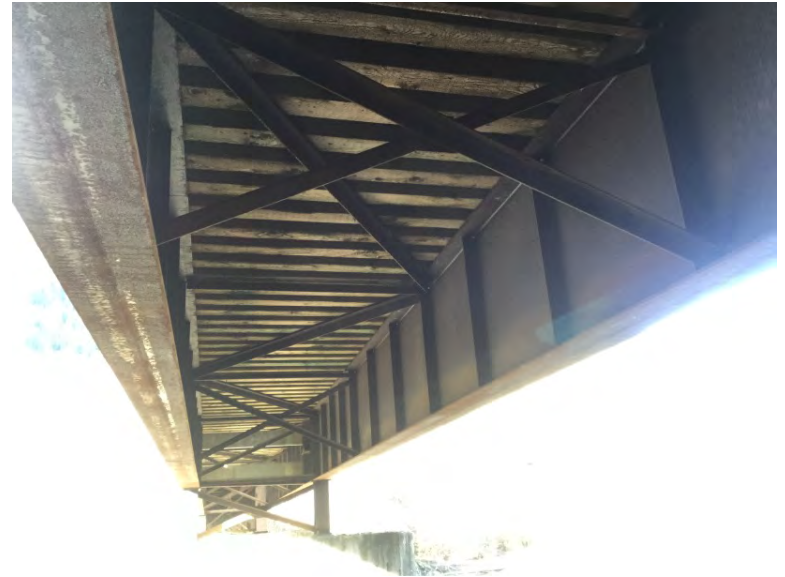
Left span superstructure

| Bracing | Good | minor corrosion |
| Diaphragms | Good | minor corrosion |
| Girders | Good | minor corrosion |

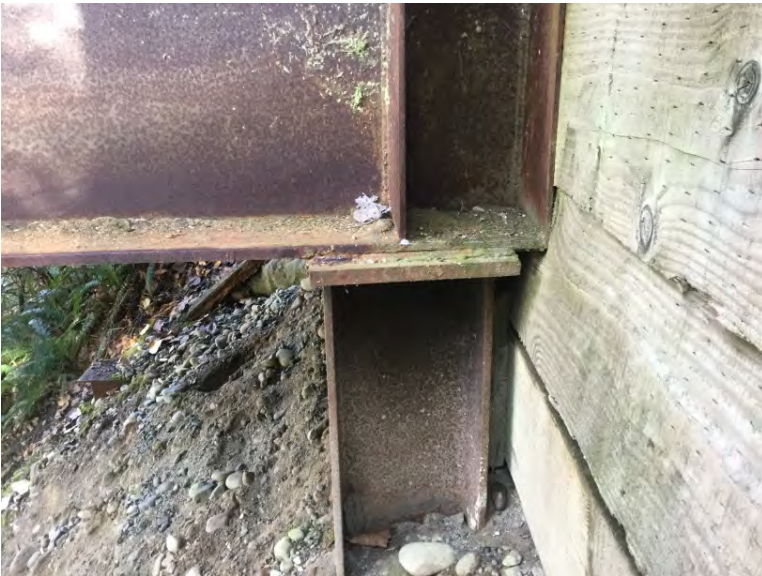
Downstream Left bank bearing

| Bearings | Good | |

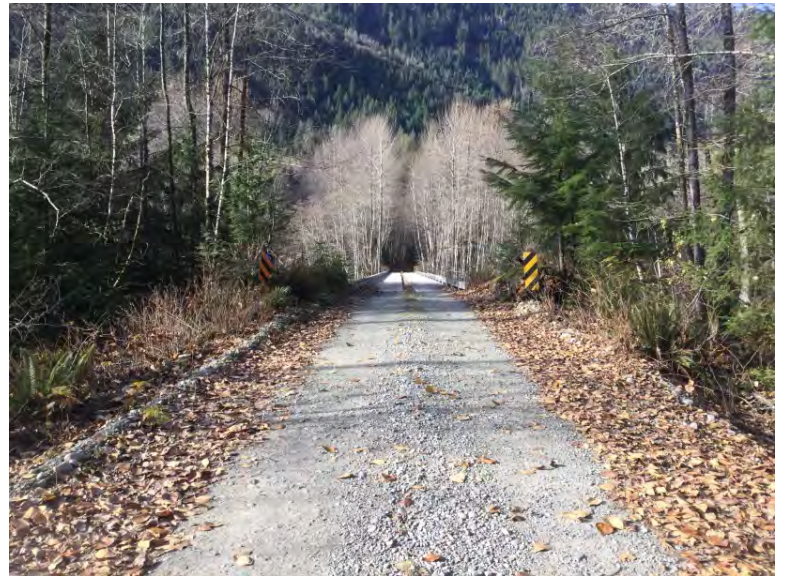
Approach from Left Bank when facing downstream

| Bridge Ahead Signs Missing | 2 | |
| Delineator Missing Left (approaching structure) | 1 | |

| | 1 | Required | Low | \$ 200.00 | Post bridge ahead signs | | | | | |

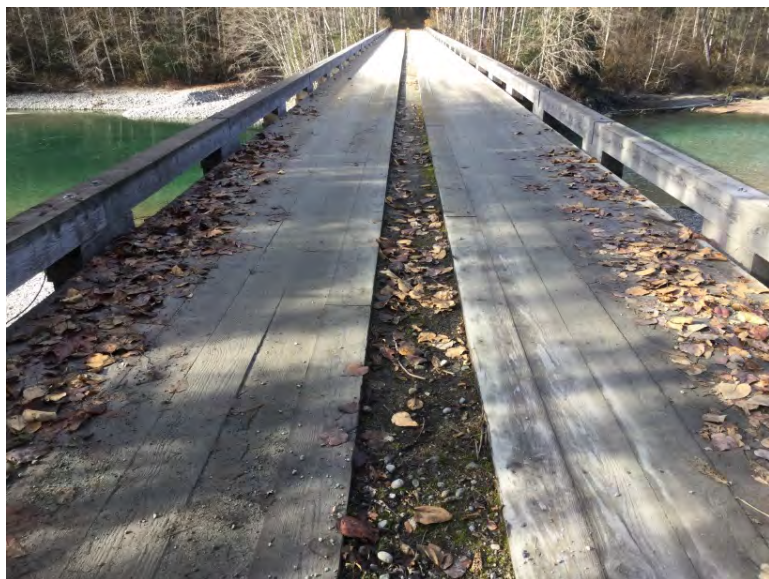
| Overall Deck Condition | Good | | | | | | |

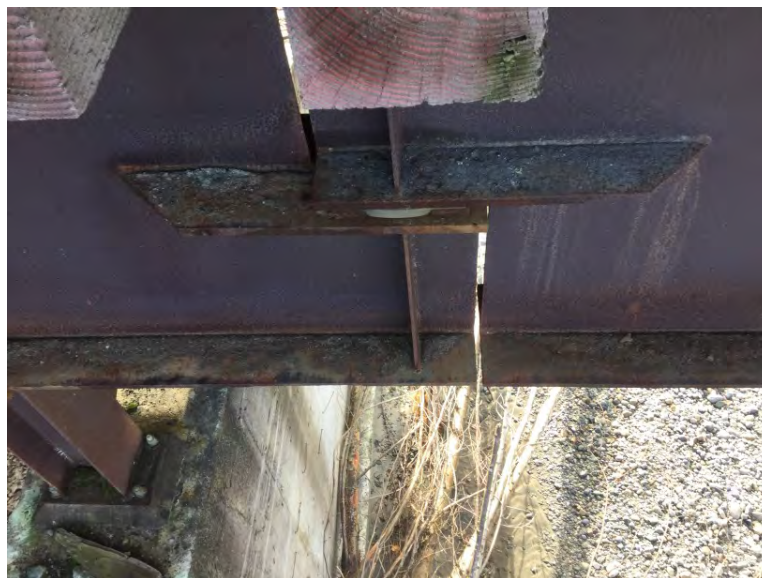
Span 1 - 2 connection

| | 1 | Monitor debris buildup between spans 1 and 2 | | | | | | | | |

| GENERAL | <b>PEng's Comment:</b> Post bridge ahead signs and monitor debris buildup between spans 1 and 2. Professional documentation confirms structural upgrades were done in 2002 increasing the load rating to L120 or 109 tonnes. This rating (L120 or 109 tonnes) to continue. | | | | | | | |

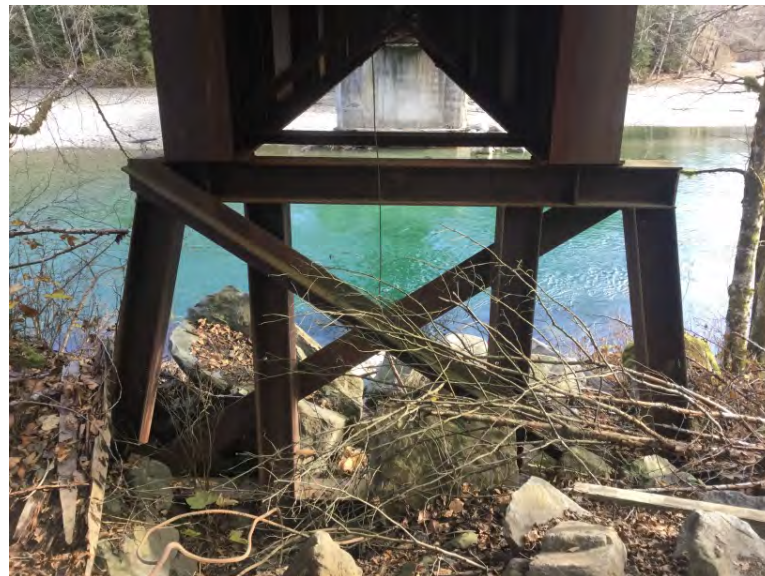
Pier 3 from left bank

| Overall | Fair | |
| Piles or Posts | Good | 4 H columns |
| Riprap | Fair | |
