# BC Ministry of Forests, Lands, and Natural Resource Operations

## Permanent Bridge Inspection Report

| Structure #: | CK-2230 | Site #: | CK-2230 | Road Name: | BOISE | Inspection Date: | 2019/11/06 |
| KM: | 7.60 | User km: | 7.60 | Crossing Name: | Boise Creek | Next Inspection Date: | 2022/11/06 |

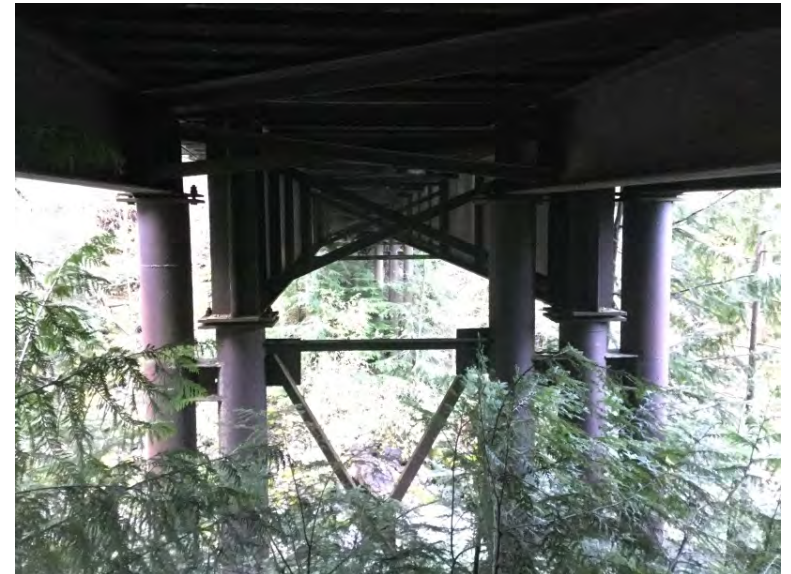
Right Pier

| Piles or Posts | Fair | 5x columns at each pier |

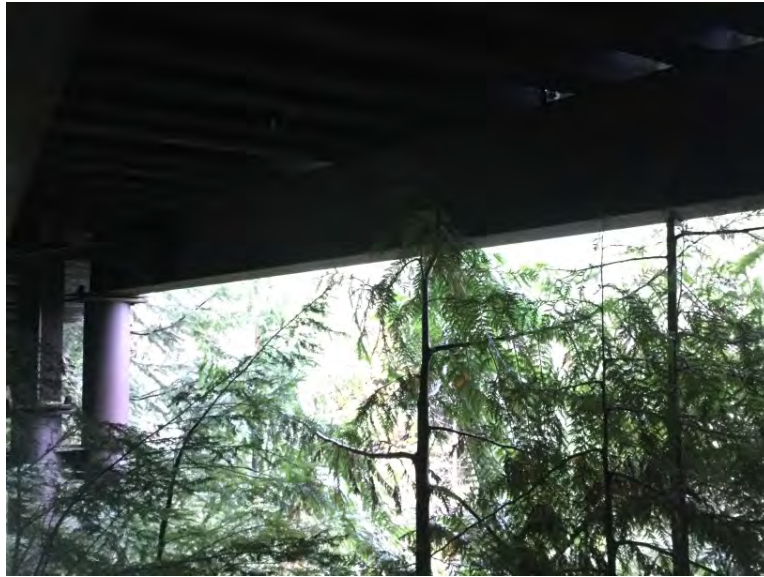
Right span flare girder

| Girders | Fair | 3x girders due to deck flare |

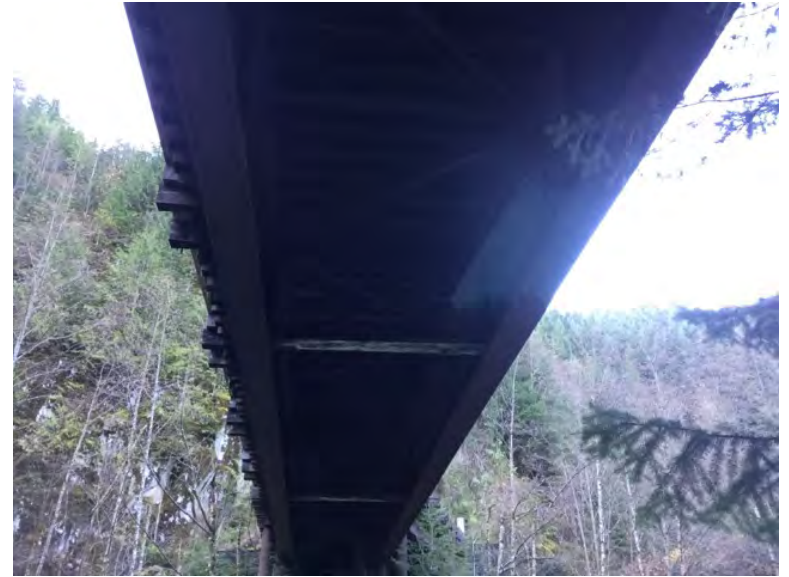
Main span superstructure

| Girders | Fair | 2x girders |

| GENERAL | PEng's Comment: | Post bridge ahead signs and replace missing fender log. Professional documentation has been located which indicates that structural upgrades were completed to the main span girders in 2002 resulting in a load rating of L120 or 109 tonnes; this load rating to continue. | | | | | |

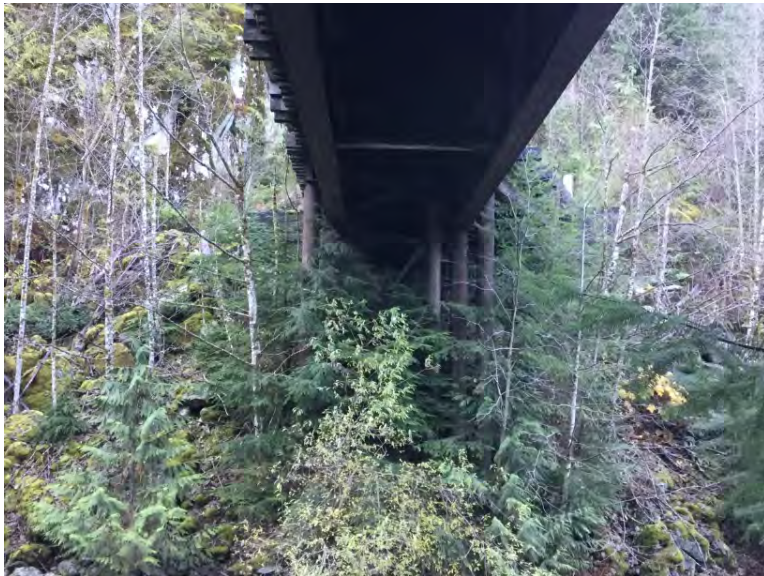
Left Pier

| Piles or Posts | Fair | 5x columns at each pier |

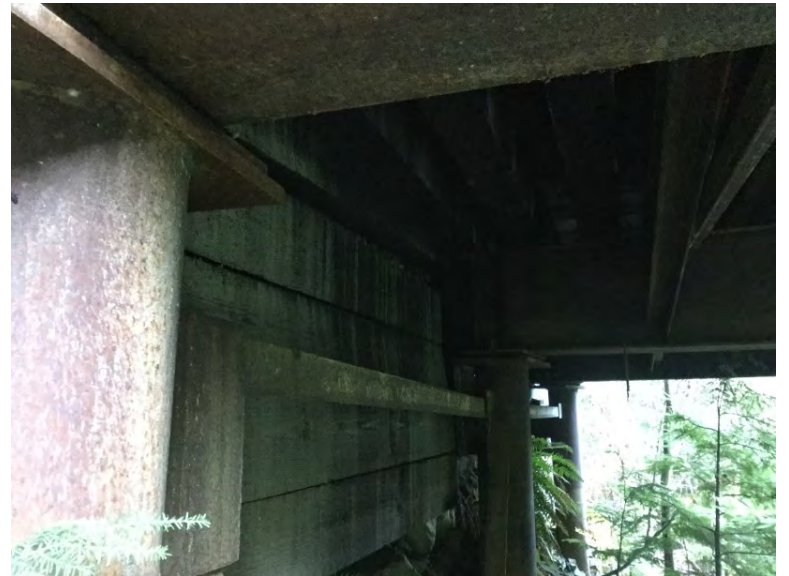
Left abutment bearings

| Bearings | Fair | |

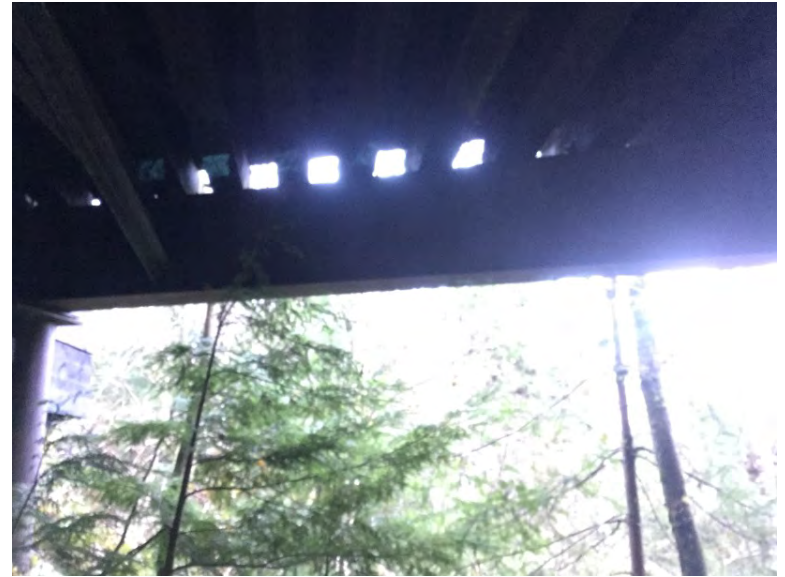
Left span flare girder

| Girders | Fair | 3x girders due to deck flare |

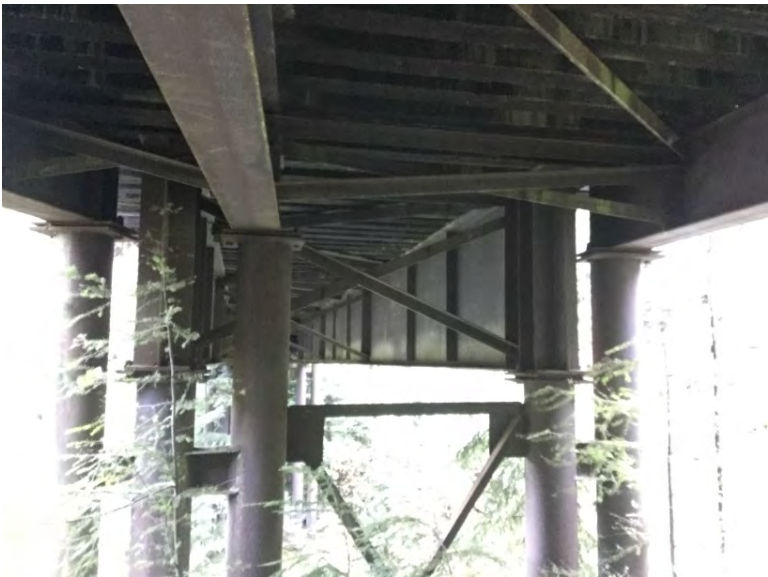
Bearings at left Pier

| Bearings | Fair | difficult to properly assess however appears in fair condition |
