# BC Ministry of Forests, Lands, and Natural Resource Operations

## Permanent Bridge Inspection Report

| Structure #: | CK-2231 | Site #: | CK-2231 | Road Name: | BUCKLIN | Inspection Date: | 2019/11/06 |

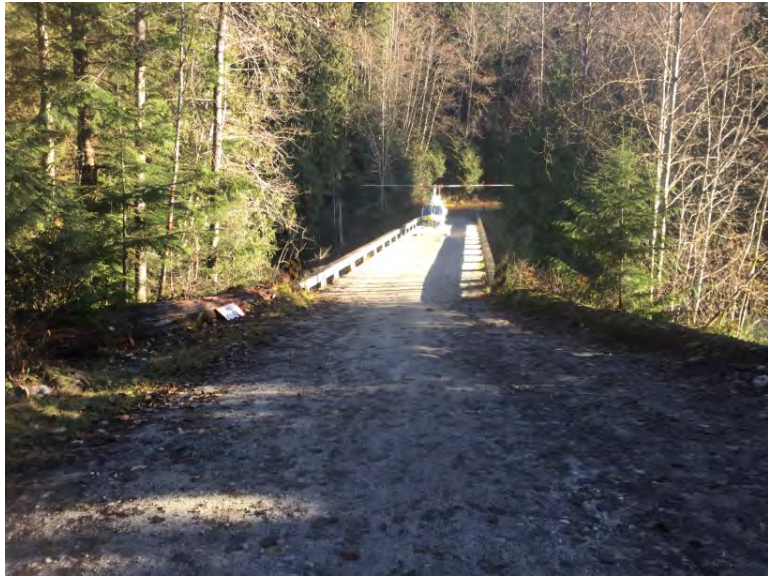
Approach from Right Bank when facing downstream

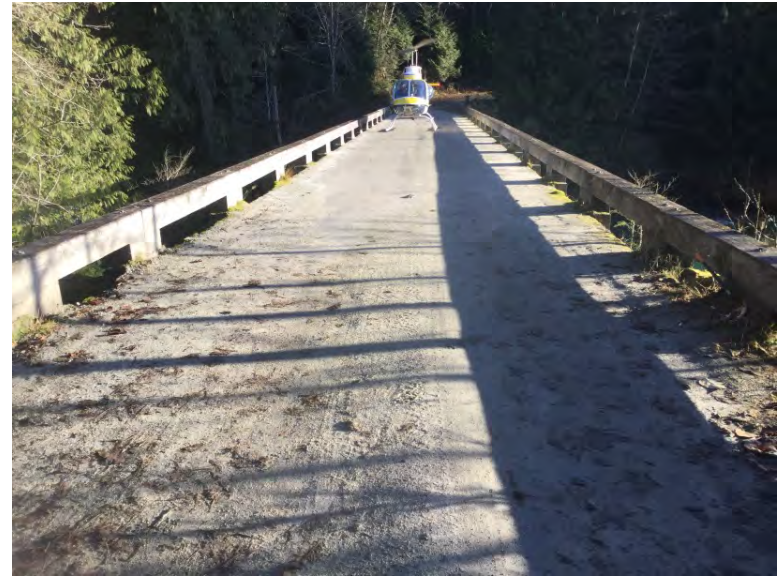
| Running Surface | Fair | right span - sediment on deck |

Deck

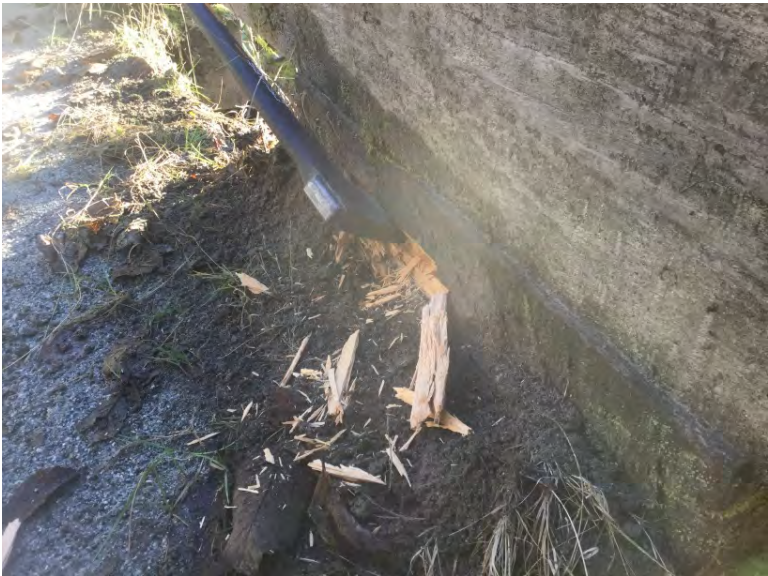
| Curb Rail/Blocks/Posts | Fair | Some risers and blocks (ones with sediment built up against) are rotting |

Riser condition

| Inspector's Comment: | Reattach damaged section of rail but replace 3 risers and side-blocks<br>Some risers and blocks rotting due to sediment accumulations at right span |

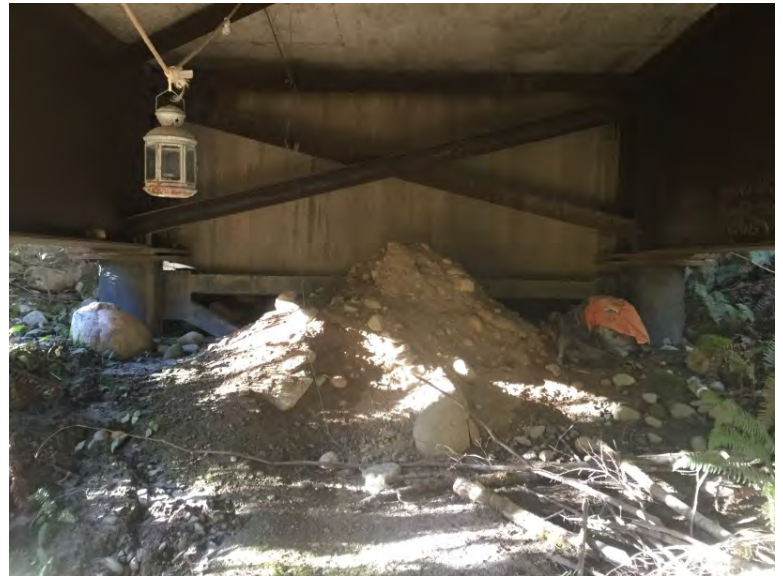
| Fill | Fair | erosion noted at left bank and previous inspection noted fill erosion at right bank |

Right Bank Abutment when facing downstream

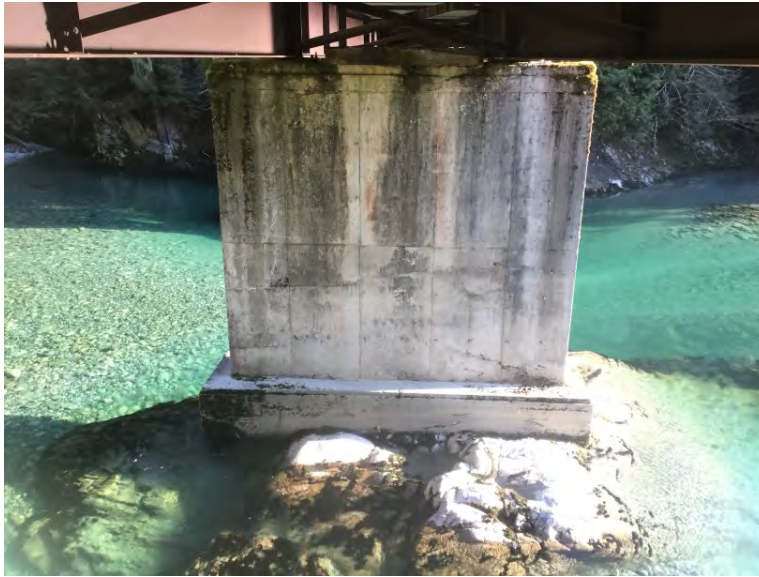
Right face of right pier

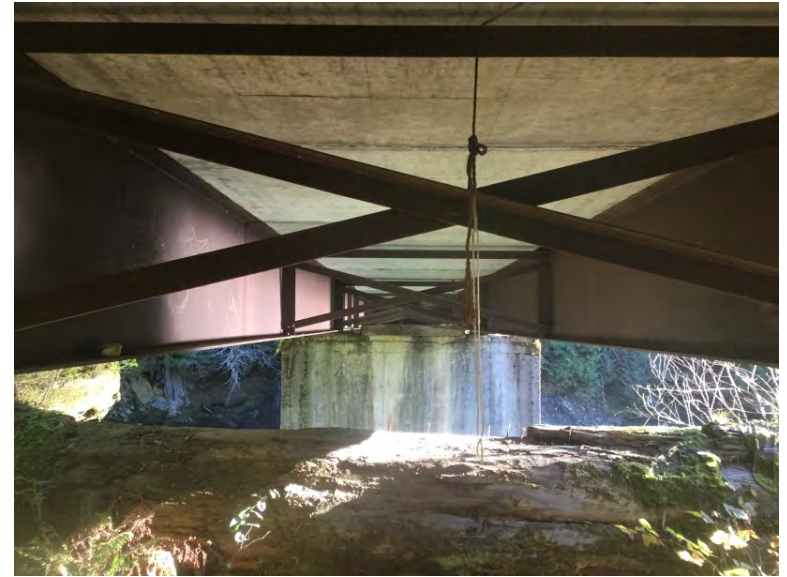
Right span superstructure

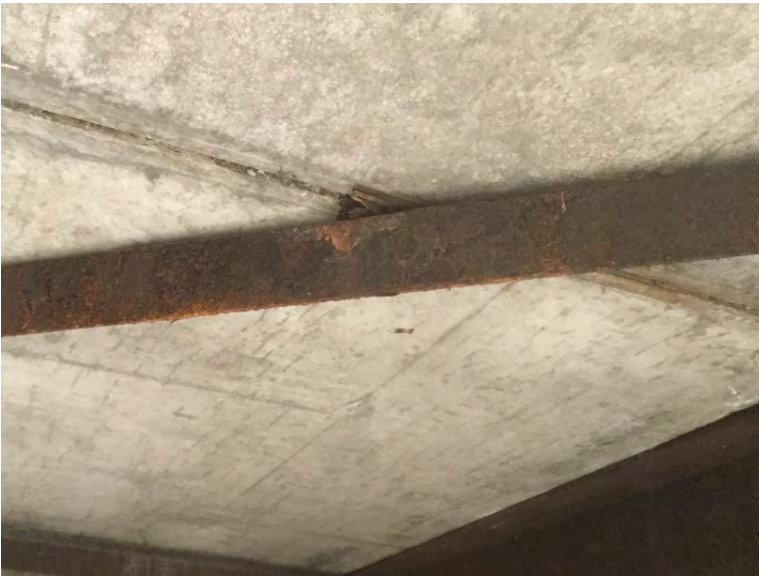
| Bracing | Fair | Minor corrosion |

Right span corrosion on bracing

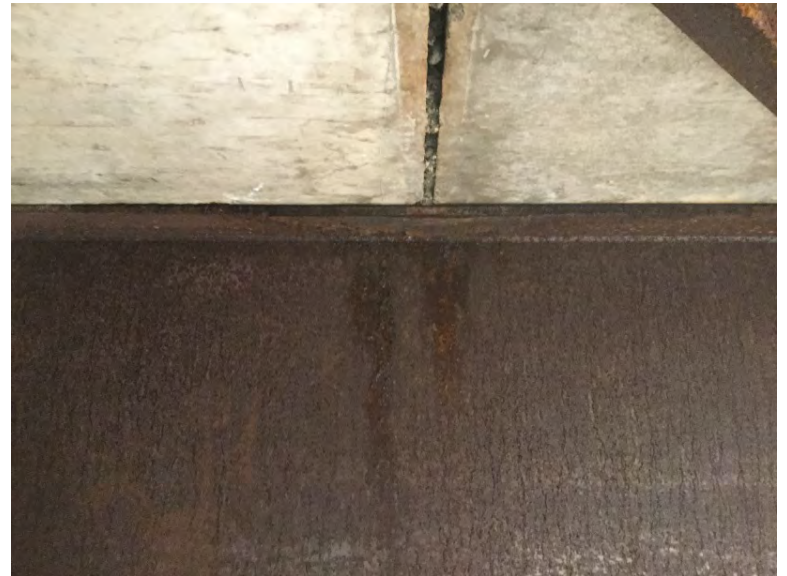
| Deck Joints | Fair | evidence of water getting through, failed pier deck joint |

Right span water getting through deck joints

| | 2 | Suggested | Medium | | clean and seal deck joints at pier locations |

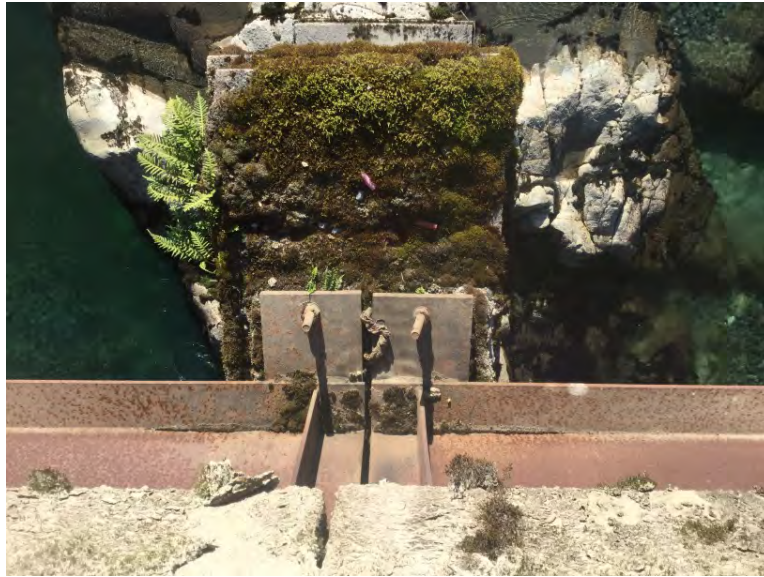
Downstream right pier bearings

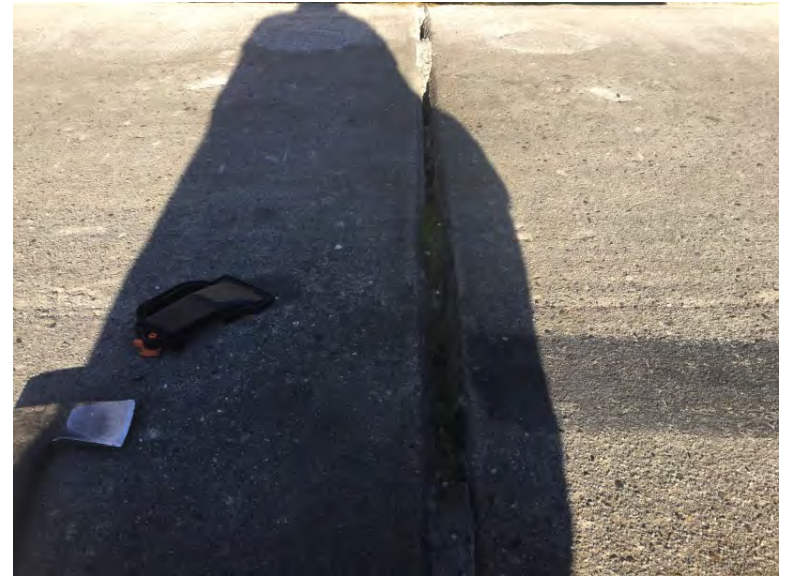
Right Pier deck joint

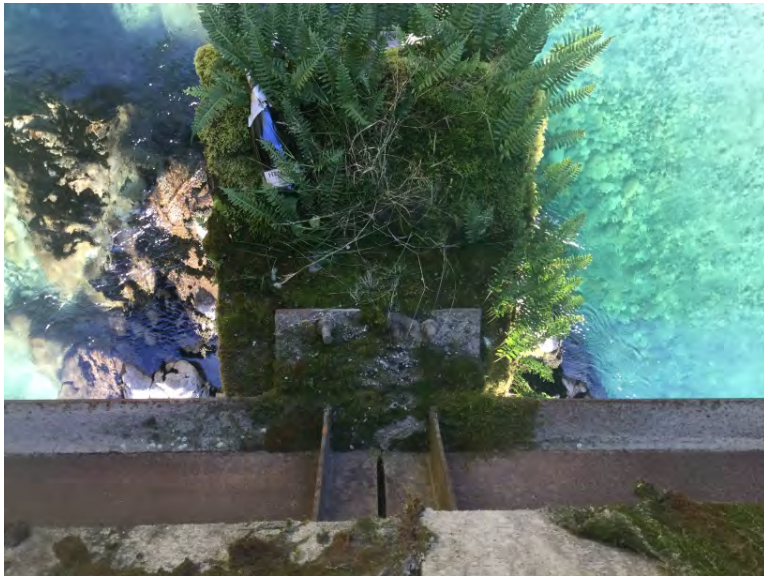
Upstream right pier bearings

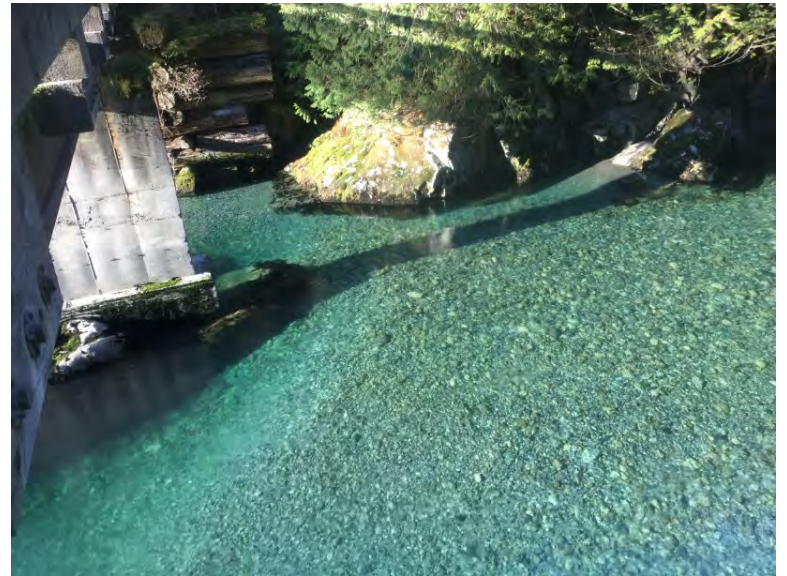
Left face or right pier

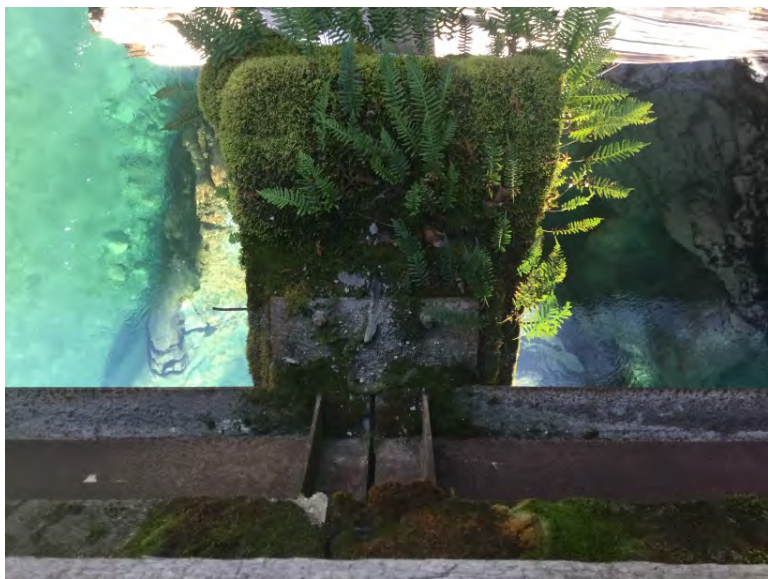
Upstream left pier bearing

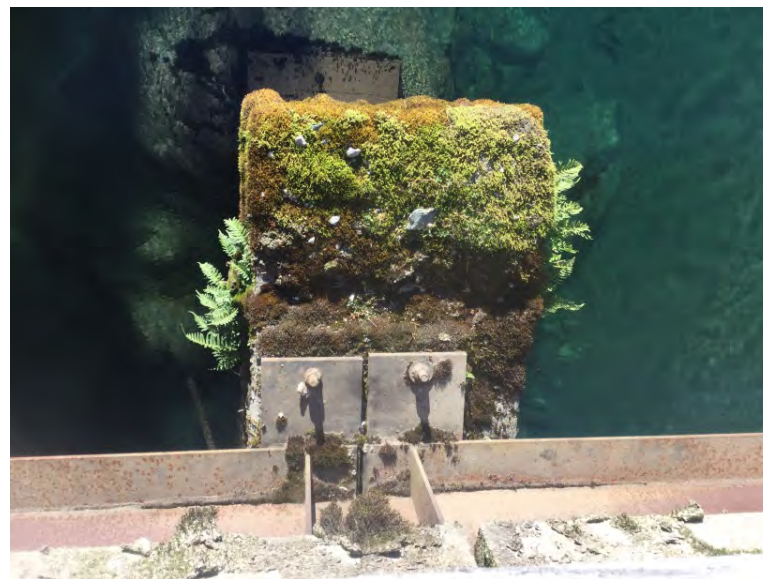
Downstream left pier bearings

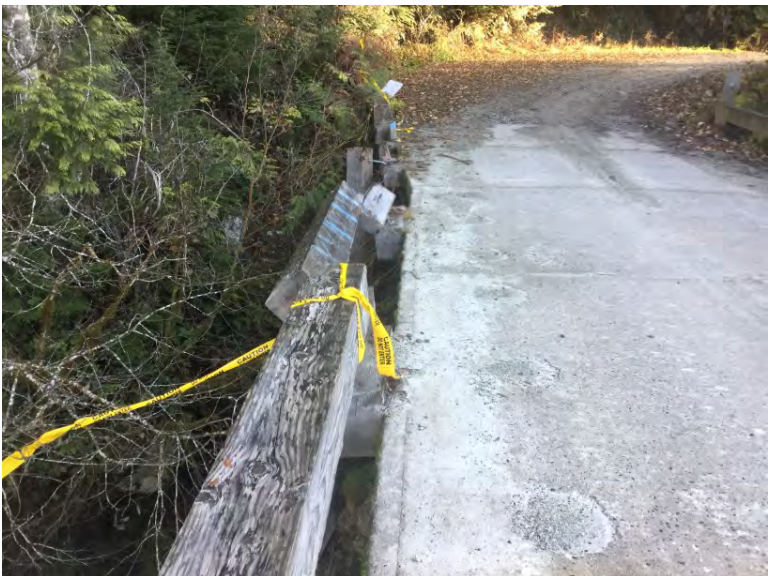
| Curb Rail/Blocks/Posts | Poor | 6m section knocked off |
| Hardware | Poor | bend/damage rail bolts |
| Overall Deck Condition | Poor | due to rail condition |

| PEng's Comment: | The upstream left approach guardrail has been struck and is left hanging from the bridge deck. Using the structure is now a safety concern and <b>I recommend closing access to the bridge (0 tonnes load rating) until the guardrail is reattached.</b> In order to reattach this section of guardrail it will require 3 new risers, 3 new side blocks and new hardware in this location. Some of the risers and side-blocks at the right approach (the ones with sediment building up on) are starting to decay and should be replaced at the same time. Clean and seal both deck joints at the pier locations with okum and a poured rubber sealant (paraseal). Replace all fender logs with concrete no post barriers or new minimum 600mm diameter x 6m long logs. The record drawings indicate a CIP footing at the left bank however monitor the condition of the fill slope at this location. |

Guardrail damage at upstream left approach

| | 1 | Suggested | High | | Reattach 6m of guardrail that is hanging from bridge, require new hardware and risers and blocks in this location |

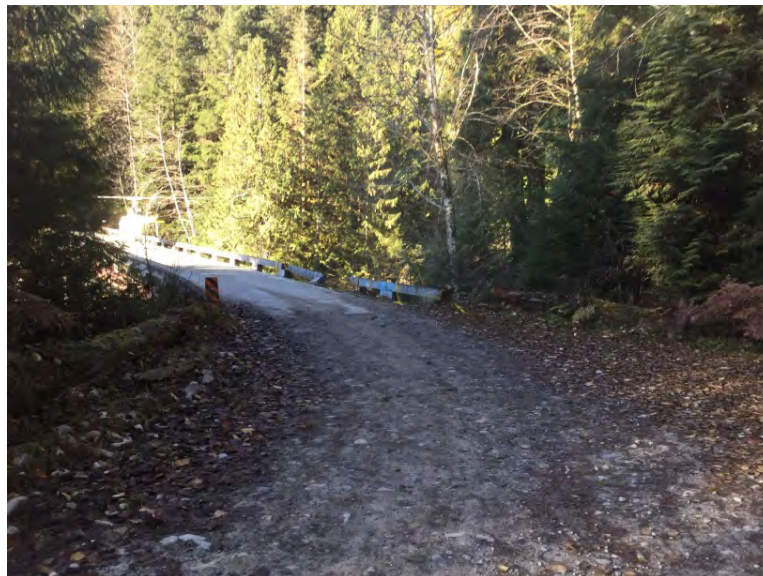
Approach from Left Bank when facing downstream

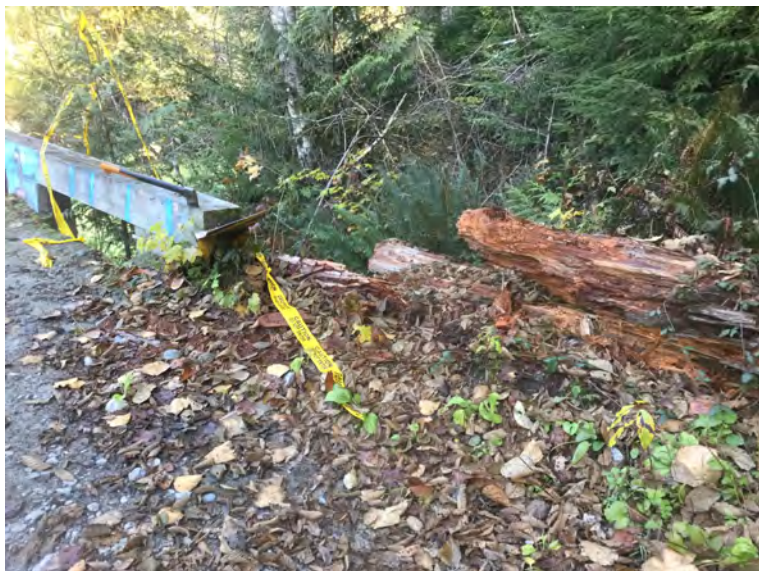
| Fender Condition | Fair | |

Upstream left approach fender condition

| | 3 | Suggested | Medium | | Replace all fender logs with concrete no post barriers or new min 600mm diameter x 6m long logs |

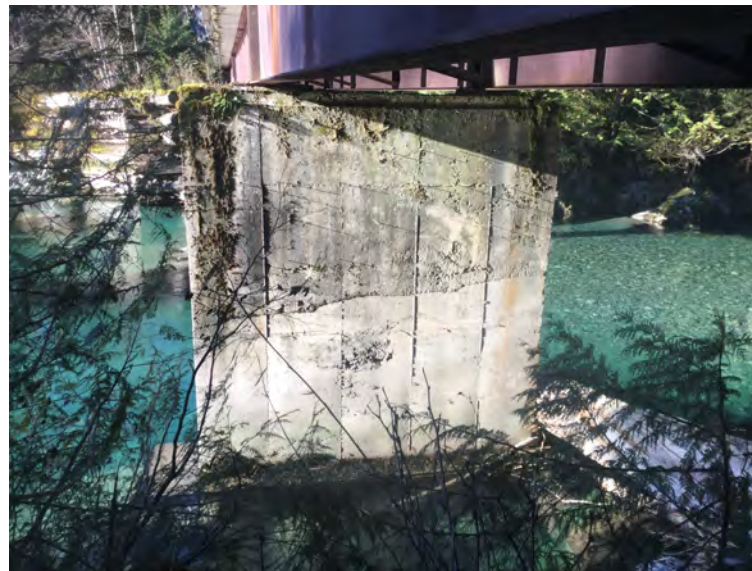
Left face of left Pier

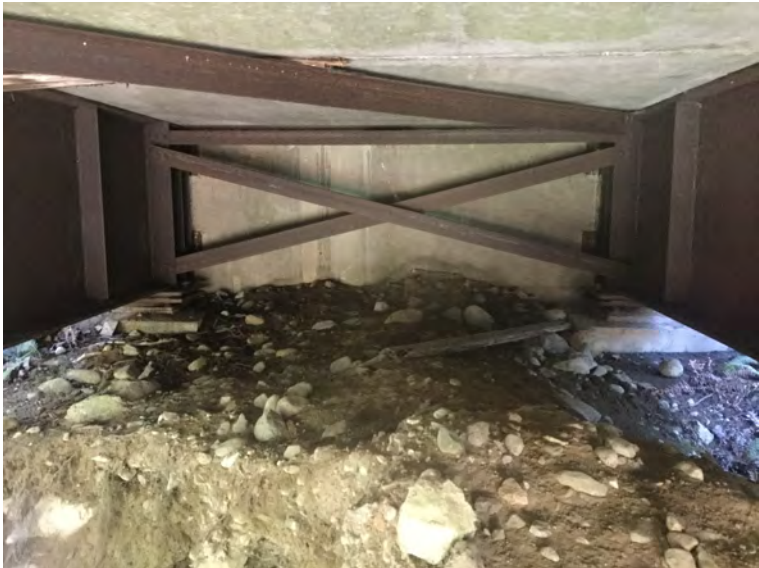
Left Bank Abutment when facing downstream

| # | Description |
|---|---|
| 1 | monitor eroding fill slope at left bank |

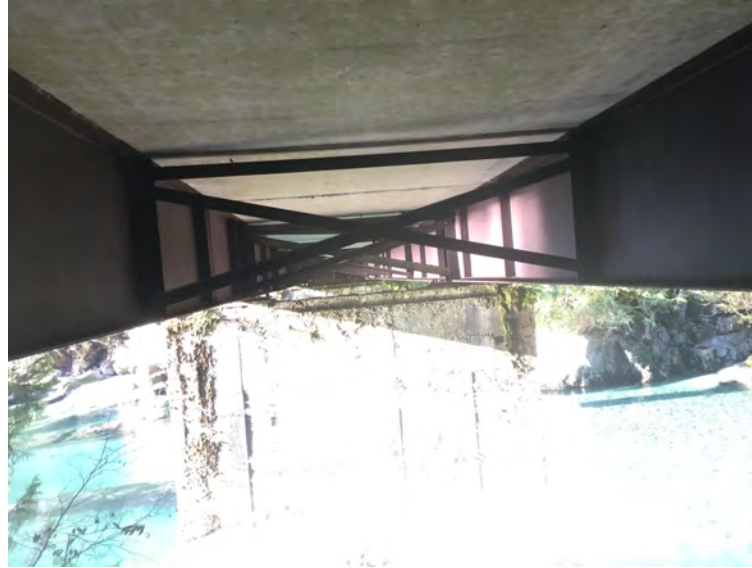
Left span superstructure

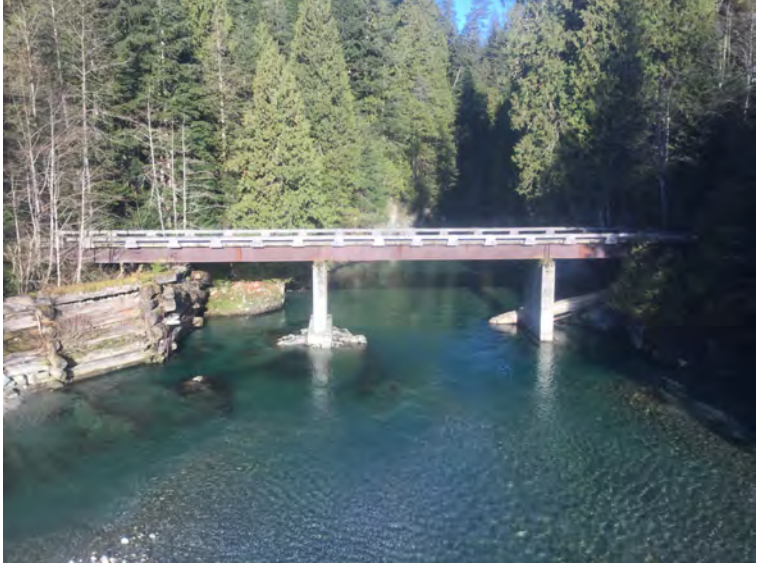
Downstream Profile
