CK-2233

STEVE 0.7km

2019 Inspection

| Crossing Name | Steve Creek |

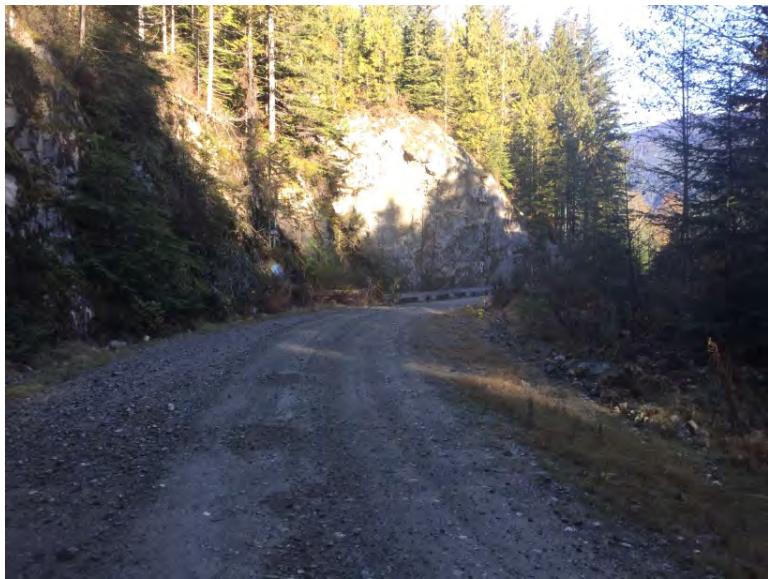
Approach from Right Bank when facing downstream

HC right approach

| 1 | Medium | Brush approaches |
| 2 | Medium | Post bridge ahead signs |

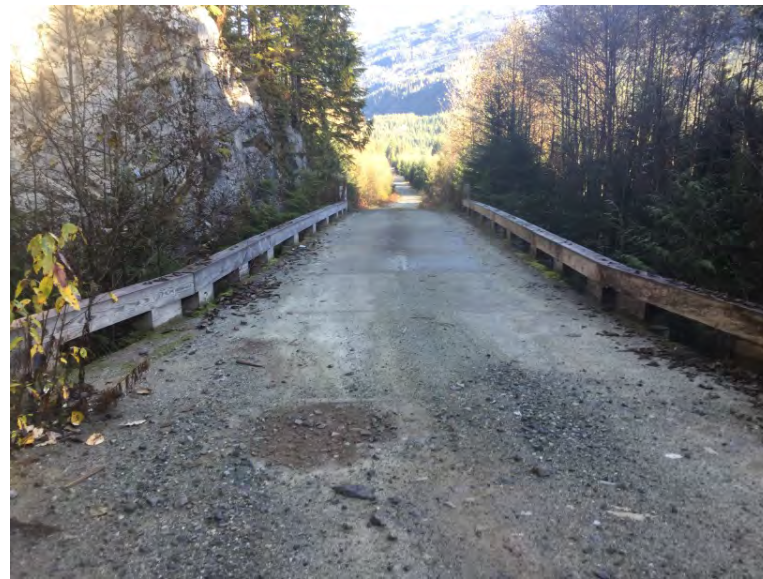
Concrete Deck      Fair      Track damage

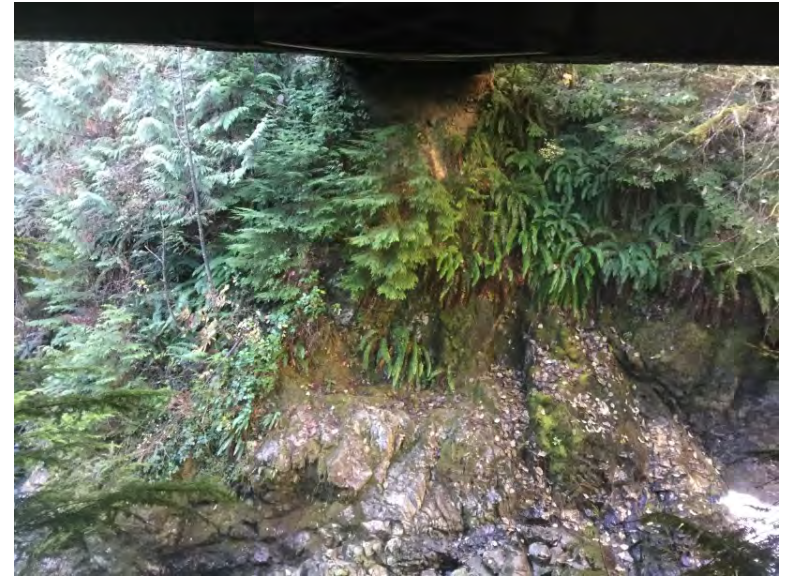
Right Bank Abutment when facing downstream

Hairline crack with efflorescence down center of right abutment wall and minor damage noted on wheel path

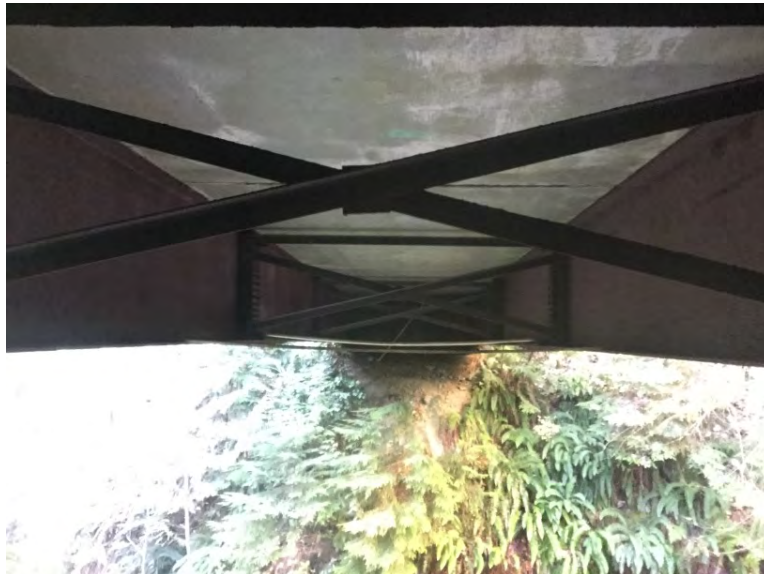
Superstructure

Diaphragms Fair 5 bolted bays with minor corrosion

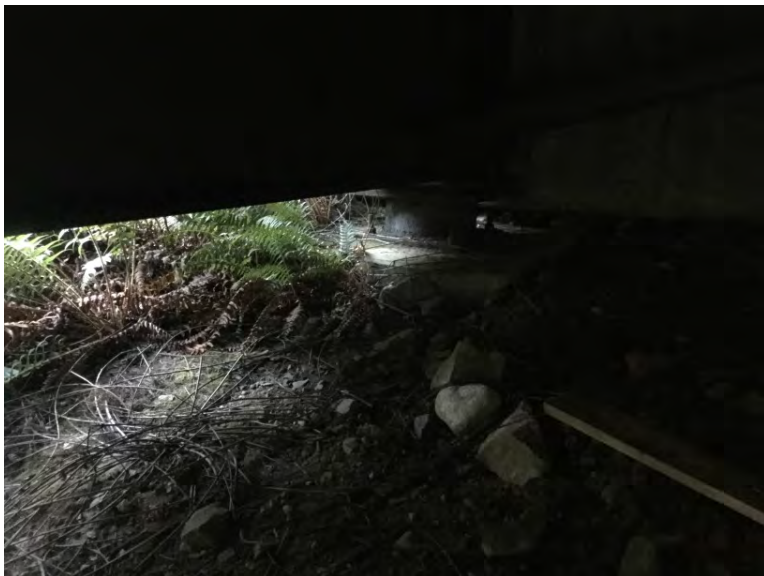
Downstream right bank abutment bearing

Bearings Fair

minor buldging
