CK-2236

SOWAQUA 9.6km

2019 Inspection

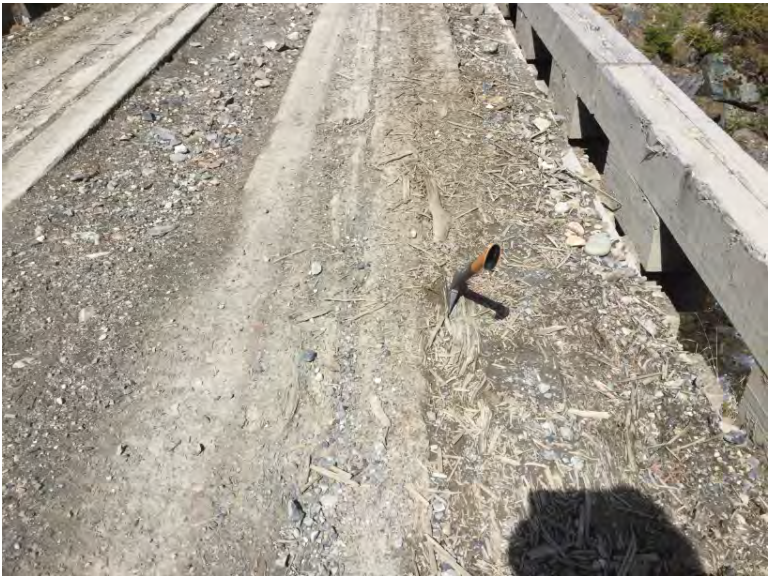
| Running Planks | Poor | Heavily worn, especially on outside 2 strips both upstream and downstream |

| Nails | Poor | Protruding |

Planks

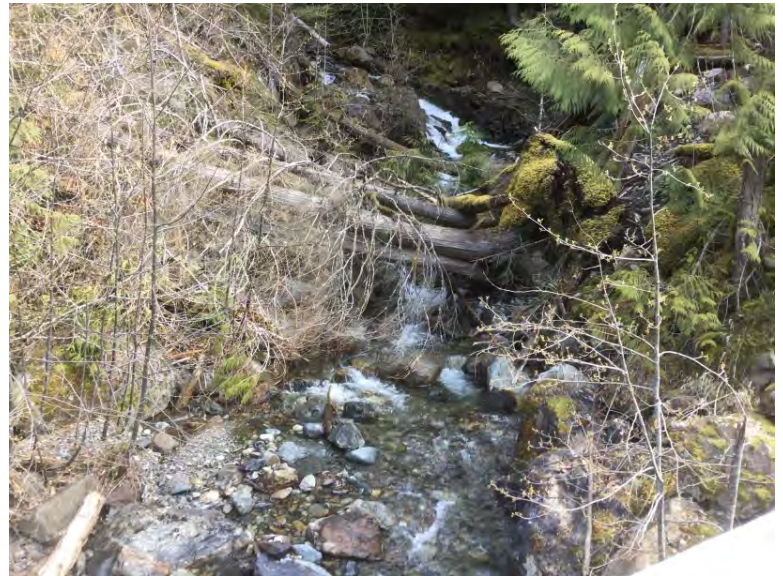
Trees have fell across stream above bridge crossing location and are a risk to being transported into the bridge in high flows

Upstream from Crossing, remove trees that have sloughed into stream

| Item | Priority | Repair Description |
|---|---|---|
| 2 | High | Remove trees that have sloughed into stream channel upstream of bridge |

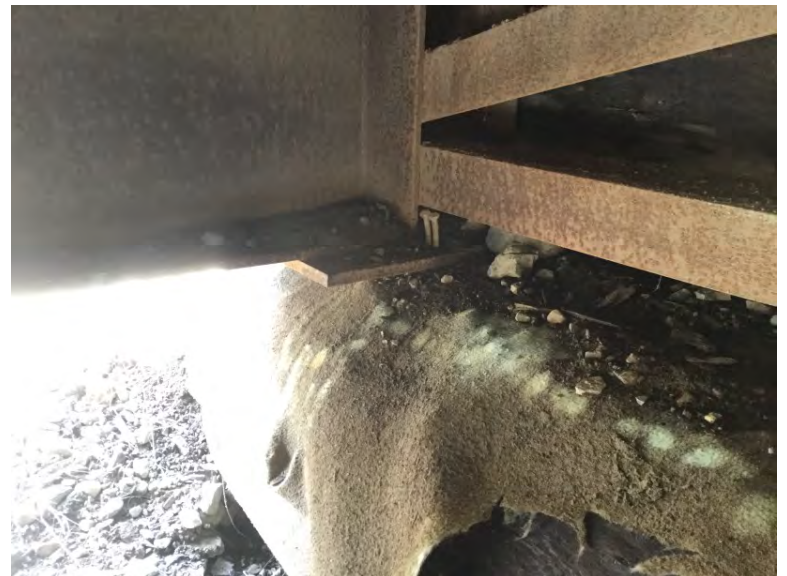
Bearing plates not completely on log sills, log sills not cut flat, and not even or square bearing

Downstream right bank bearing

| Item | Monitor Description | Frequency |
|---|---|---|
| 1 | bearing plate deformation | Routine inspection |

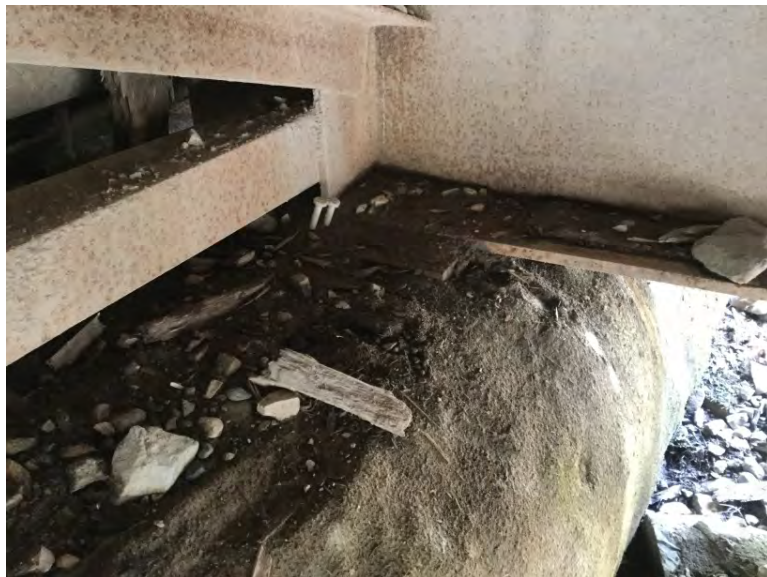
Upstream right bank bearing

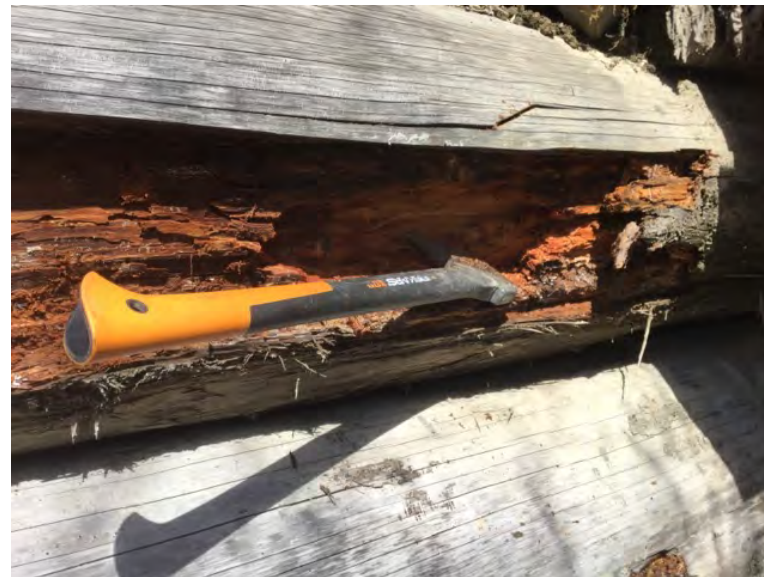
Right bank log ballast wall rotten but functional, see attached picture

Log ballast wall rotten but still functional

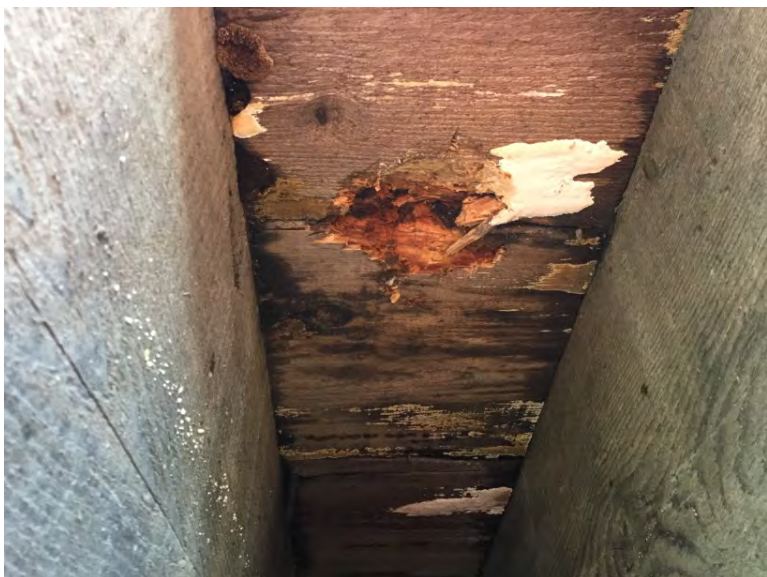
| Sub Deck | Poor | The first 4m on right bank in poor condition, remaining in fair condition |

Subdeck condition

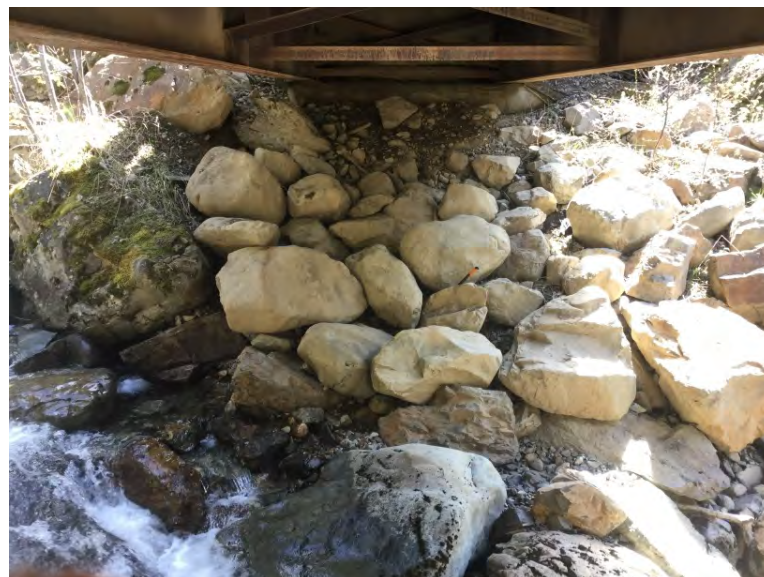
Left bank log sill is old with up to 50mm sap rot, right bank log sill appears newer

Left Bank Abutment when facing downstream

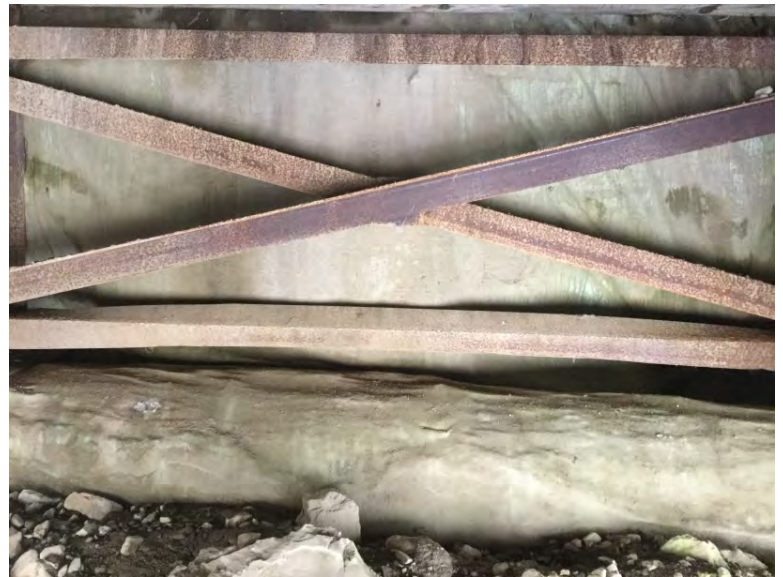
4 welded bays with minor corrosion. Both bottom chords at abutments slightly twisted

Bottom chord at left bank bent
