CK-2237

SOWAQUA 14.6km

2019 Inspection

| Crossing Name | Montigny Creek | | |

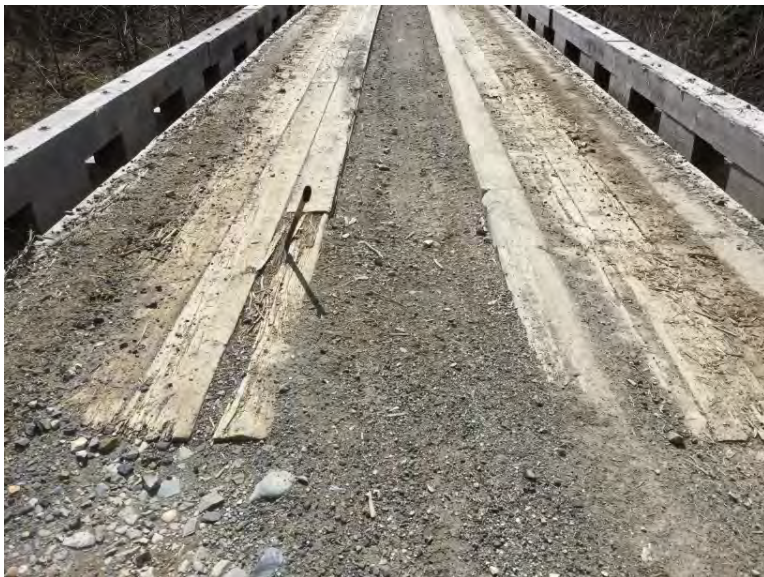
Planks are wearing

Deck wear

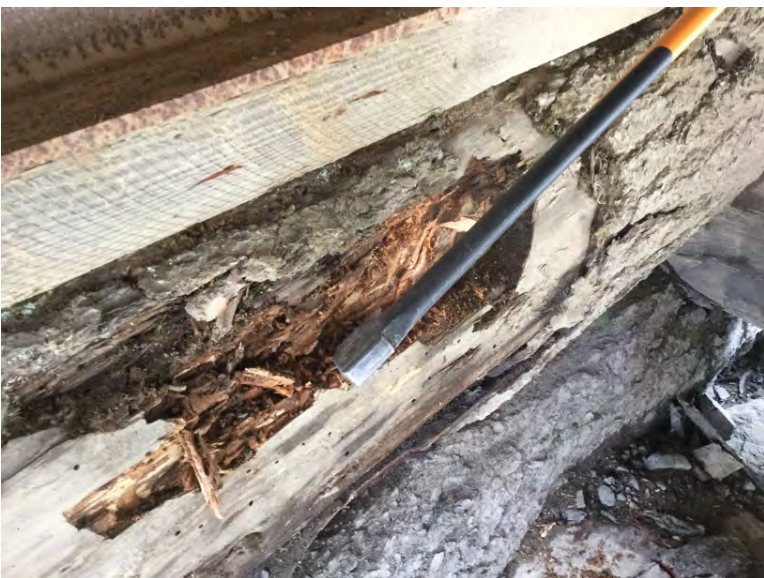
2x Fd face logs with bark still on, with up to 60mm sap rot

Top face log condition at right bank abutment

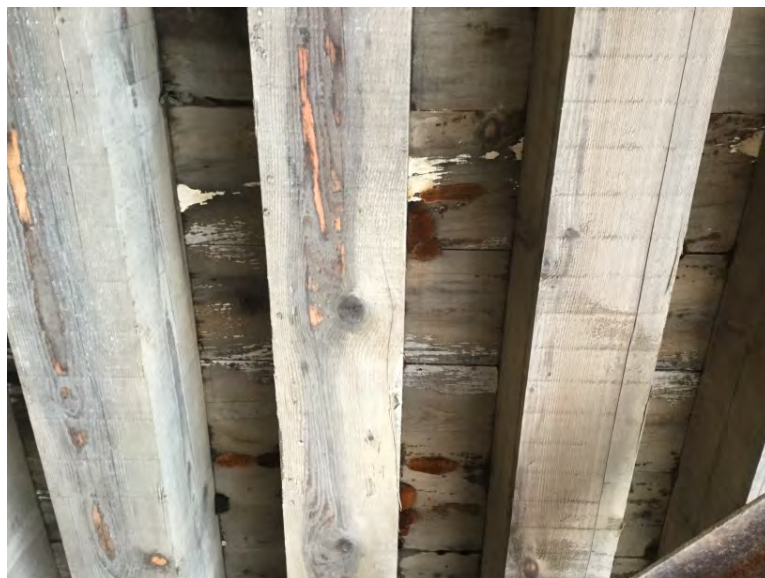
Rot indicators all over undear side of subdeck

Subdeck condition at right abutment

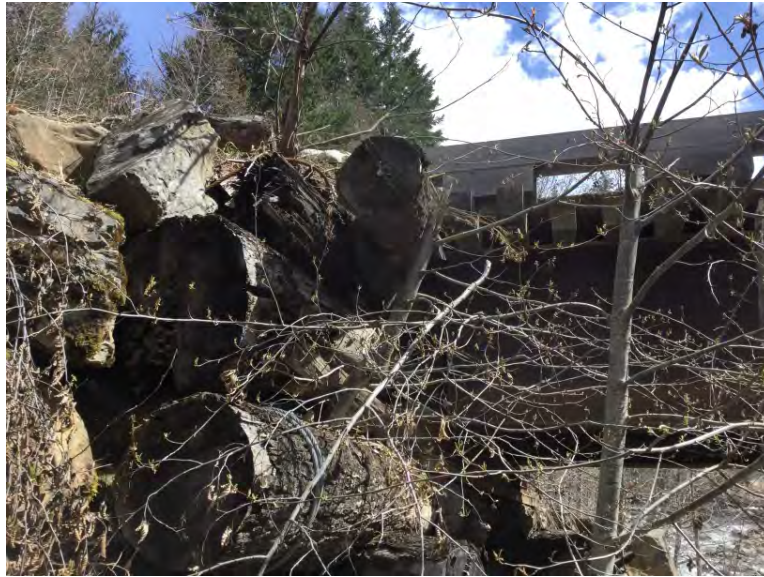
old logs with significant rot, top log on right abutment has failed downstream

Top log of ballast wall at right bank is failing

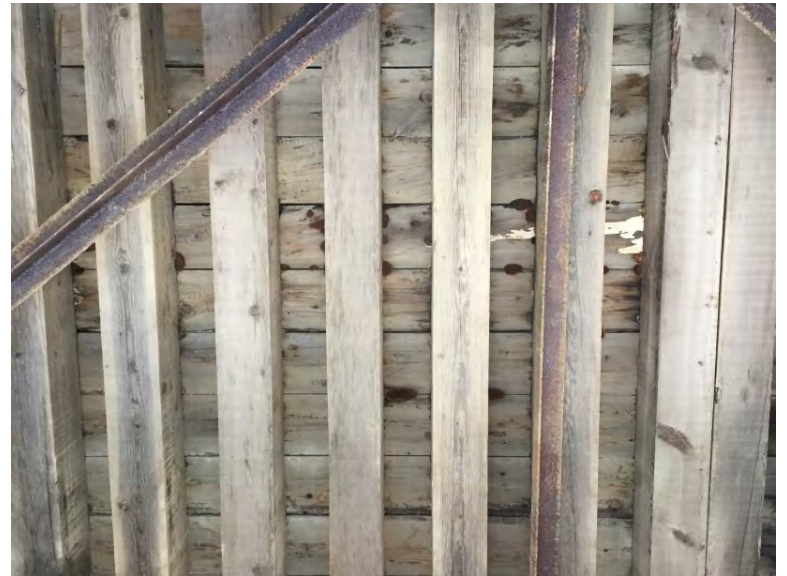
Subdeck condition at midspan

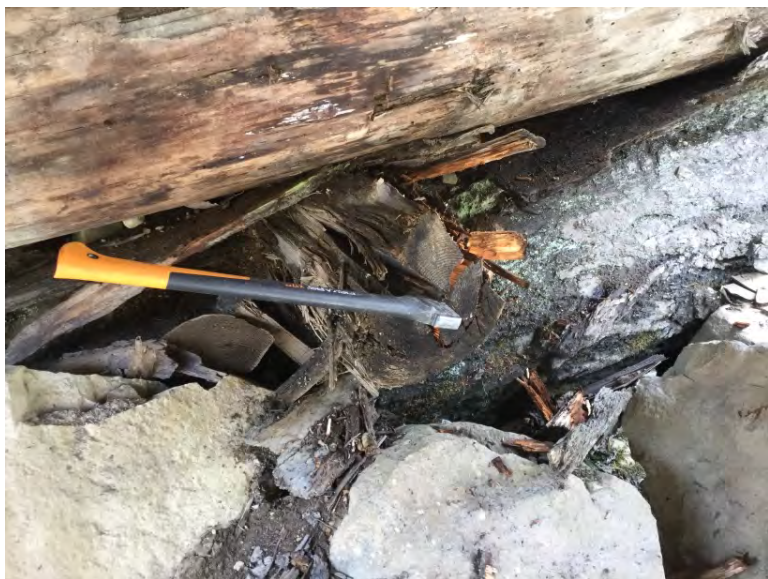
3x unpeeled, small diameter (300mm) and rotting

Tieback condition at left bank

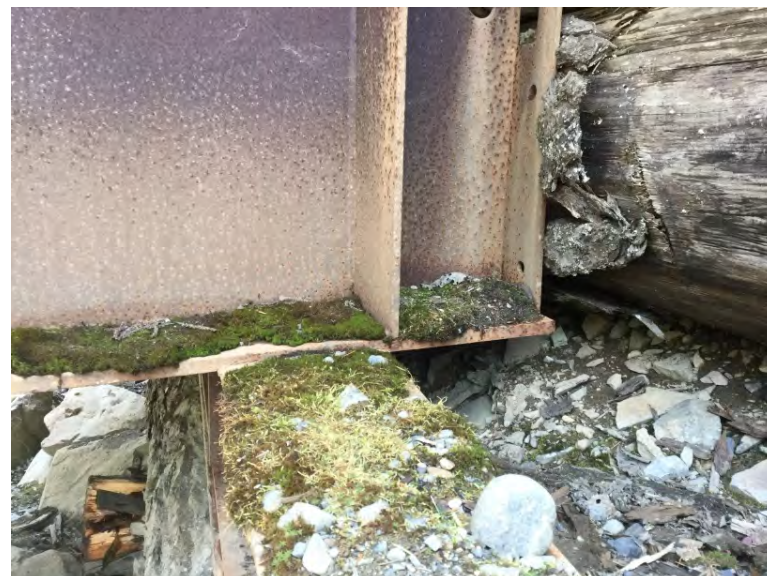
Steel girders do not bear squarely on abutment and are unconnected

Bearing at downstream left bank
