CK-2240

SPUZZUM 5km

2019 Inspection

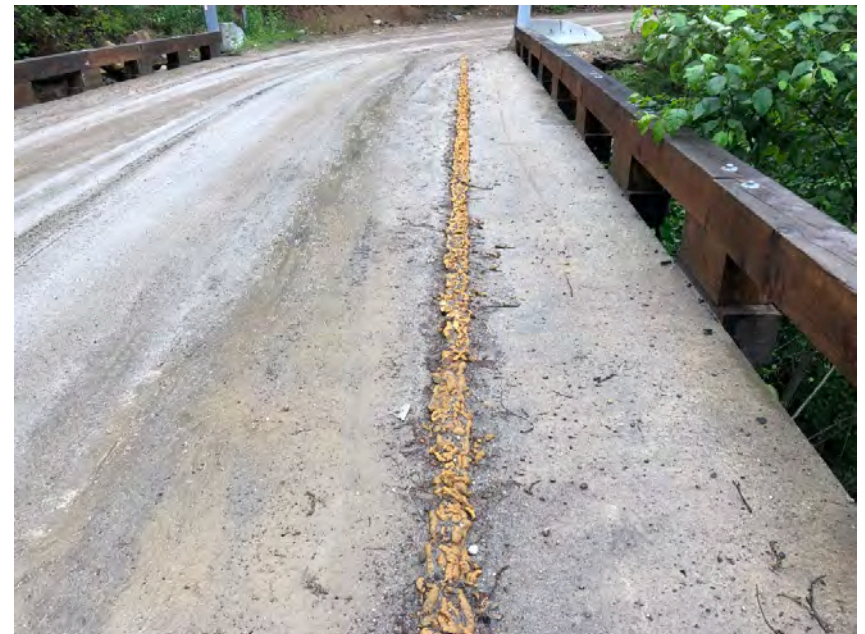
The 2 outside slab girders were added to the original 4 inside slab girders 2 years after the original install. Since the original outside slab girders do not have keys and not attached to the existing outside slab girders there is differential movement between them, which will causing the joint to disintegrate over time, monitor. Also, the riprap recently placed at the left upstream corner is steep and needs to be monitored. The current load rating of BCL-625 or 64 tonnes to continue.

Concrete Deck      **Fair**      2 outside panels are not shear connected to the inside ones

6 concrete slabs, outside ones not shear connected to the inside ones

Spray foam used to fill joint on outside slabs

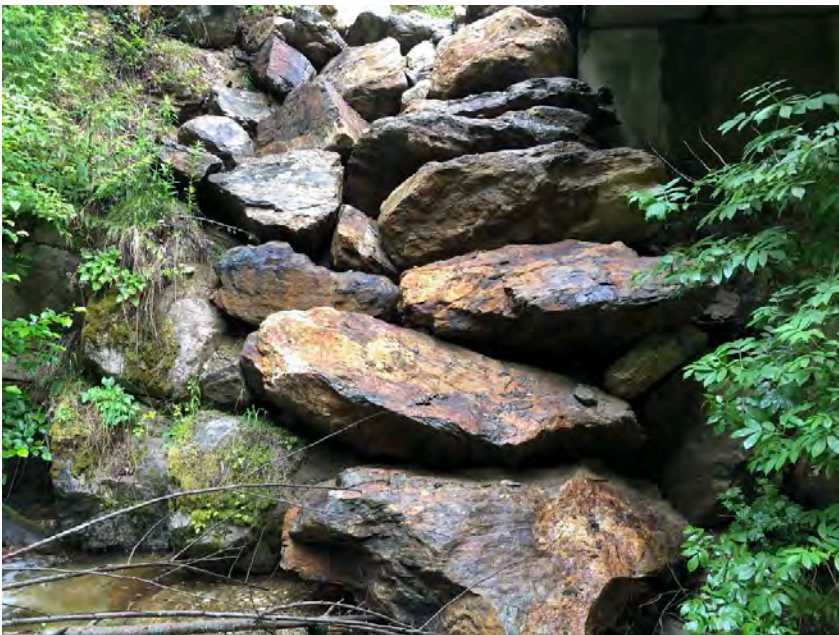
Riprap Fair Upstream left bank is steep - monitor

Comments    Monitor riprap at upstream left bank

Upstream left bank riprap

| Item | Monitor Description | Frequency |
|---|---|---|
| 1 | Upstream left bank riprap | Routine Inspection |
