CK-2241

SPUZZUM 25.4km

2019 Inspection

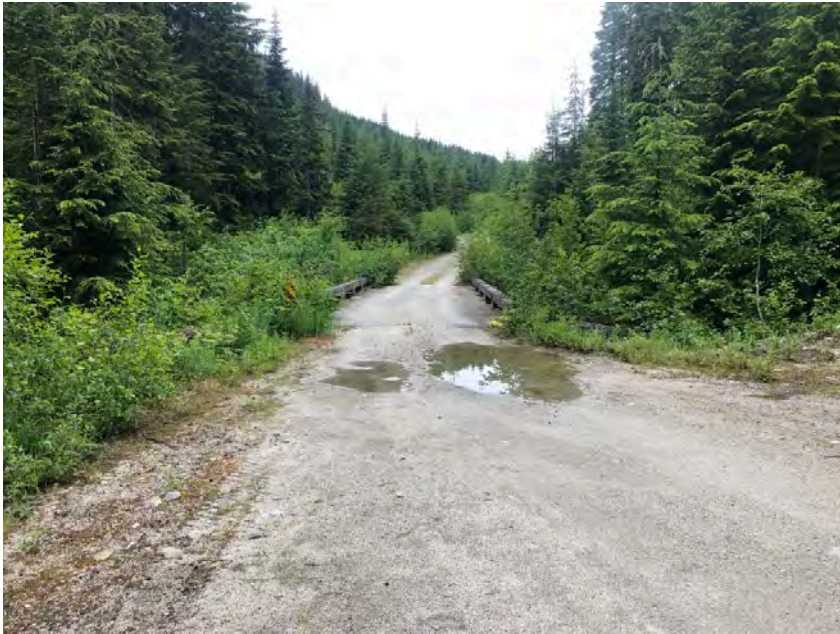
Approach from Left Bank when facing downstream

Requires material at left approach

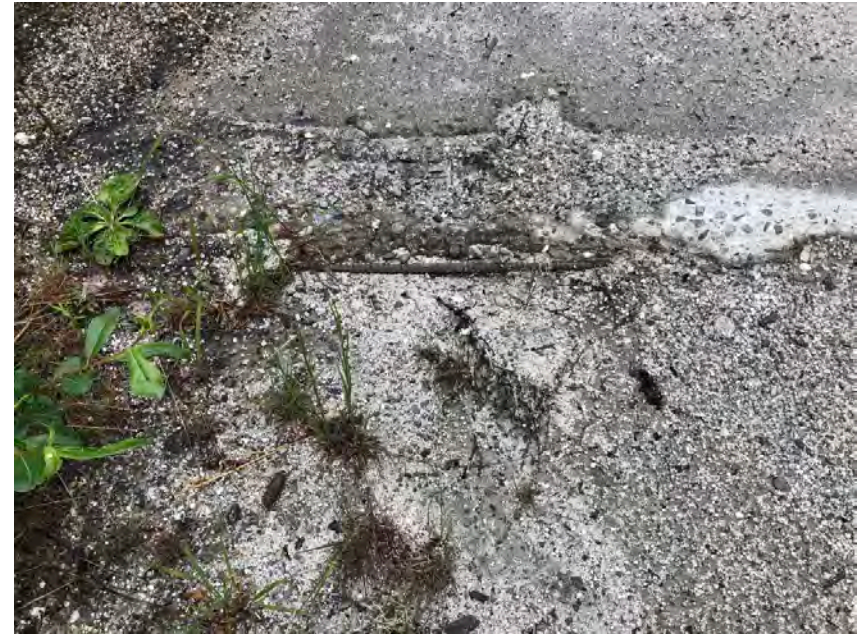
Ballast Wall Fair damage noted to top at left bank

Damage noted to ballast wall at road surface

Replace the guardrail, risers and blocks; repair the damage to the ballast wall consistent with the Concrete Repair Guide for Concrete Bridge Components written by the Ministry of Forests, Lands and Natural Resource Operations (2017); brush and grade approaches and replace the approach fender logs. Monitor the deck joint condition. The current load rating of L60 or 54 tonnes to continue.

| 2 | Medium | Repair damage to top of ballast wall |

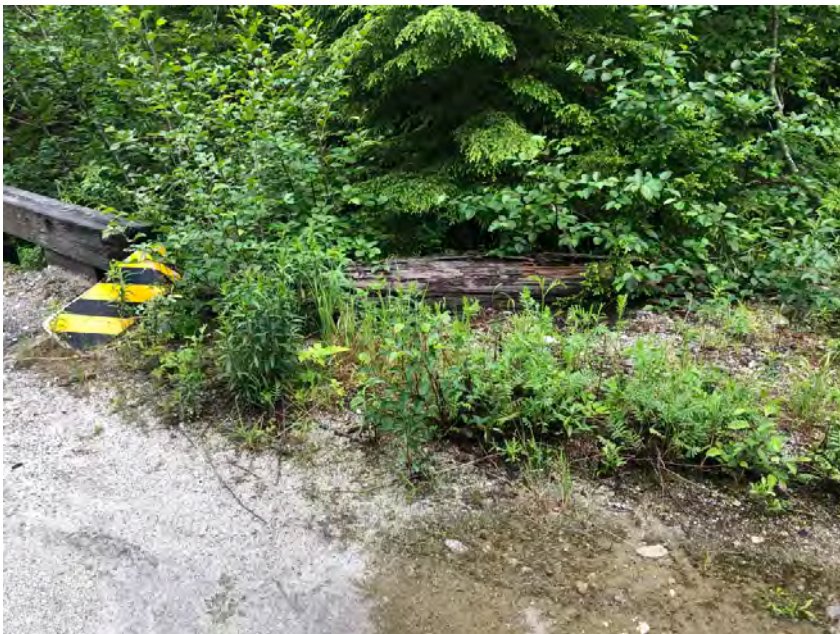
Fender Condition Poor

Old rotten logs

Fender logs

| 3 | Medium | Brush and grade approaches, and replace fender logs |

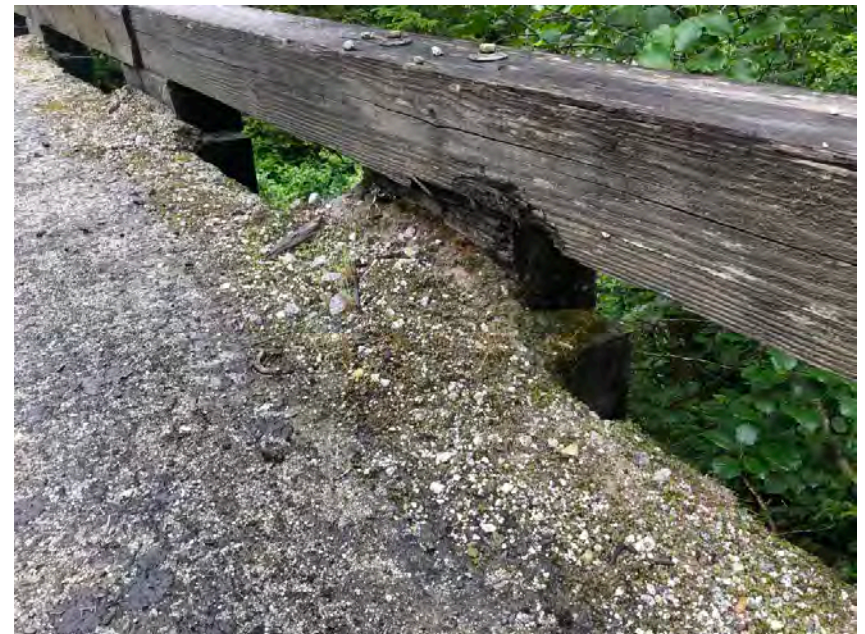
| Curb Rail/Blocks/Posts | Poor | Rotten |

| Hardware | Poor | Loose rail bolts |

| Overall Deck Condition | Poor | Due to rail condition |

Rail condition

| 1 | High | Replace guardrail, risers and blocks |

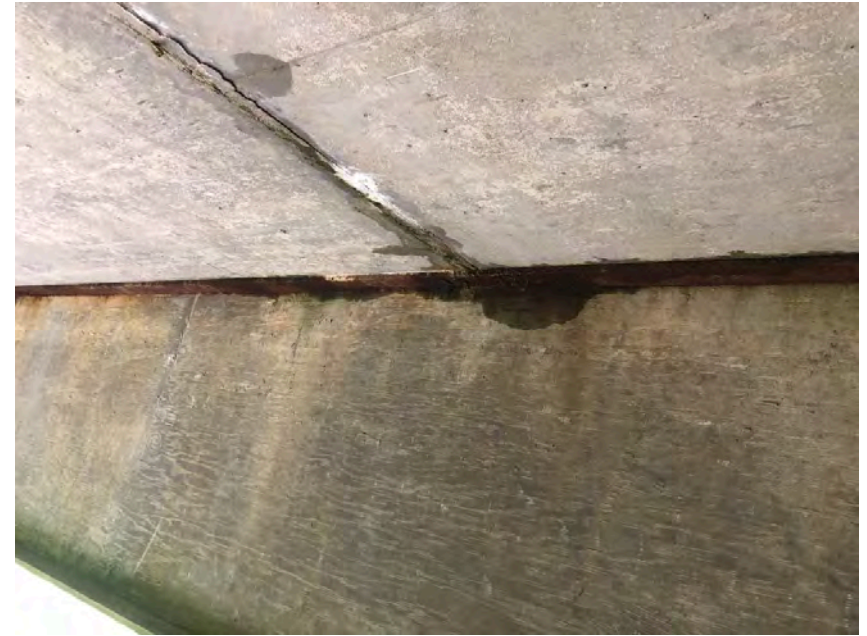
| Deck Joints | Fair | Evidence that water is getting on 2 deck joints |

Evidence that water is getting through some deck joints

| 1 Deck joints | | Routine Inspection |
