CK-2253

SQUEAH 3.2km

2019 Inspection

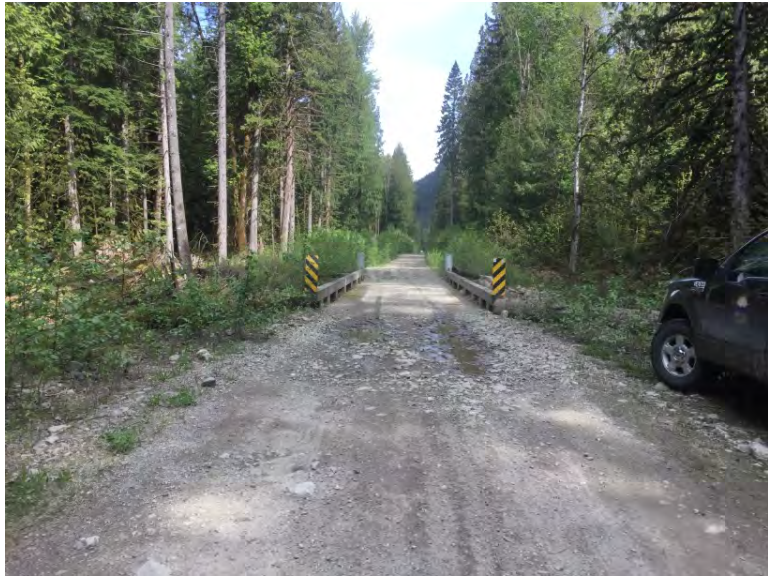
Approach from Left Bank when facing downstream

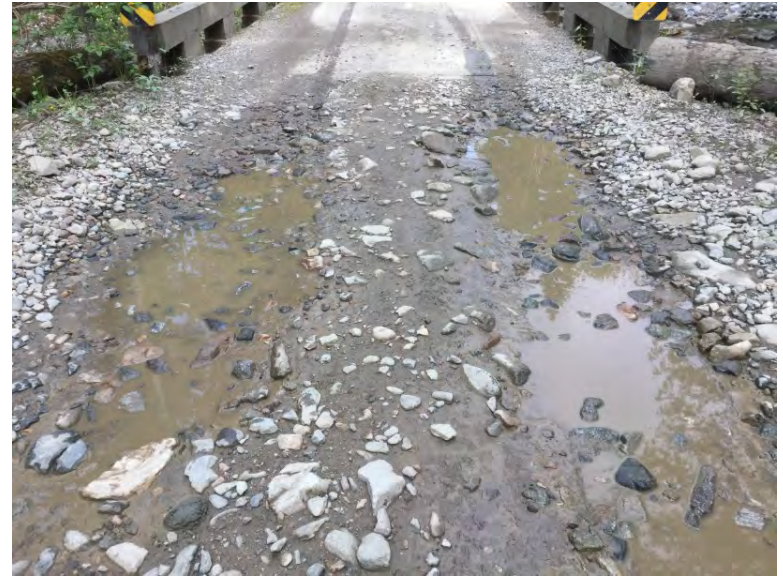
Road Surface Poor Requires surfacing at both approaches

No surfacing at left approach

| Item | Priority | Repair Description |
|---|---|---|
| 2 | High | Add surfacing to both approaches prior to industrial activity |

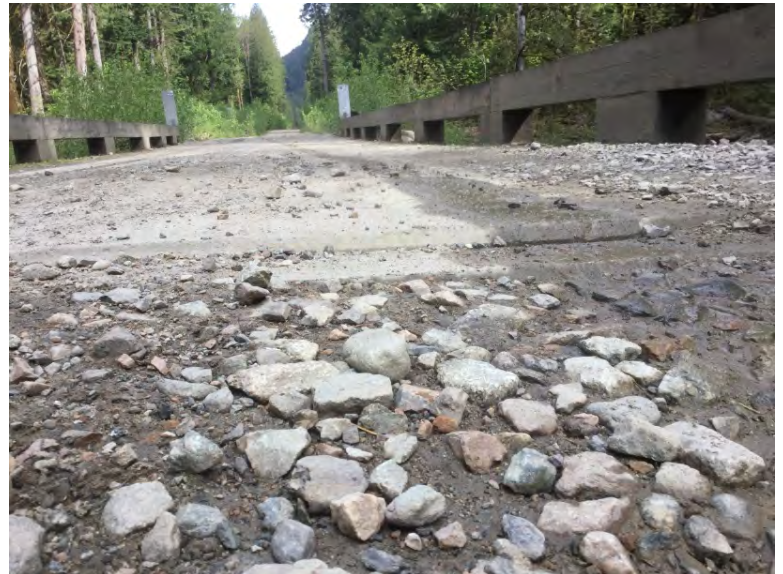
Left bank ballast wall installed 30mm lower than deck panels

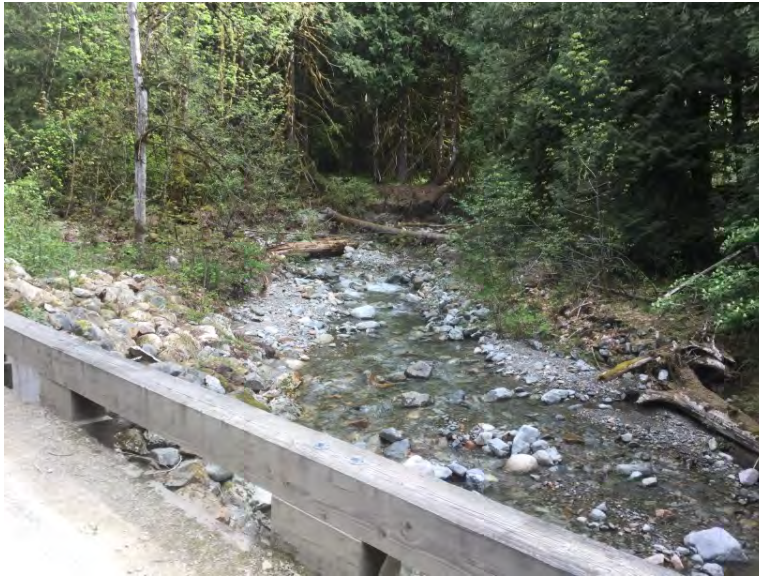
Upstream from Crossing, note debris in stream

Clean debris accumulations from beneath the bridge and upstream the crossing location. Consider adding additional riprap upstream where the debris accumulations are, where the stream changes direction significantly. Add surfacing materials to both approaches and brush. Monitor the debris accumulations at this site. The current load rating of L100 or 91 tonnes to continue.

| Item | Priority | Repair Description |
|---|---|---|
| 1 | High | Clean debris from stream channel above bridge crossing and under bridge |

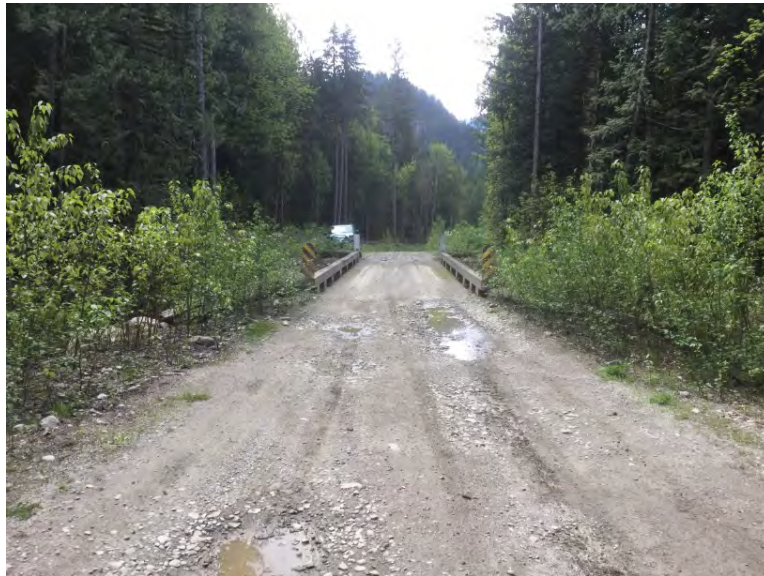
Approach from Right Bank when facing downstream

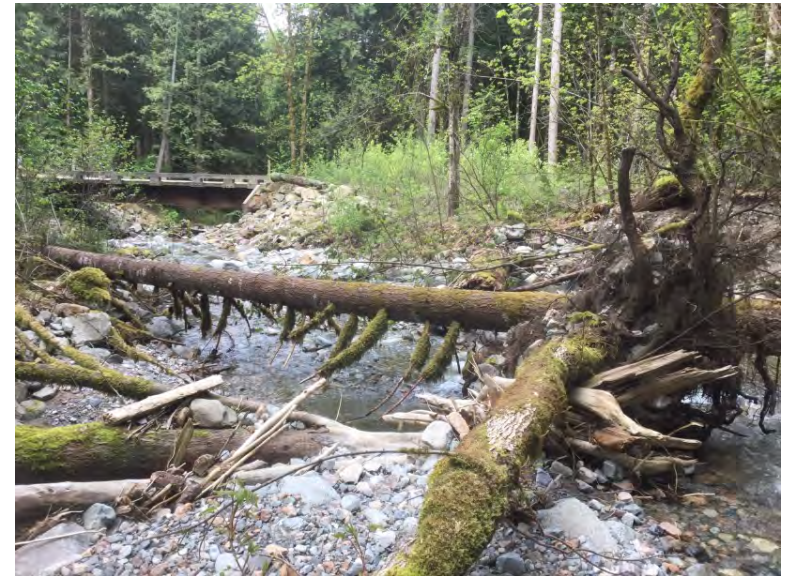
Consider adding riprap upstream of bridge crossing where debris accumulations are starting. The stream changes direction 60 degrees here.

Debris in stream located above bridge crossing

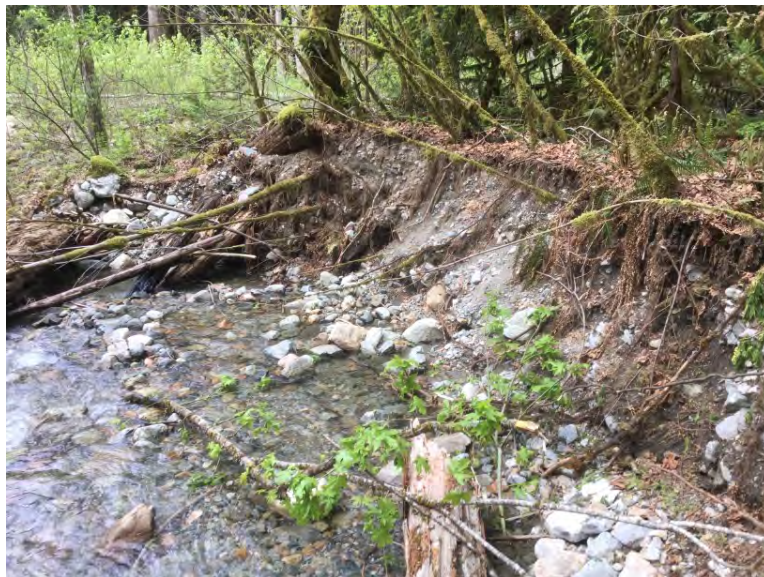
Bank erosion upstream from bridge crossing

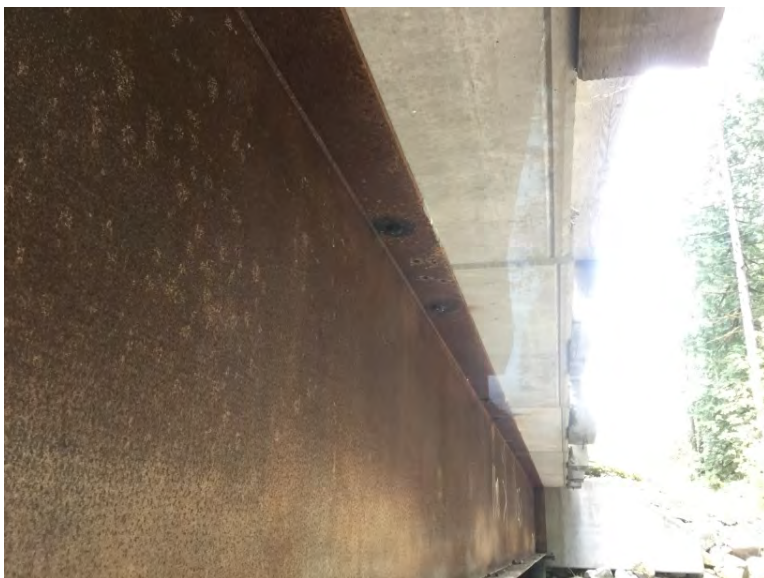
Deck bolts installed and functional

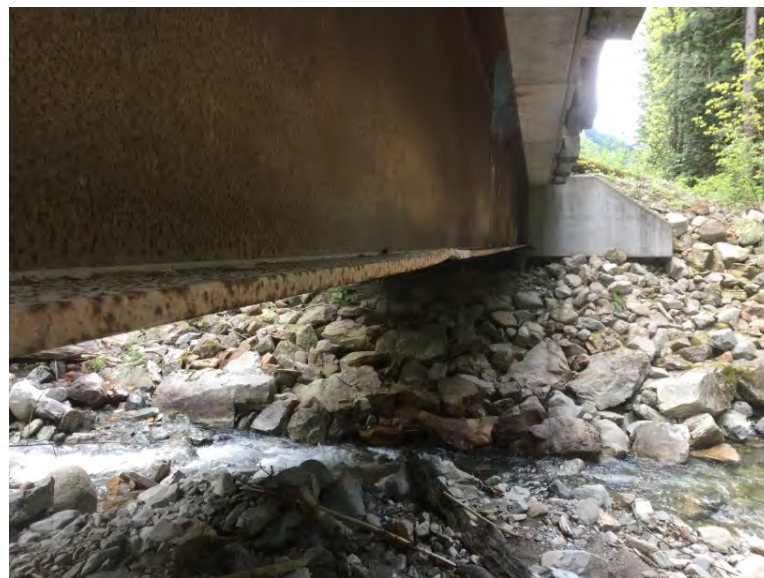
Some damage noted to bottom flange of downstream girder

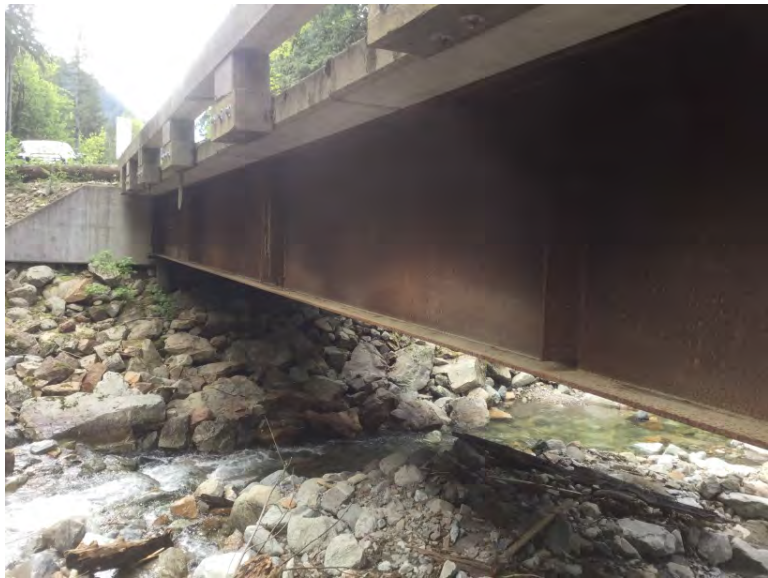
Stiffeners on outside of upstream girder but not downstream girder

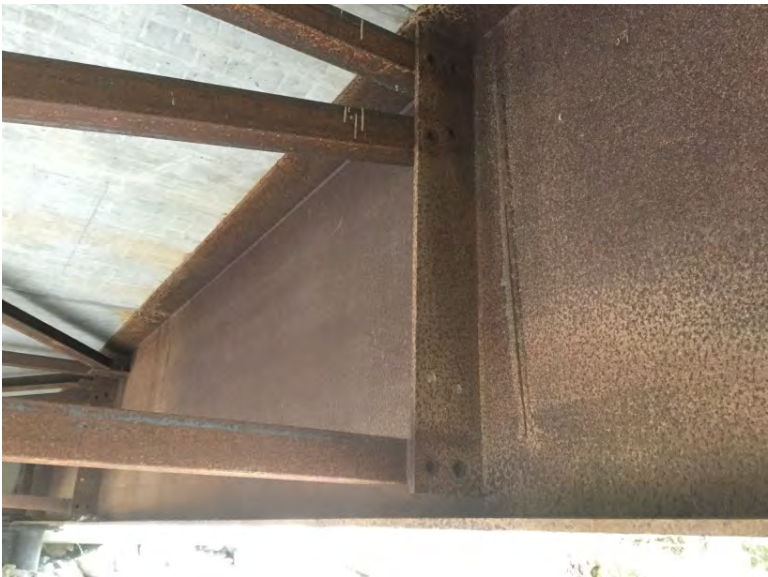
Bolt holes in stiffeners but all bracing welded
