CK-2254

SQUEAH 6km

2019 Inspection

| Structure Class | Permanent Bridge |

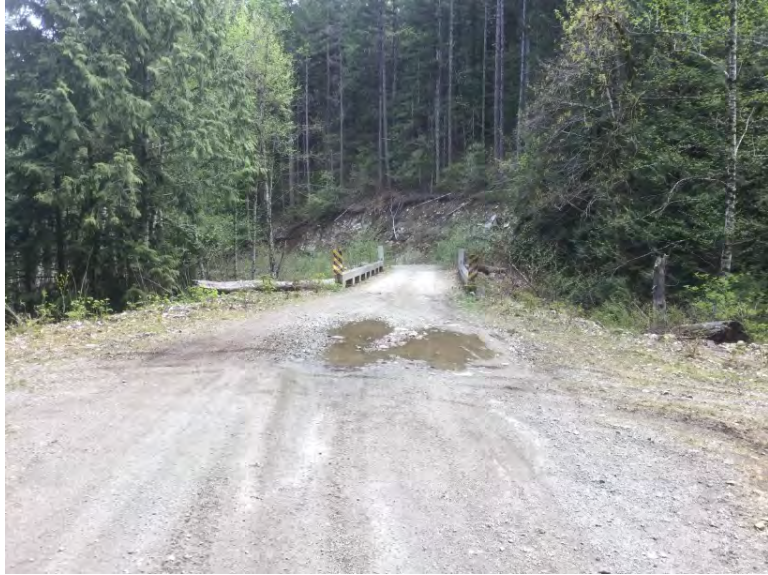
Approach from Left Bank when facing downstream

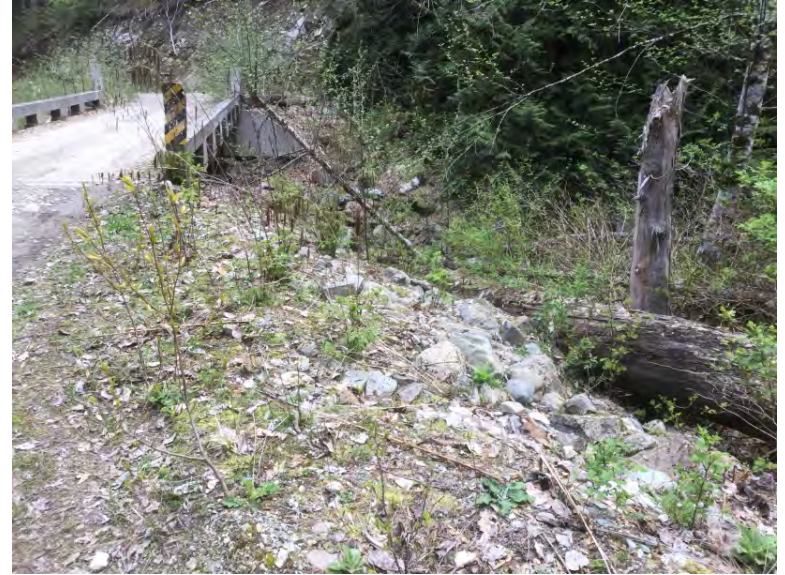
Missing upstream left approach

Missing upstream left bank fender, has rolled off road

Add surfacing to both approaches; replace the failed upstream left approach fender log; and brush approaches. The current load rating of L75 or 68 tonnes to continue.

| Repair Item | Priority | Repair Description |
|---|---|---|
| 3 | Medium | Replace failed log fender at upstream left approach |

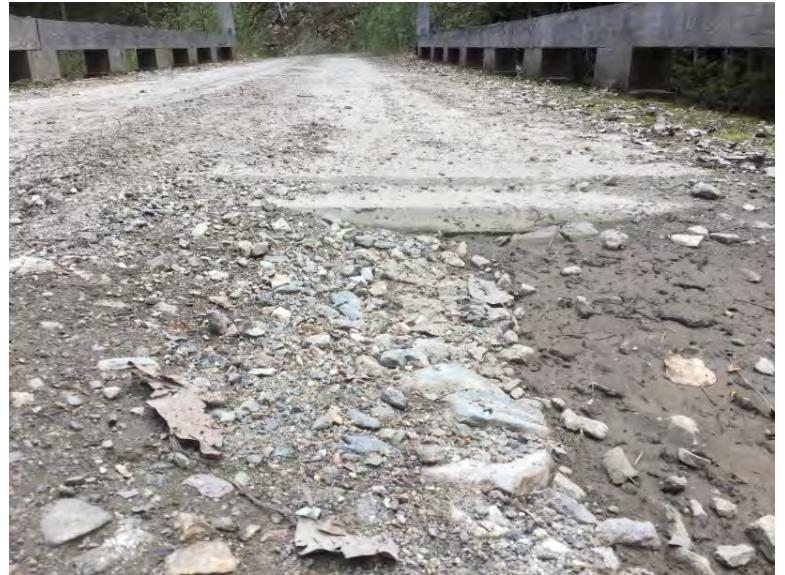
Ballast wall at left bank is 30mm lower than deck panel

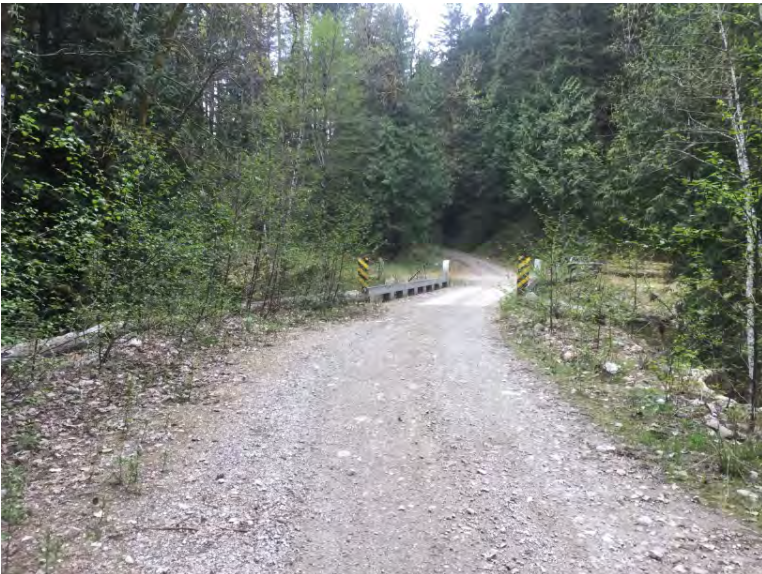
Approach from Right Bank when facing downstream

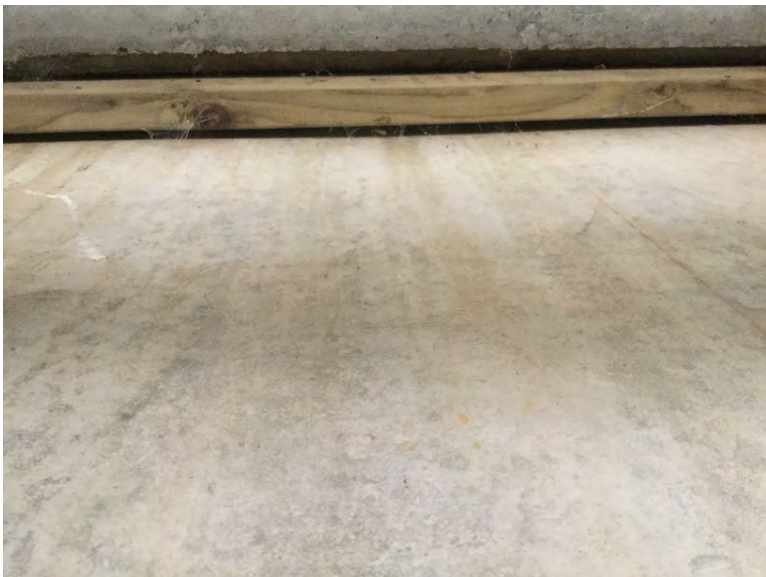
Gap between deck panel and ballast wall on right bank filled with treated timber

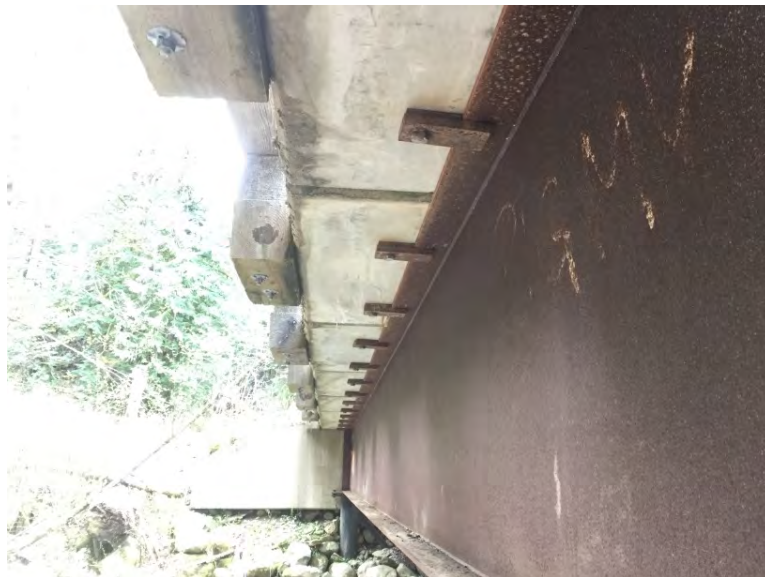
Deck clips in place and functional

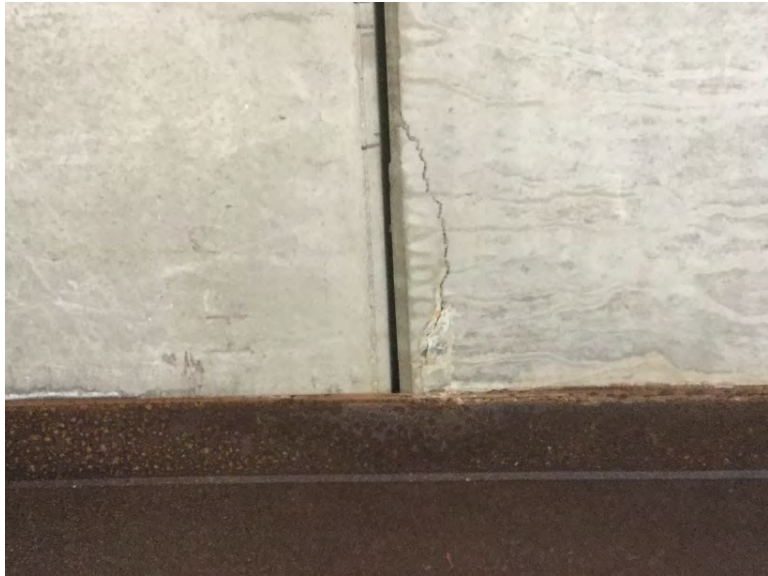
Minor damage noted to panel 3 at left bank

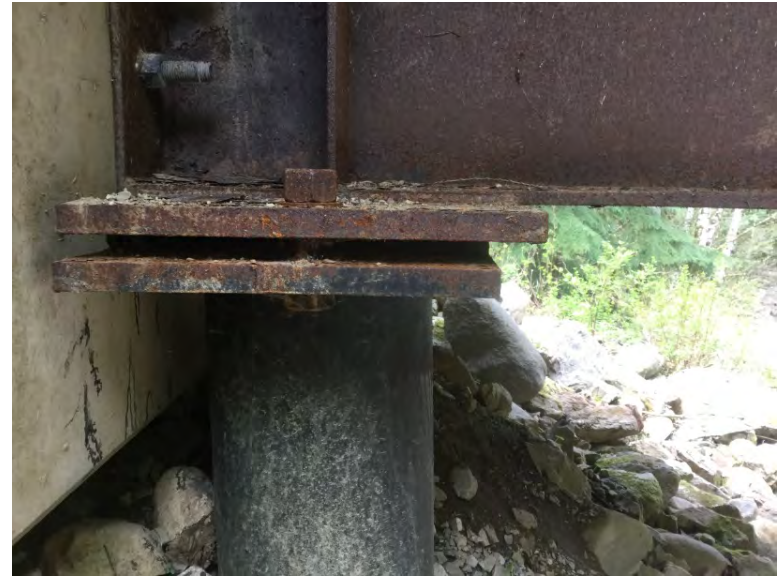
Upstream bearing plates misaligned but appears it was installed that way

Bearing plates misaligned at upstream left bank

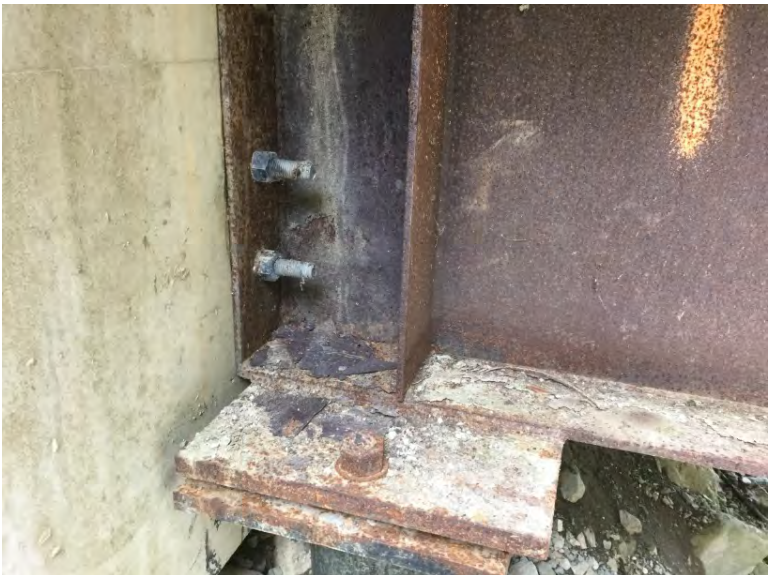
Minor steel delamination
