# BC Ministry of Forests, Lands, and Natural Resource Operations

## Log Stringer Bridge Inspection Report

| Structure #: | CK-2261 | Site #: | CK-2261 | Road Name: | STAVE | Inspection Date: | 2019/11/04 |
| KM: | 8.50 | User km: | 7.50 | Crossing Name: | Winslow Creek | Next Inspection Date: | 2019/06/06 |

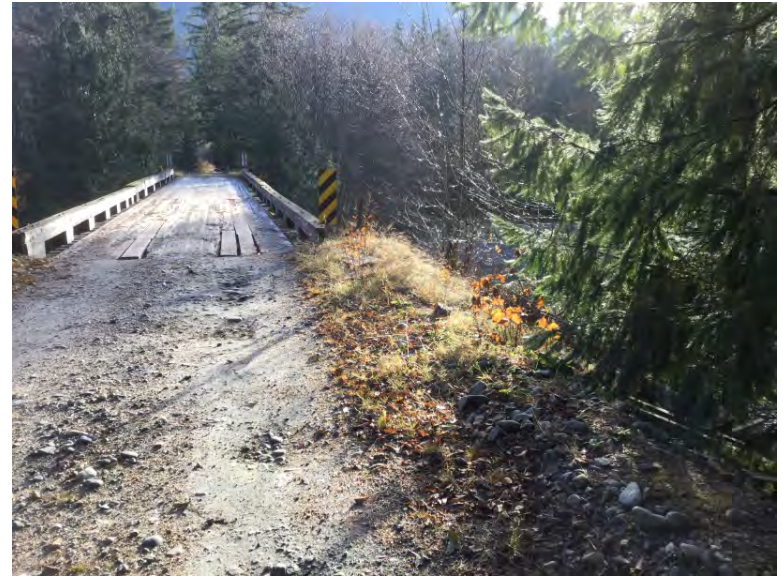
| Fender Condition | Poor | downstream right and left approach barriers failed off road surface |

Downstream right bank barriers missing

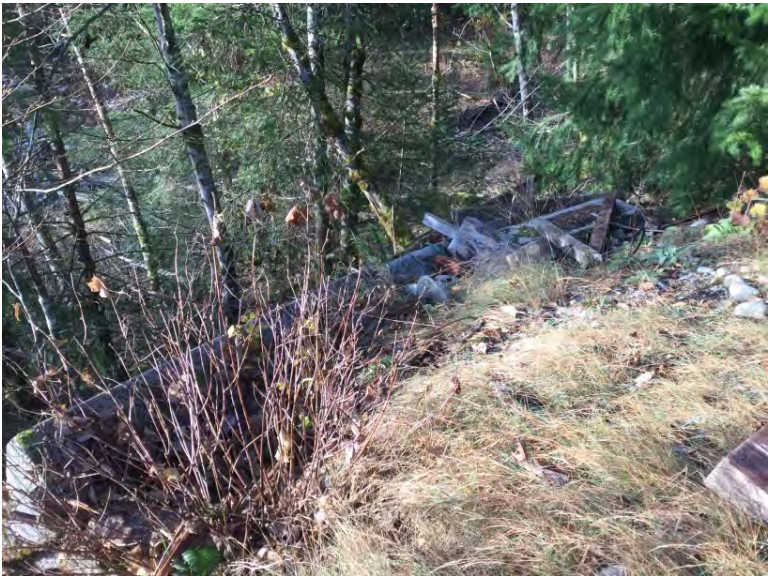
Downstream right bank barriers over bank

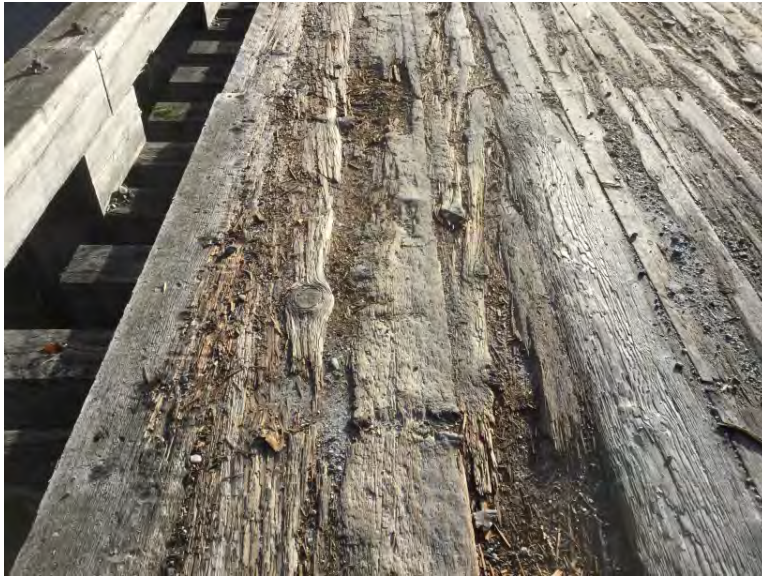
| Running Planks | Poor | Heavy wear with holes in deck |

Plank condition on right span

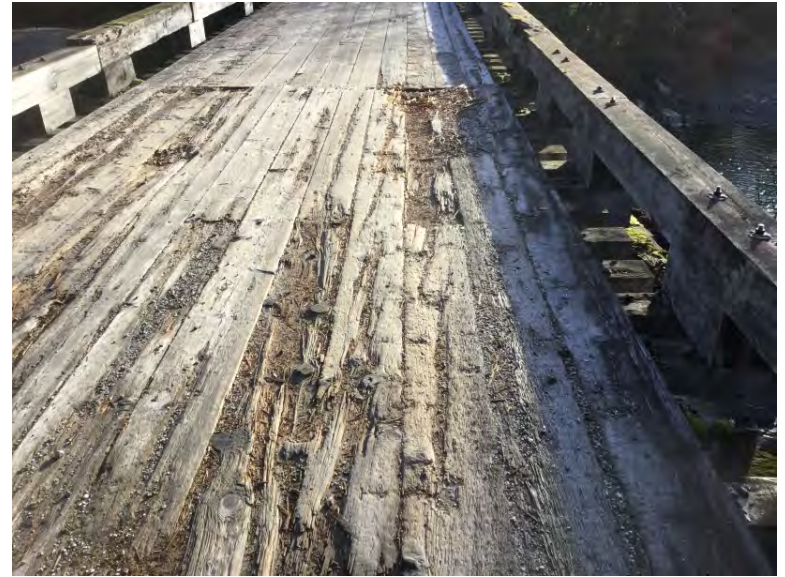
Plank condition on right span

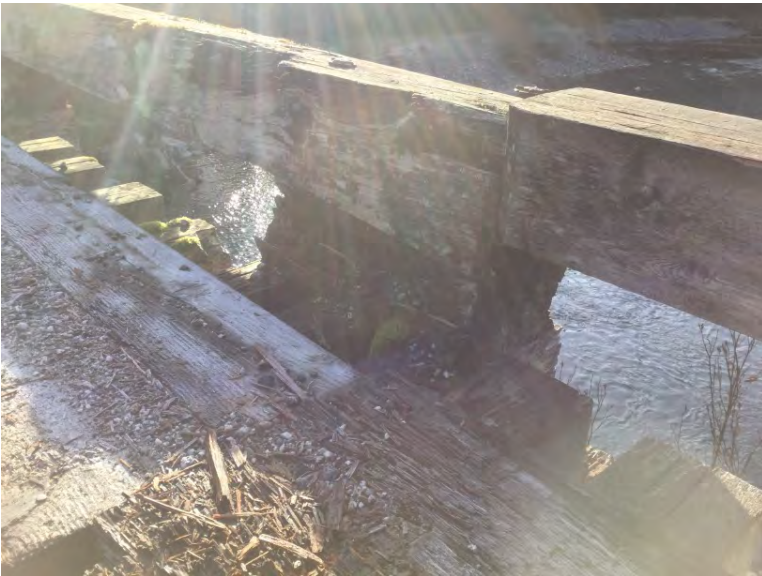
| Curb Rail/Blocks/Posts | Poor | Rotten |

Guardrail condition poor

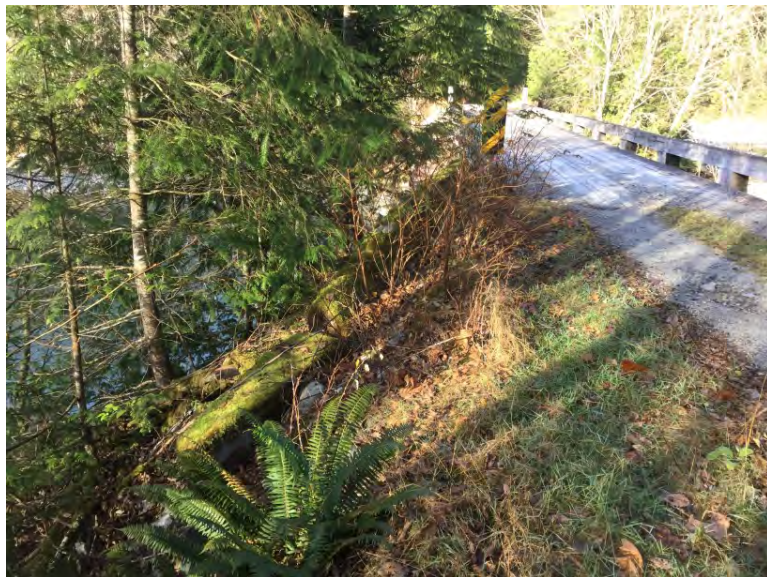
Downstream left bank barriers failing

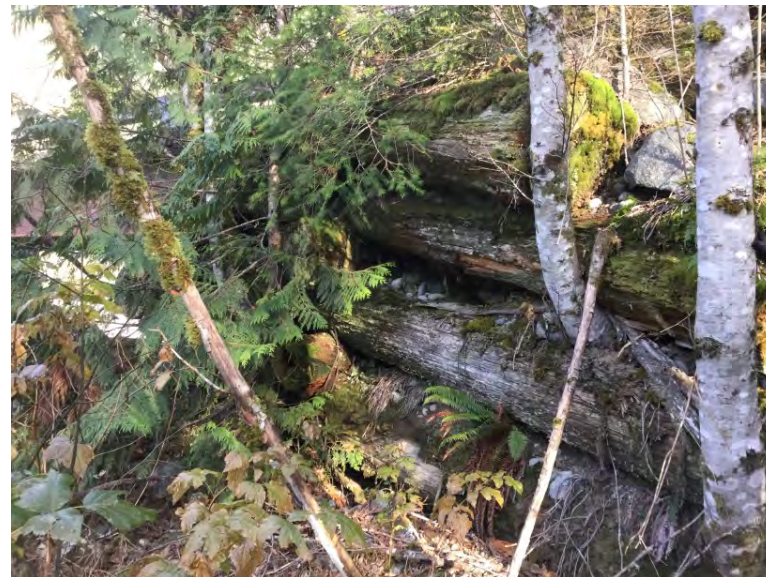
| Wing Wall | Poor | Rotten with alder growing within |

Downstream left bank wingwall condition

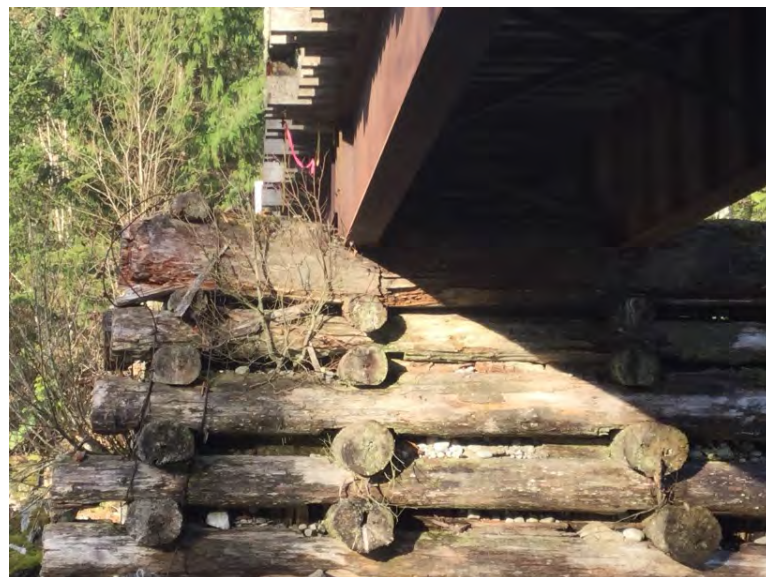
| Bearings | Poor | top face log in pier for left span continues to degrade |

| Bearings | Poor | uneven at the left span location |

Top face log on left side of pier cracked through and girder settling

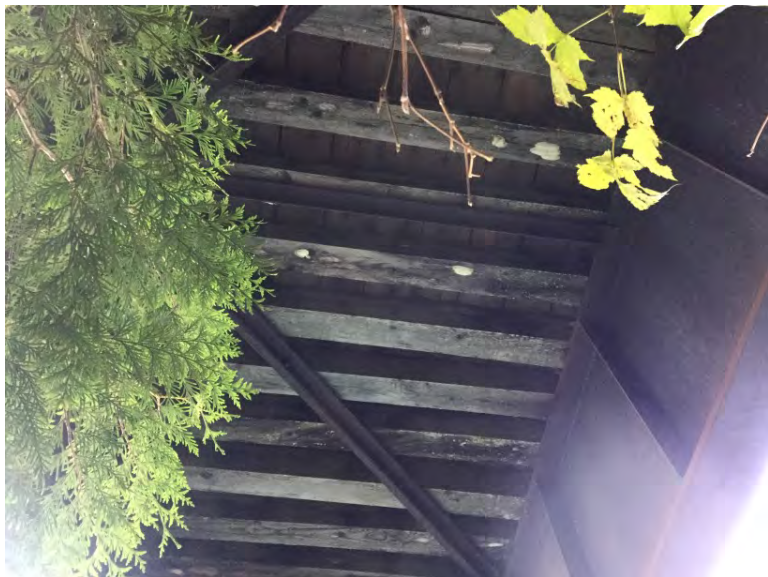
| Ties | Poor | Visible indications of rot |

Left span tie condition

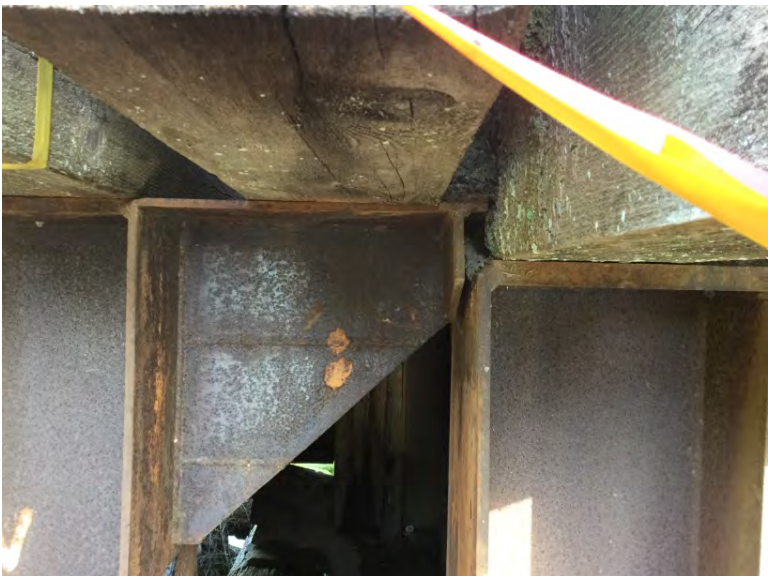
Downstream left span girder 63mm lower than right span girder

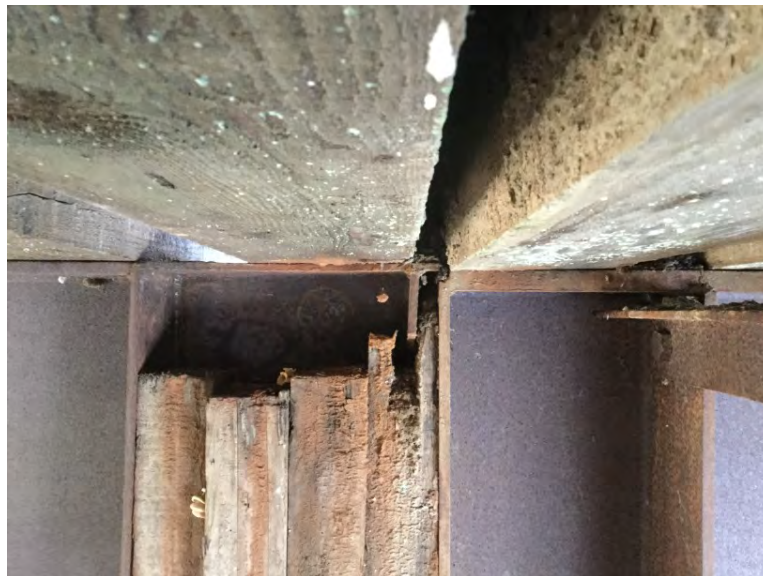
Upstream left span girder 10mm lower than right span girder

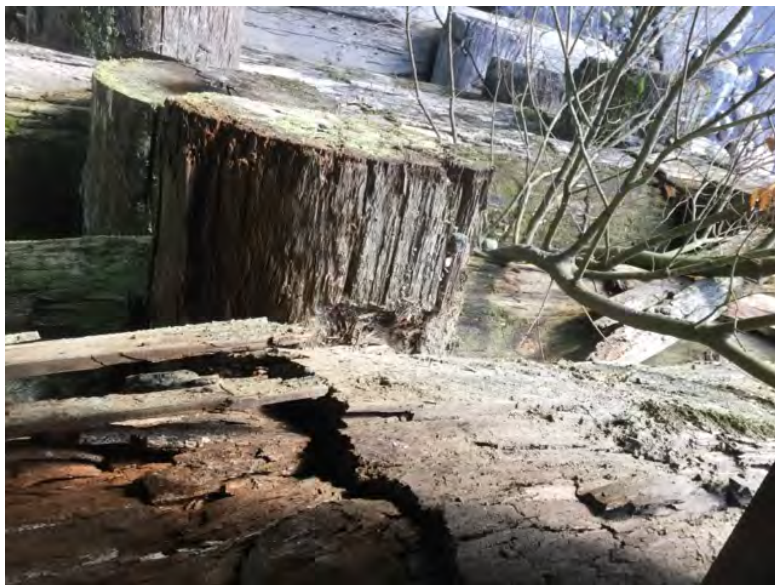
| | 1 | Top face log condition at the left face of Pier | | | | | | | | |

Vertical crack in top face log of left face of Pier
