CK-2262

STAVE 9.4km

2019 Inspection

| Structure Class | Temporary Bridge |

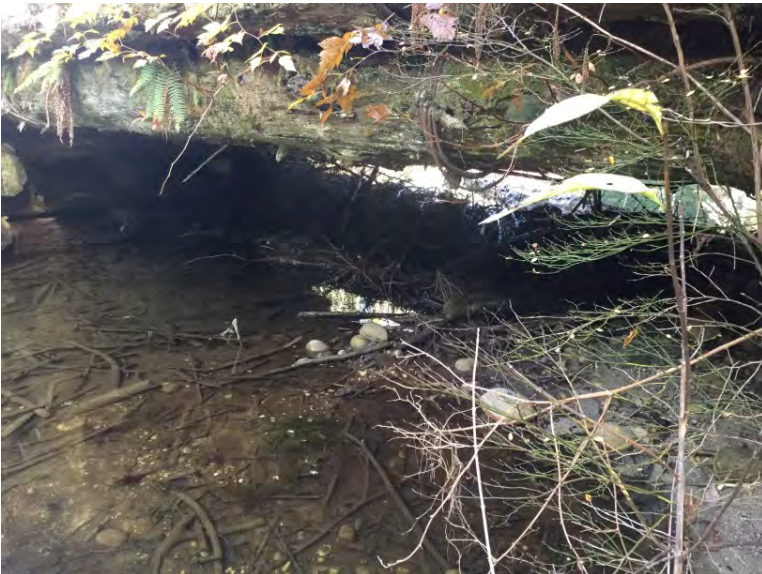
Comments Beaver activity has resulted in stream blockage. Stream flow is getting through but has caused significant flooding upstream of crossing

Beaver activity has resulted in almost complete blockage of stream

| 1 | High | Remove beaver dam |

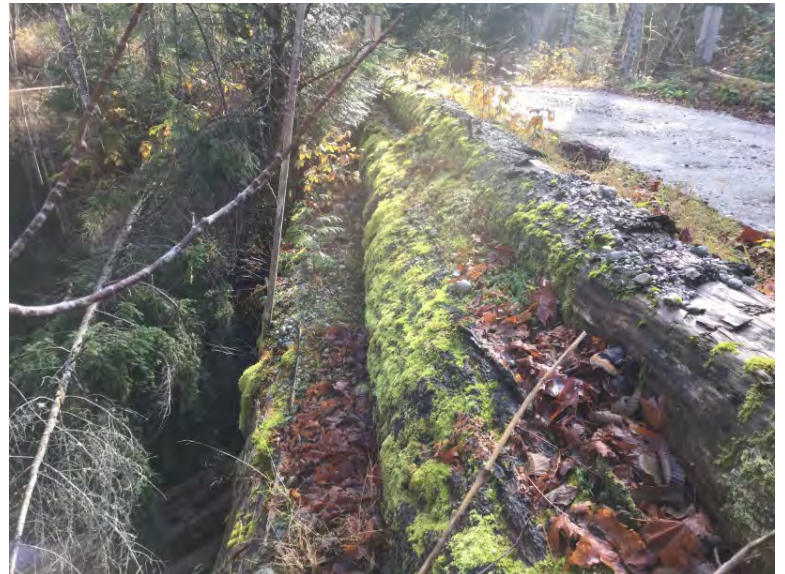
There are 2 layers of stringers on this structure. Neither layer is accessible for a proper assessment.

Stringers over stringers

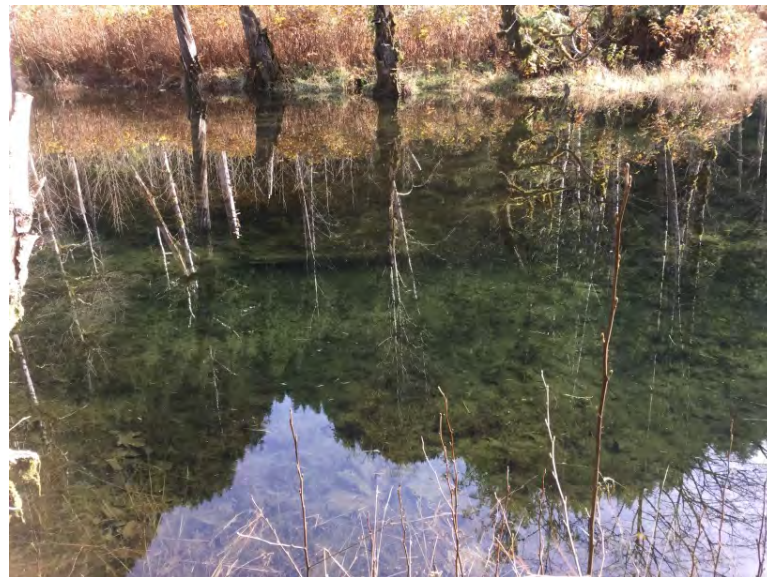
Significant flooding upstream
